re: **Proposed Residential Subdivision**
Lot 2 in DP1115877 - 53A Warriewood Road, Warriewood
Contamination Assessment Report Update

Lot 2 in DP1115877 – 53A Warriewood Road, Warriewood

**DRAWING NO 14855/1-AA1
(SITE FEATURES)**

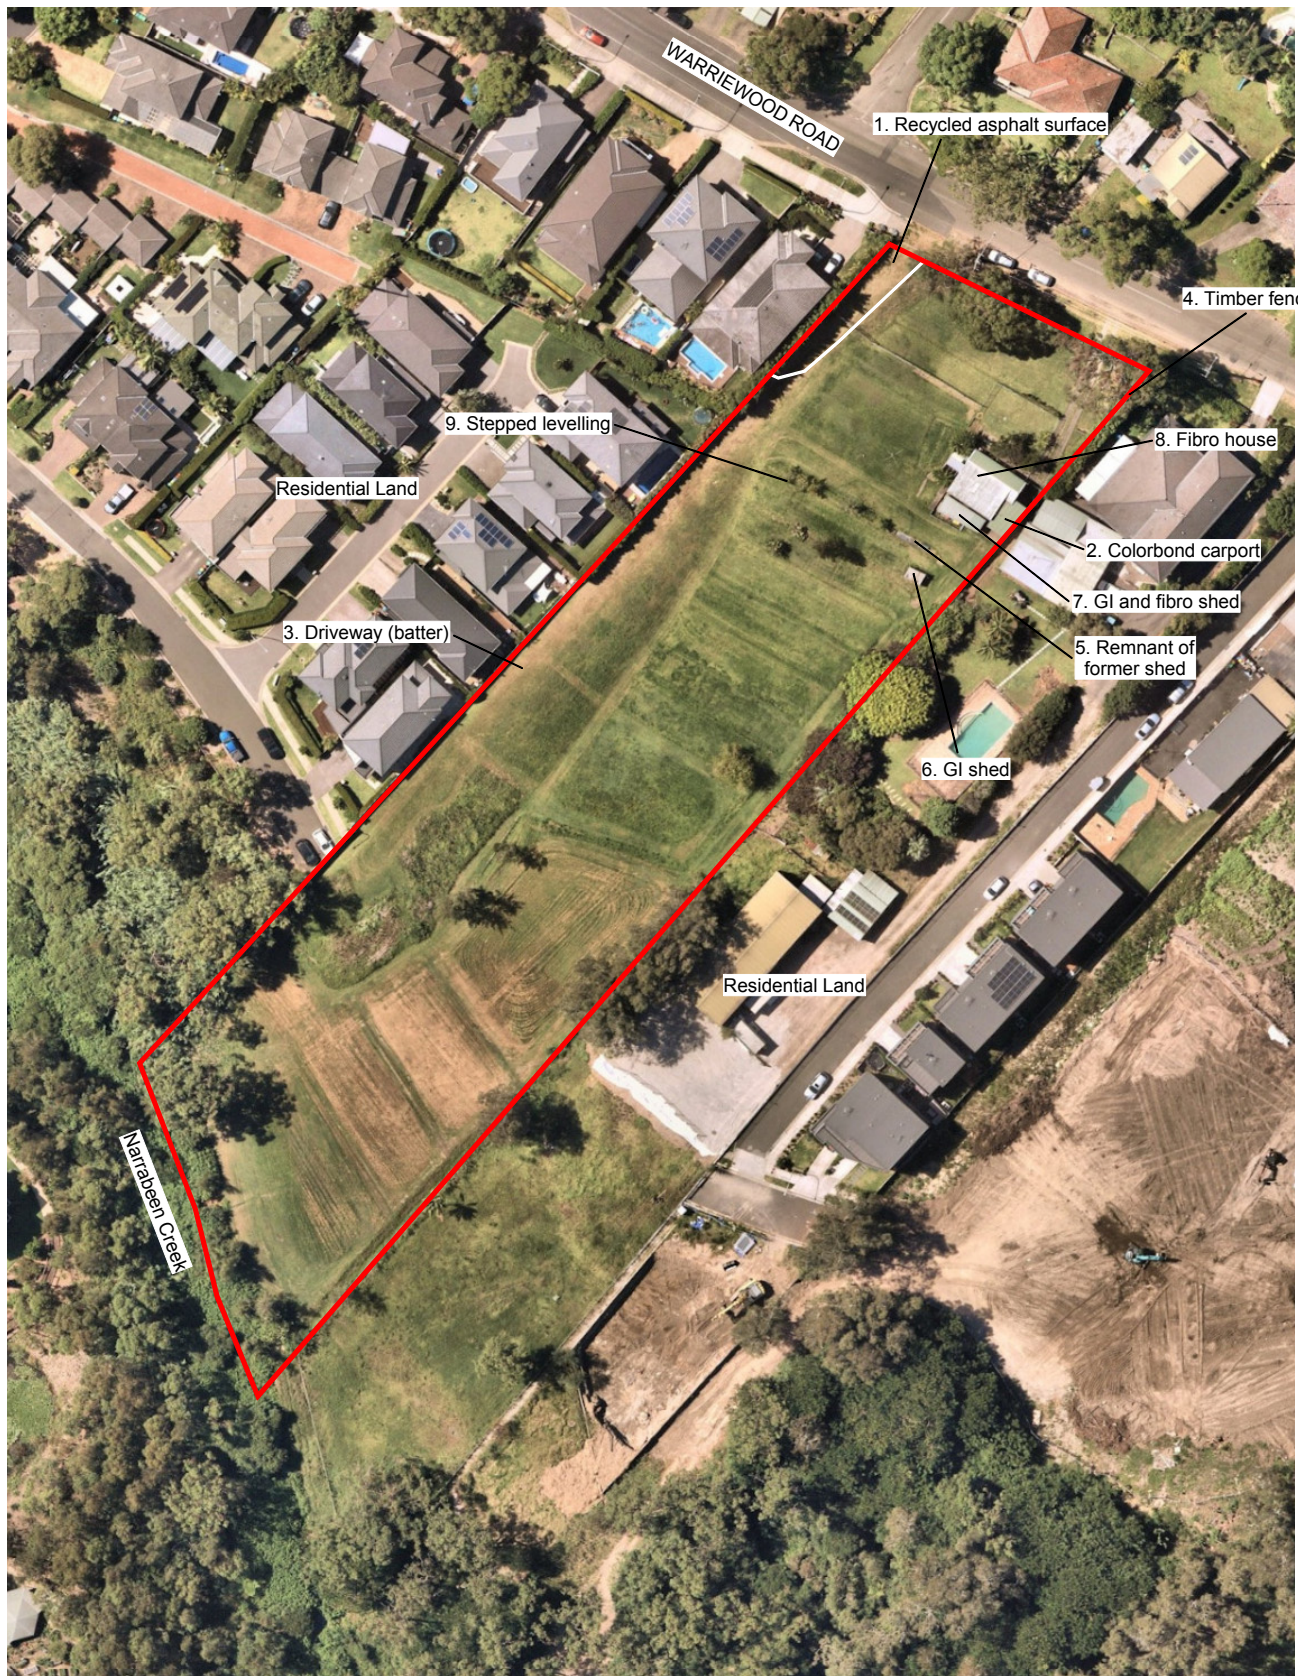
At the time of inspection on 10 February 2021 by an Environmental Scientist from Geotechnique as a part of report updated, the site comprised one (1) individual property (53A Warriewood Road) facing Warriewood Road, as observed during Phase 1 PCA in July 2014 and during the Phase 2 CA in May 2016. The site condition remains almost unchanged with the exception of removal of a glasshouse, a galvanised iron (GI) chook shed and a GI shed from the site, as indicated on Drawing No 14855/1-AA1 in Attachment A. The former glass house and GI chook shed were located near the remnant of former shed and the former GI shed was located adjacent to GI and fibro shed.

- Detailed sampling and testing in the vicinity of location of concern FCP2, as indicated on Drawing No 13757/2-AA2, to delineate the extent of asbestos contamination, as other locations of concern (TP14, TP20 and TP25) are located outside the current site boundary.
- Sampling and testing of soils in the footprints of site features such as the house, sheds and recycled asphalt covered area, after complete demolition and removal or clearing and in the footprints of former glass house and two former GI sheds.
- Development of a remedial action plan (RAP) to remediate asbestos contaminated natural sandy silt plus any other contamination identified through the recommended additional sampling and testing, followed by appropriate validation. We consider that the site can be made suitable for the proposed development following appropriate remediation and validation.

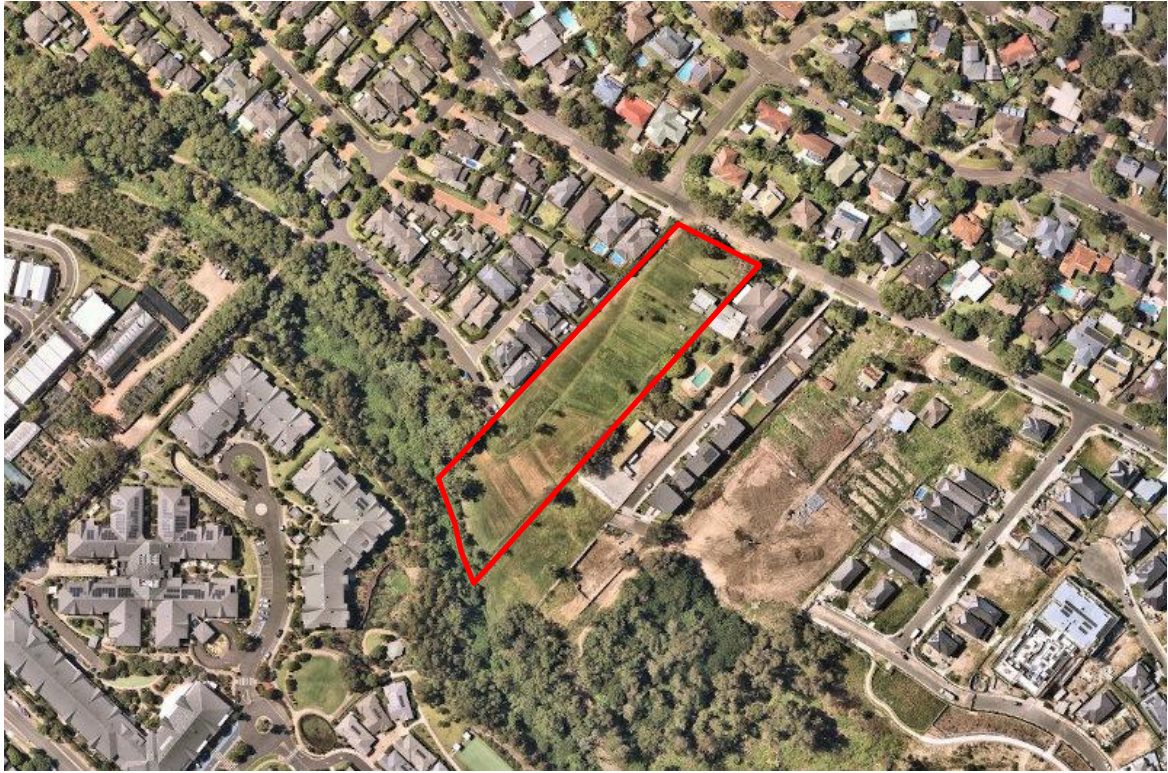
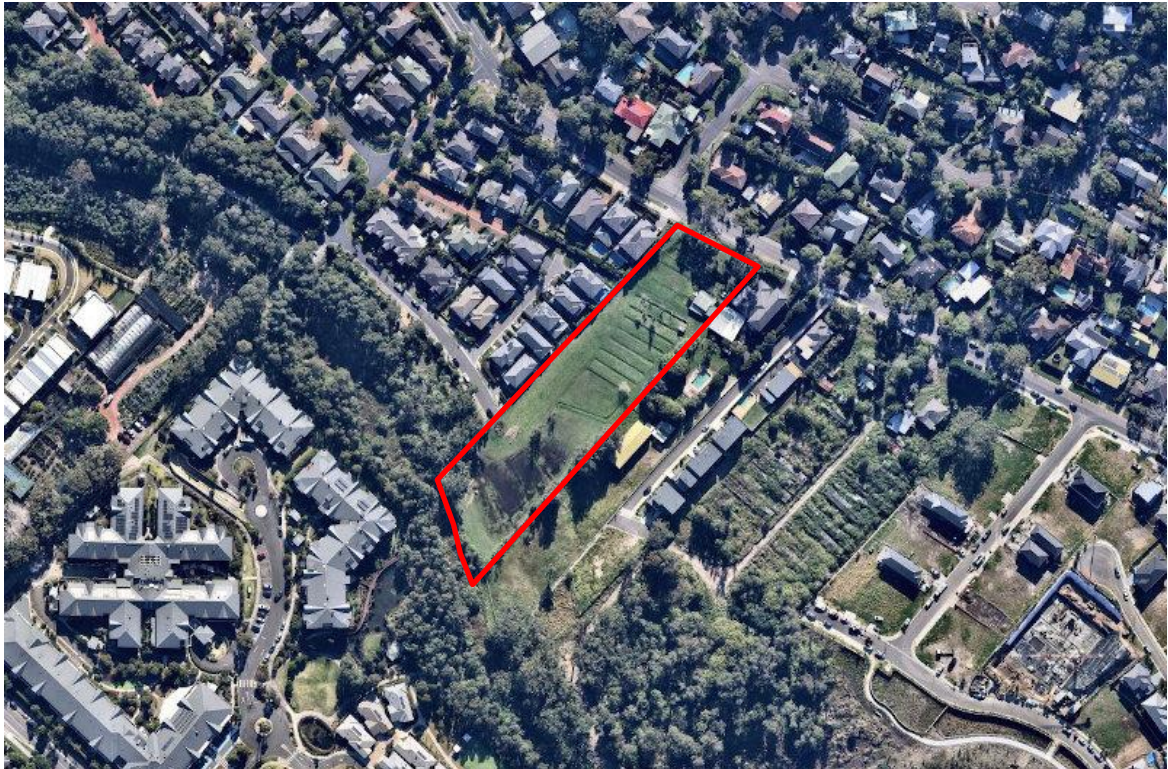
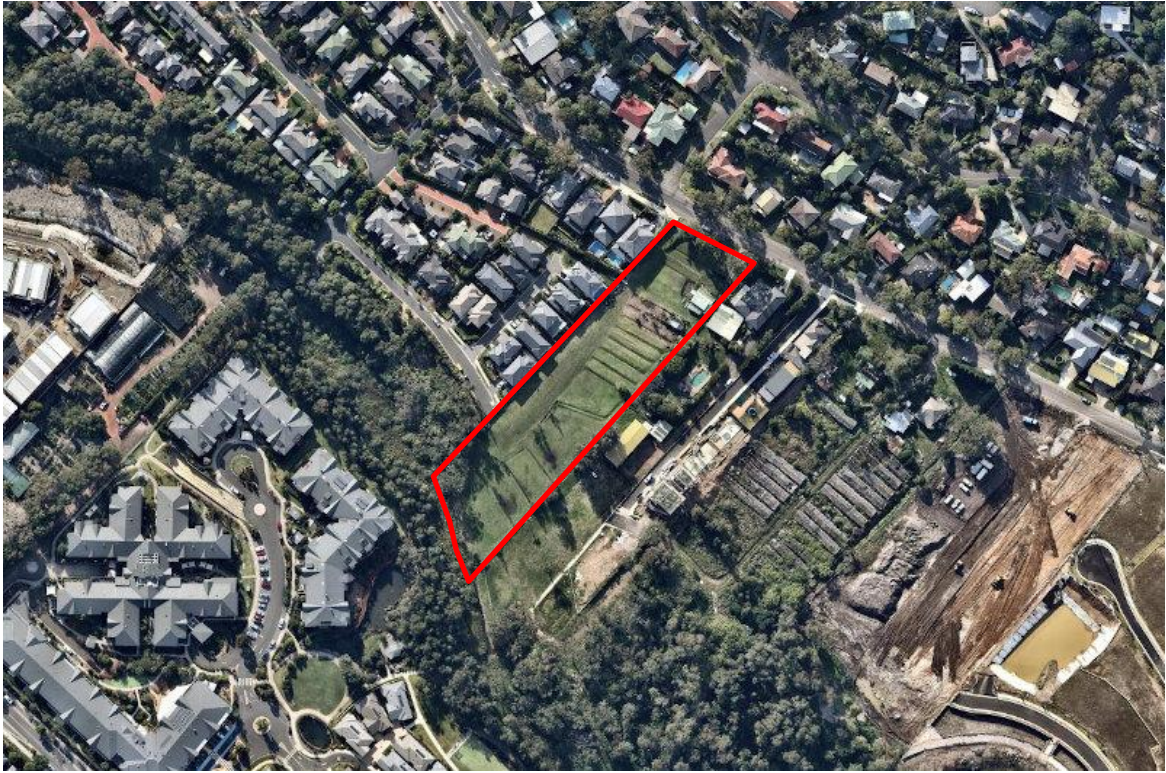
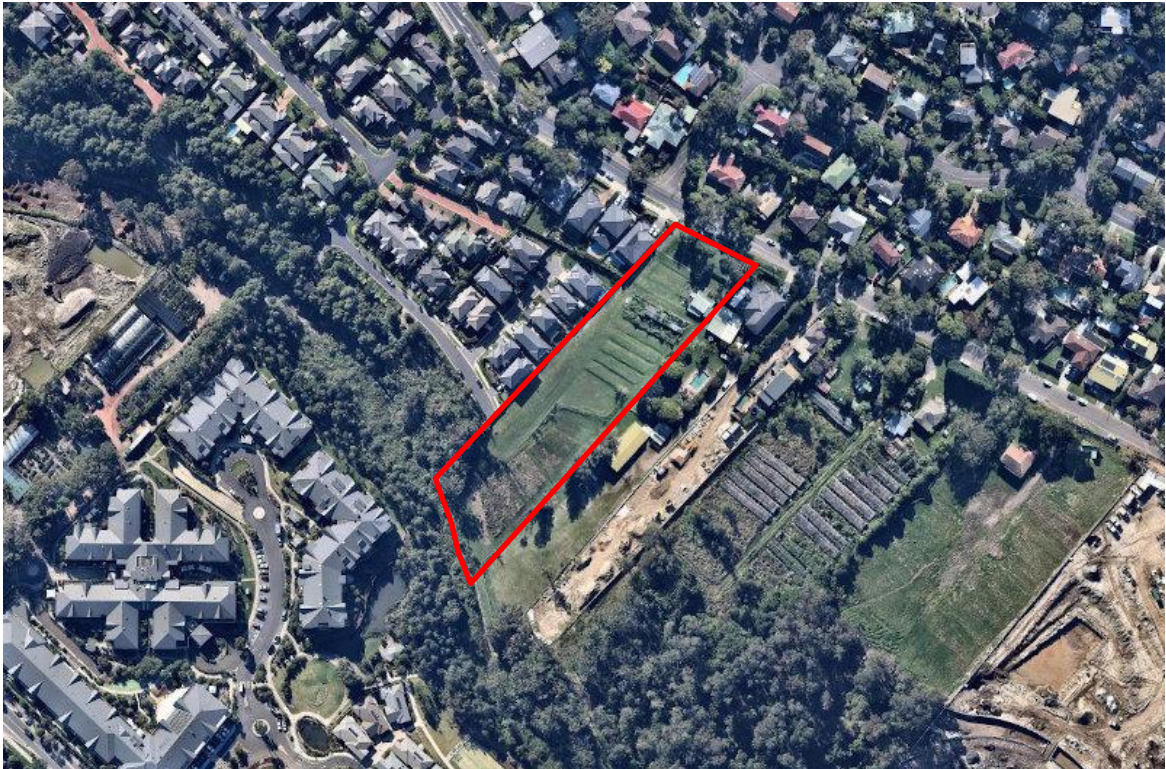
NearMap images in May 2017, June 2018, June 2020 and January 2021 in Attachment B also show no significant change to the site over this time period.
