# *Tree Assessment & Management Report for Development Application*

May 2021

**Site:** Lot 17 in DP 9362  
143 Balgowlah Road  
BALGOWLAH, NSW

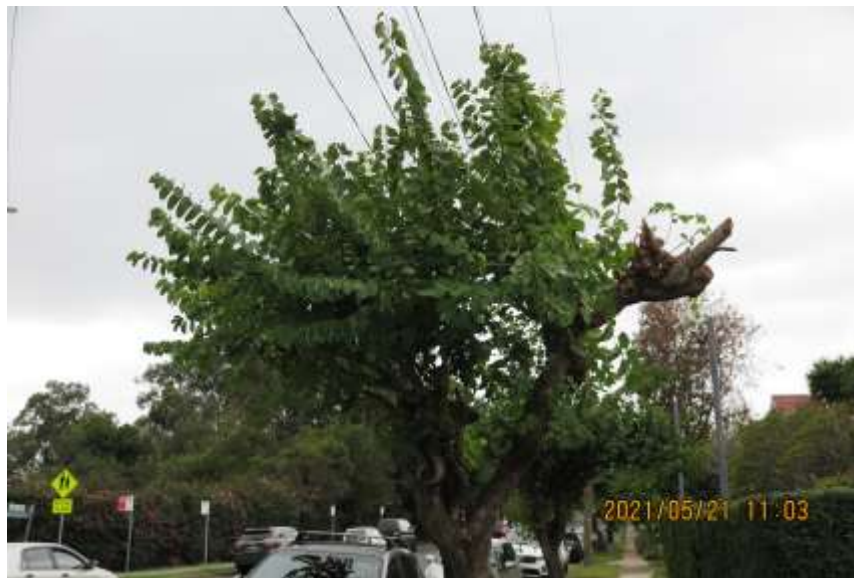
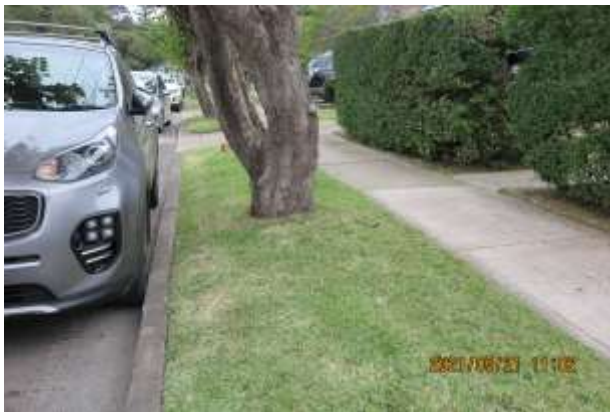
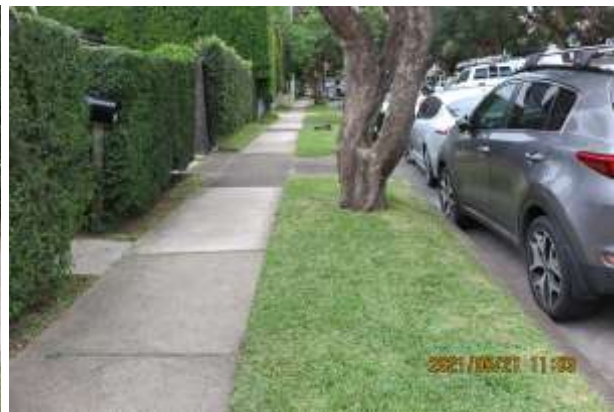
Approximate canopy spread: <7.50 (very poorly pruned/maintained)

Tree Canopy is 100% epicormic shoots by origin.

Tree is confirmed to have genetic structural defects most commonly called co-dominant stems with bark inclusions.

Figure 5: Illustrates tree health, location & growing environment.

**OPTION 2:** Total tree replacement. This can either be equal distance from east & west driveway crossovers or at a site specified by the NBC.

- Replacement tree must be sourced from a grower/supplier whose stock meets the production benchmarks within the *Australian Standard (AS2303-2015 Tree stock for landscape use)*.
- Tree must be professionally planted.
- Tree must be professionally managed for at least one (1) full coastal Sydney growing season (mid-August thru late-May).

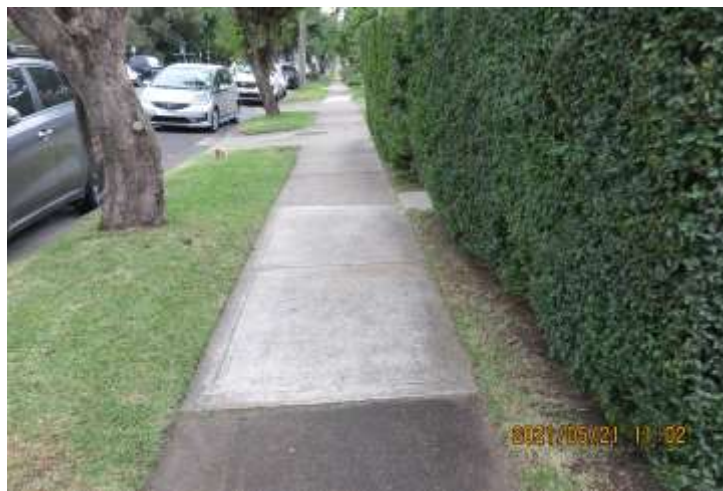
By virtue of tree condition, previous management (e.g., pruning) & the fact it has been subjected to likely multiple 'significant diameter live roots' being previously pruned (for concrete footpath repair, see below photographs) for long term sustainability of a tree in the present location of the discussed tree this document will support, total tree replacement.

Figure 6: Above confirms previous footpath repair that likely required supporting live roots to be severed. Below illustrates poor pruning practices undertaken over the long term.

**OPTION 1:** Undertake manual tree root location investigation so as to locate/confirm the presence or otherwise of any 'significant diameter live roots' being present. In this situation, 'significant diameter live roots' are defined as being greater than 50mm in diameter.

- Live Woody Tree Roots' less than 50mm in diameter can be cleanly pruned without the input of the sites retained Practicing/Consulting Arborist.
- Should any 'significant diameter' 'live woody tree roots' be exposed the sites retained Practicing/Consulting Arborist must be summonsed to assess & prepare a likely root pruning management strategy on a root by root basis.
- Completed line/s of excavation closest to the discussed tree trunk base must be photographed (only the retained Project Arborist can complete this) to confirm the strategy applied/supported relative to 'significant diameter live woody tree roots' required to be managed.
