1 Tabalum Road, Balgowlah Heights

Geotechnical Comments for New DA.

GEOTECHNICAL INVESTIGATION:

New House and Pool at 1 Tabalum Road, Balgowlah Heights

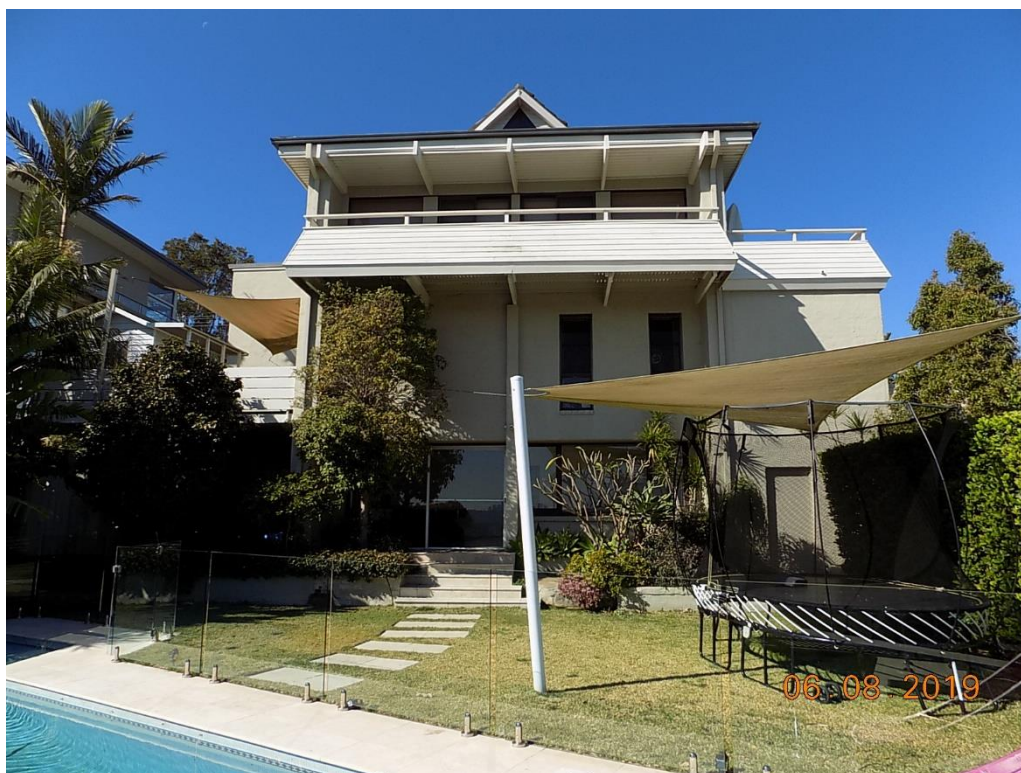
Photo 6

observed to be supported directly onto outcropping sandstone bedrock and will be demolished as part of the proposed works (Photo 6). A pool has been constructed on the downhill side of the property and will be partially demolished as part of the proposed works (Photo 7). A gently sloping lawn-covered fill has been placed around the pool and is supported by a stable sandstone block retaining wall ~4.0m high (Photo 8).

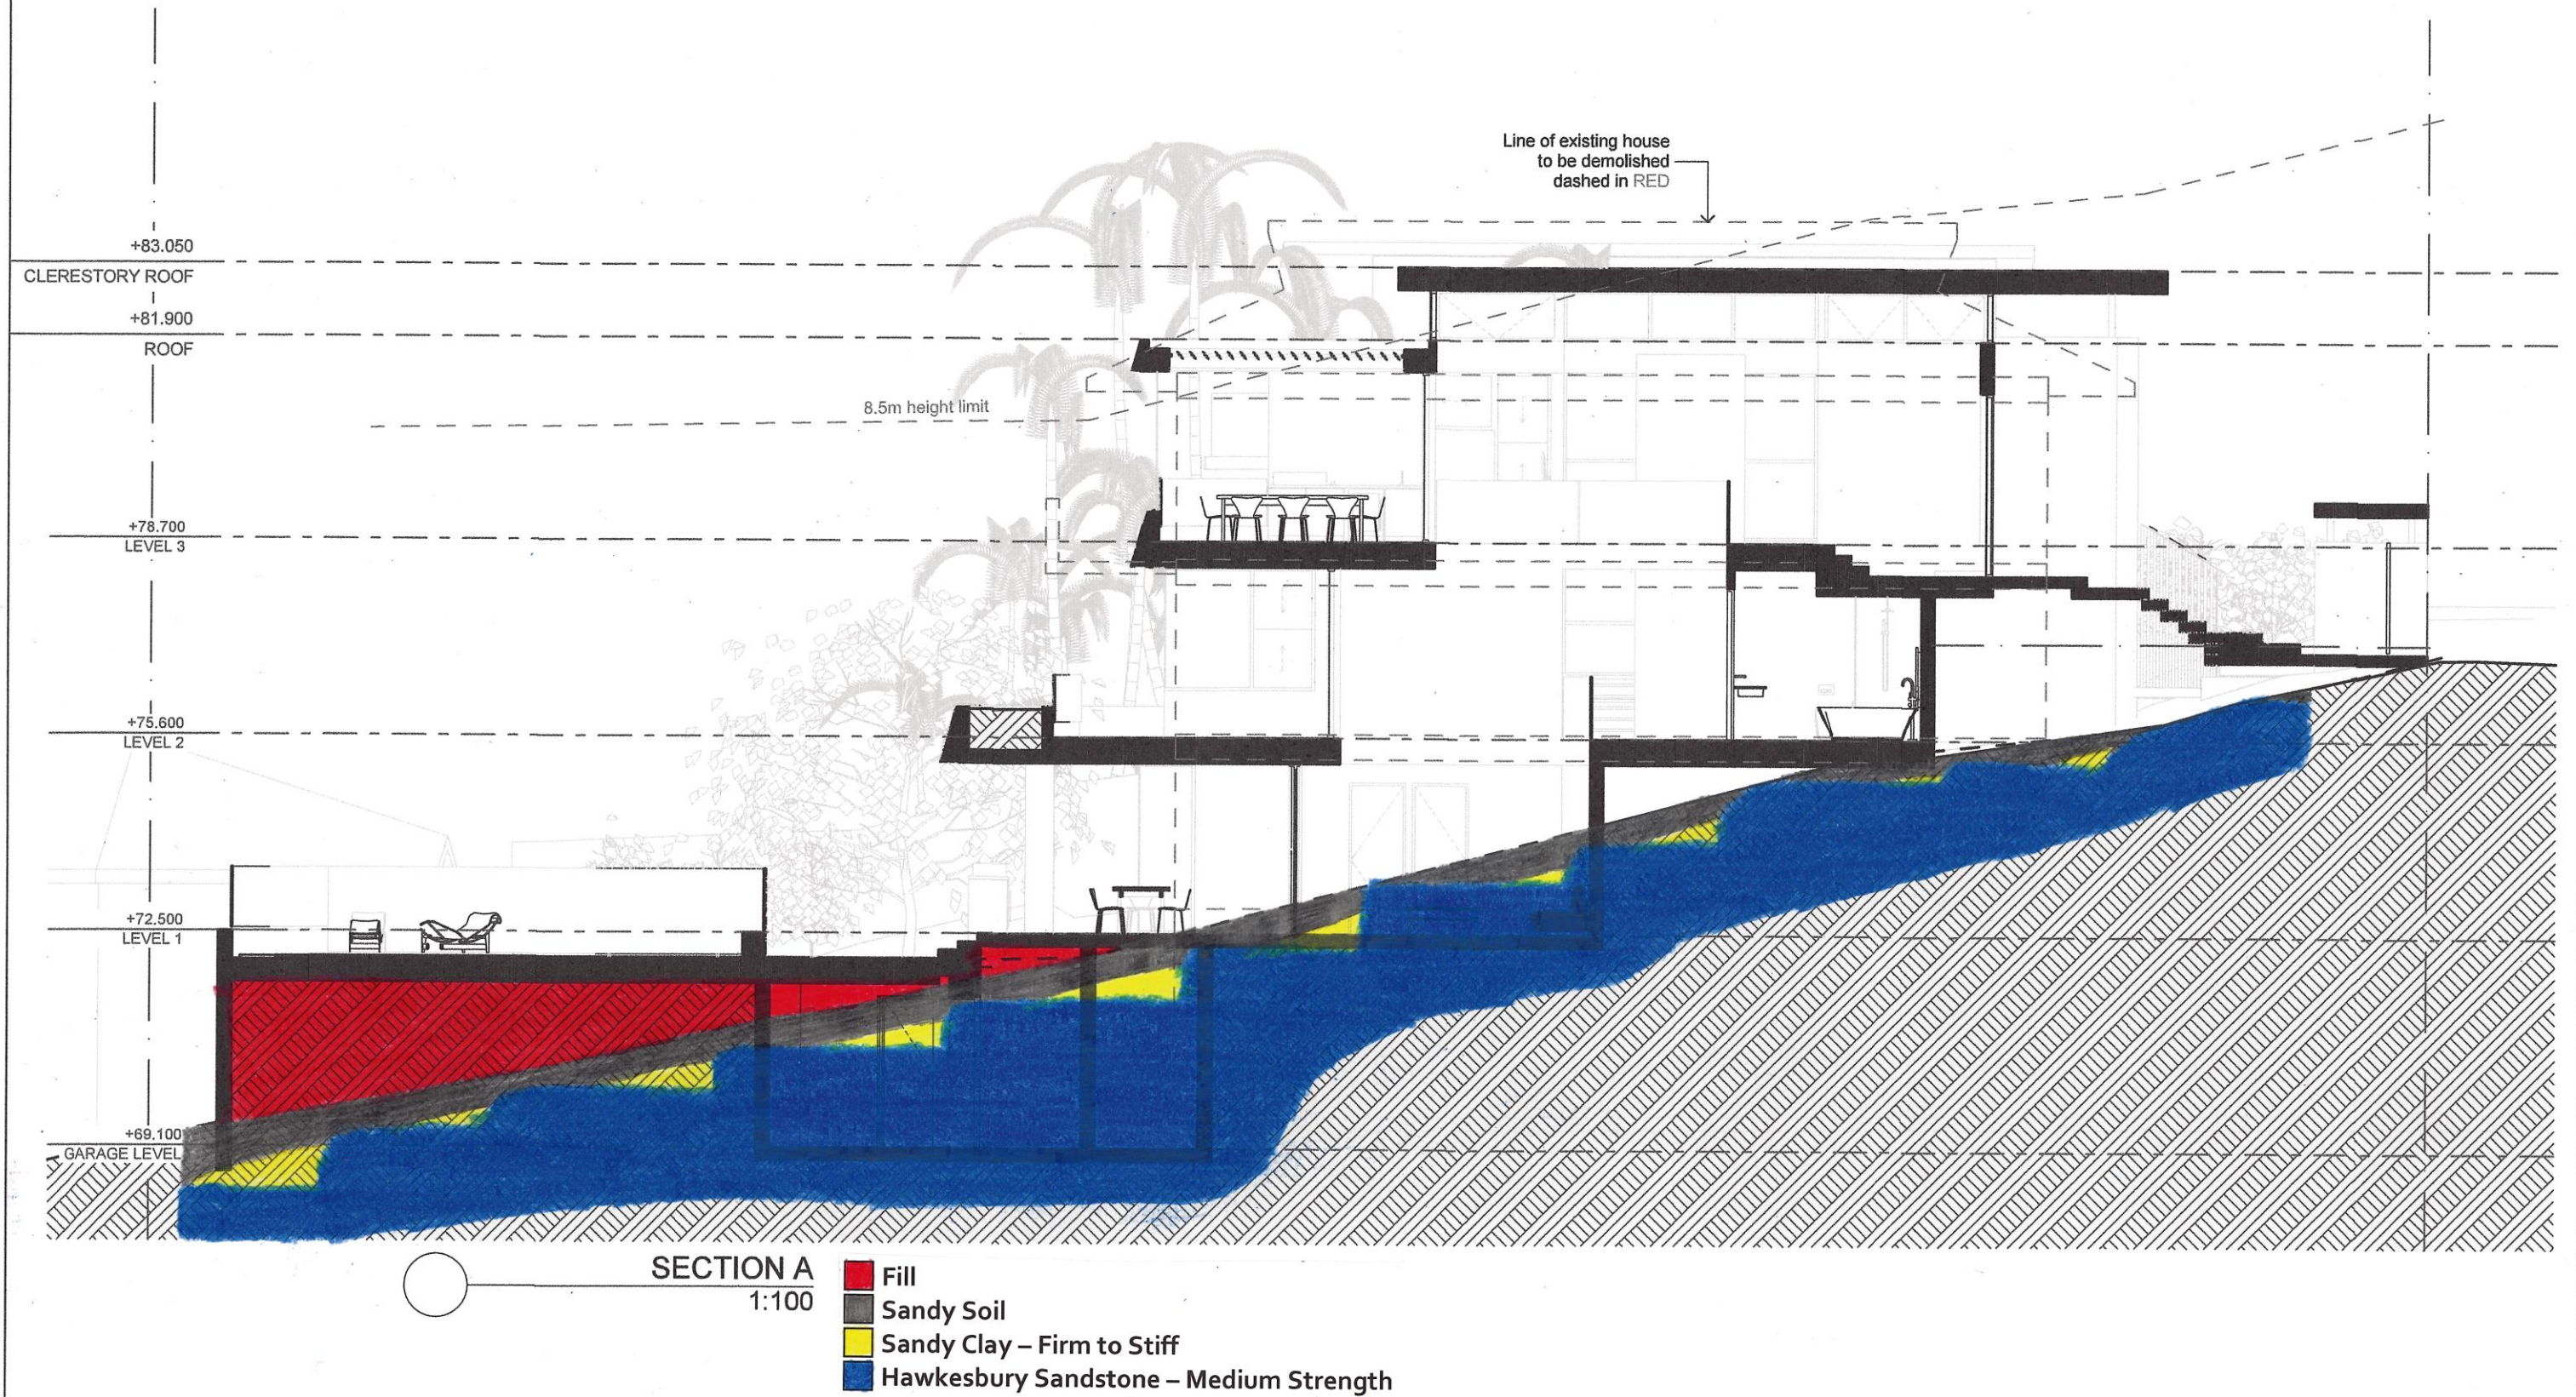
TYPE SECTION – Diagrammatical Interpretation of expected Ground Materials

The surface features of the block are controlled by the outcropping and underlying sandstone bedrock that steps down the property forming sub-horizontal benches between the steps. Where the grade is steeper, the steps are larger, and the benches narrower. Where the slope eases, the opposite is true. Where the rock is not exposed, it is overlain by natural sandy soils and firm to stiff sandy clays that fill the bench step formation. In the test locations, where rock was not exposed, it was encountered at depths of between 0.2 to 0.9m below the current surface, being deeper due to the stepped nature of the underlying bedrock. Relatively deep fill has been placed across the downhill side of the property for a level lawn and pool area. DCP5 was taken through this fill and encountered rock at a depth of 2.8m. The exposed sandstone across the site is estimated to be Medium Strength and a similar strength rock is expected to underly the entire site. See Type Section attached for a diagrammatical representation of the expected ground materials.
