Report Title: Geotechnical Report <b>34 Plateau Road, Bilgola Plateau</b>
Report Date: <b>30/05/24</b>
Author: <b>BEN WHITE</b>
Author's Company/Organisation: <b>WHITE GEOTECHNICAL GROUP PTY LTD</b>

## **GEOTECHNICAL INVESTIGATION:**

House Extension and New Carport at **34 Plateau Road, Bilgola Plateau**

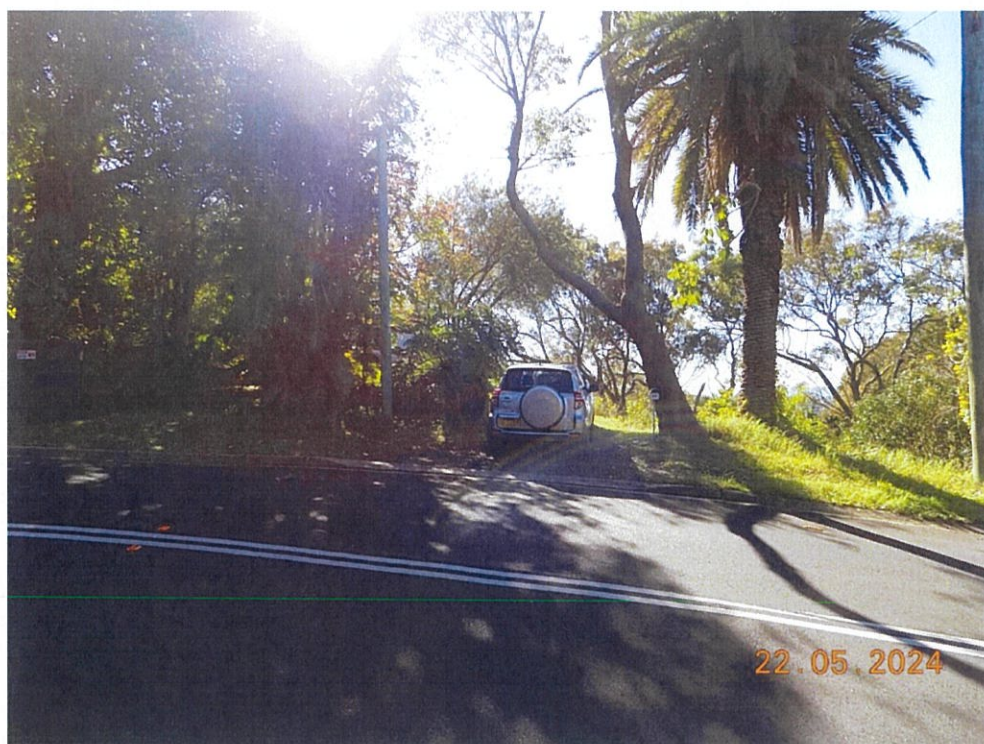
Photo 1

- 2.3** At the road frontage, a bitumen driveway runs to a parking area on the S side of the house (Photo 1). A Hawkesbury Sandstone rock face that is estimated to be up to ~5m high is located on the downhill side of the driveway and house (Photos 2 to 4). A portion of the rock face near the S end has detached (Photo 5) but appears to be currently stable and is set back sufficiently from the driveway/parking area. A portion of the rock face near the downhill side of the house is undercut by up to ~1.5m (Photo

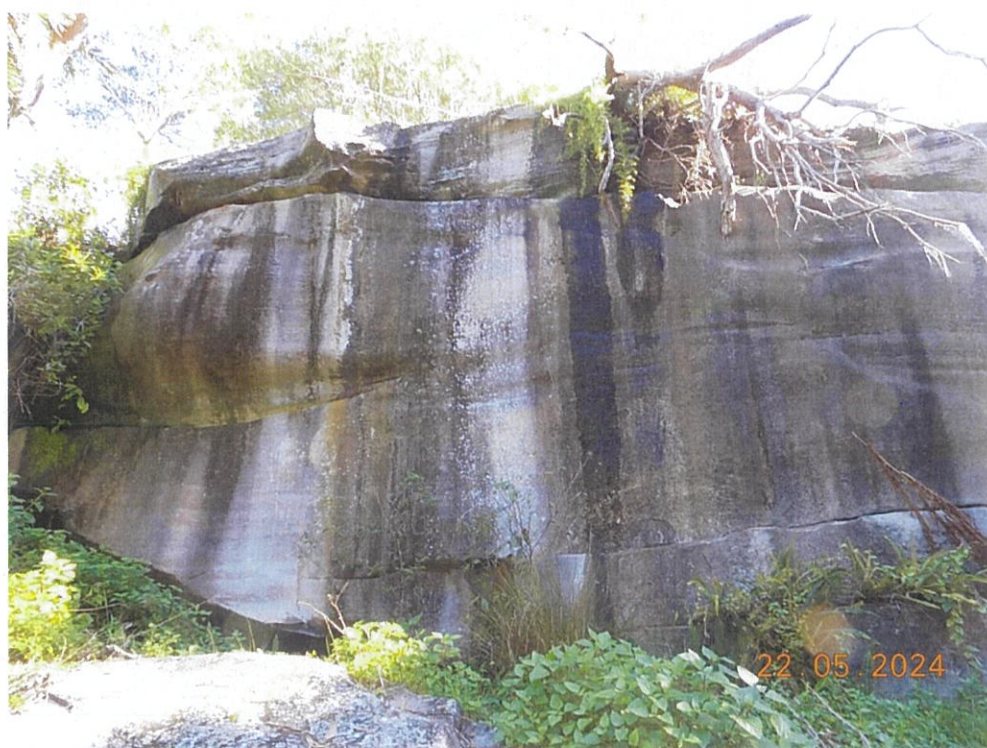
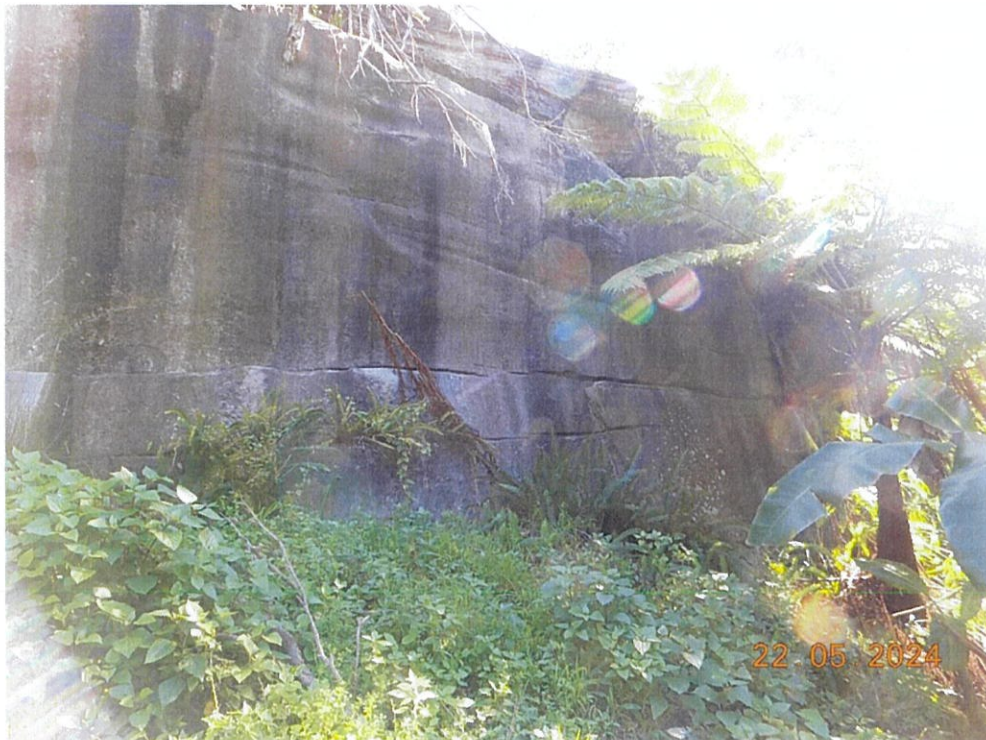
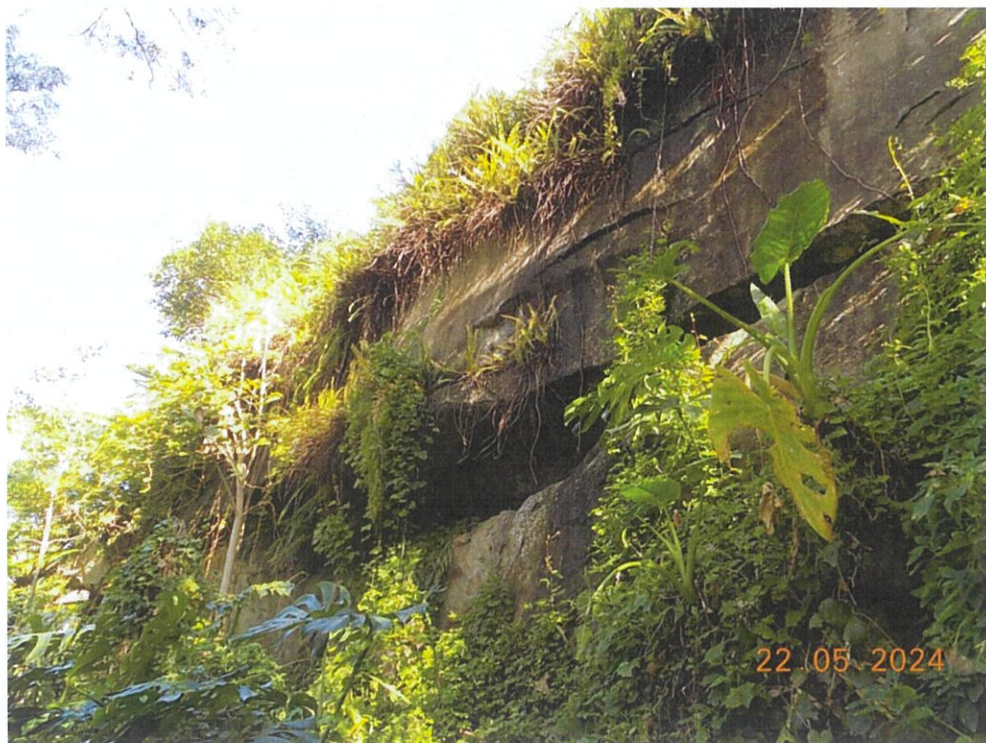
Photo 2

HAZARDS	Hazard One	Hazard Two
TYPE	The moderate to steep slope that falls across the property and continues above and below failing and impacting on the property.	A mass failure of the cliff on the downhill side of the house (Photos 2 to 6) impacting on the property.
LIKELIHOOD	'Unlikely' ( $10^{-4}$ )	'Unlikely' ( $10^{-4}$ )
CONSEQUENCES TO PROPERTY	'Medium' (12%)	'Medium' (30%)
RISK TO PROPERTY	'Low' ( $2 \times 10^{-5}$ )	'Low' ( $2 \times 10^{-5}$ )
RISK TO LIFE	$8.3 \times 10^{-7}$ /annum	$8.3 \times 10^{-7}$ /annum
COMMENTS	This level of risk is 'ACCEPTABLE'.	This level of risk is 'ACCEPTABLE'.

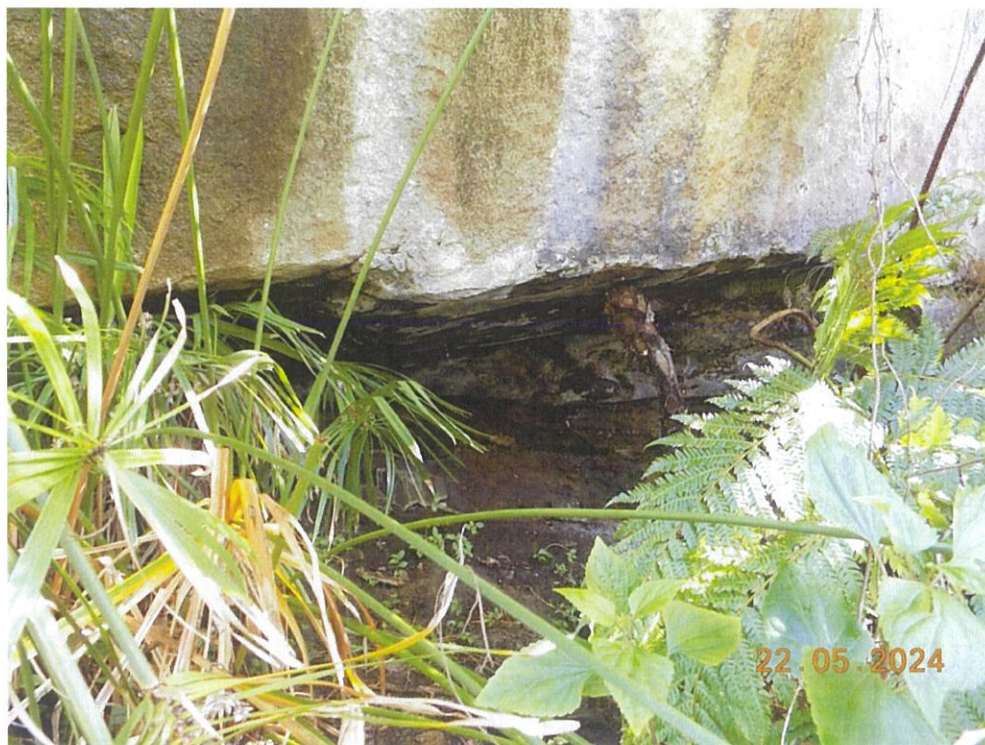
Photo 6

6). The timber deck on the downhill side of the house is constructed over the undercut (Photos 7). However the undercut has a thick cantilever arm in relation to its overhang length and is considered to be stable.

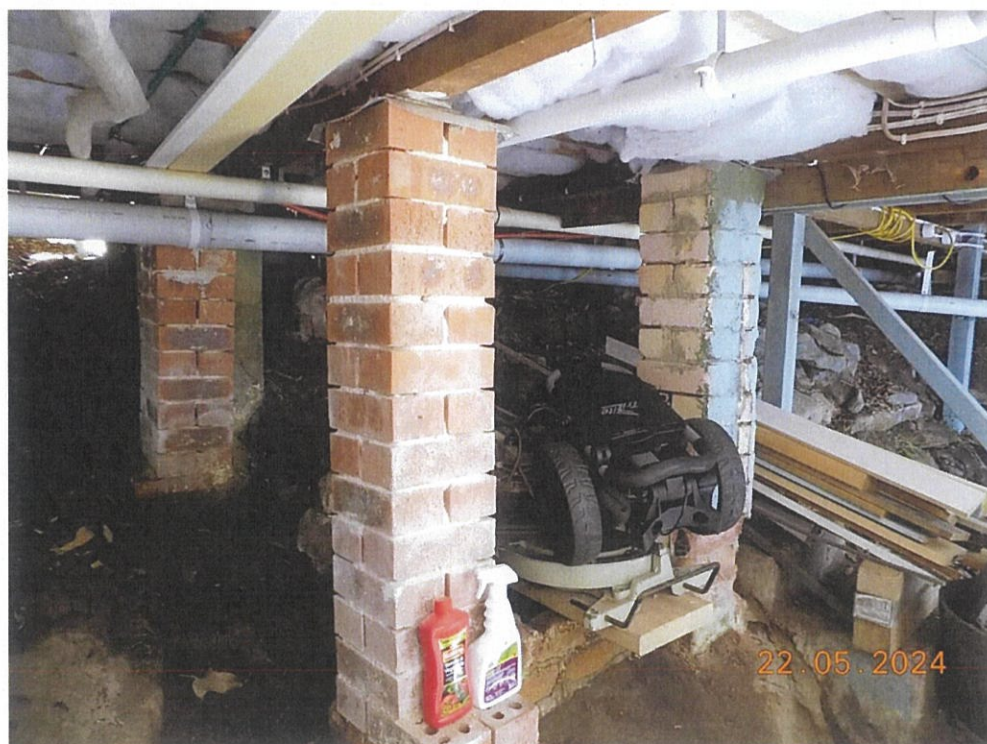
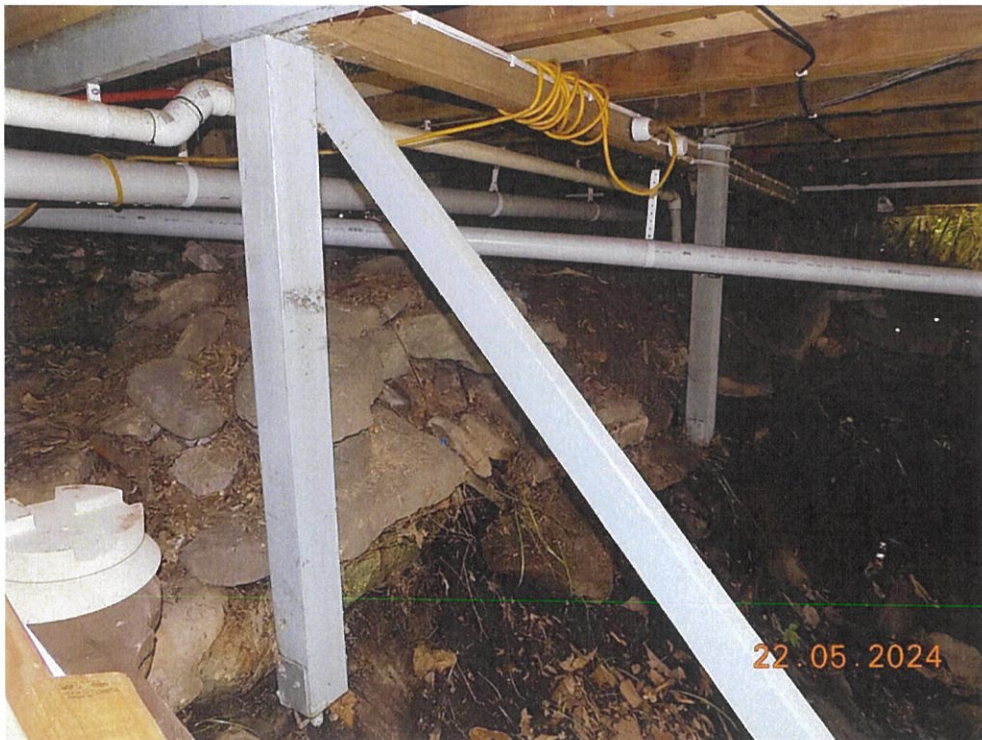
Photo 8

The single storey timber clad house is supported by brick walls, brick piers, and timber posts, (Photos 8 & 9). Some of the supporting walls and piers were observed to be supported on outcropping competent Medium Strength Sandstone from within the foundation space of the house. No significant signs of movement were observed in the supporting walls, and the supporting piers stand vertical. Stable Sandstone bedrock outcrops on the uphill side of the house (Photo 10). Low fill terraces a lawn area uphill of the rock (Photo 11). A fibre cement, steel clad and concrete block garage/workshop is located near the uphill property boundary (Photo 12). No signs of slope instability were observed on the property that could have occurred since the property was developed. The adjoining neighbouring property was observed to be in good order as seen from the street and subject property.

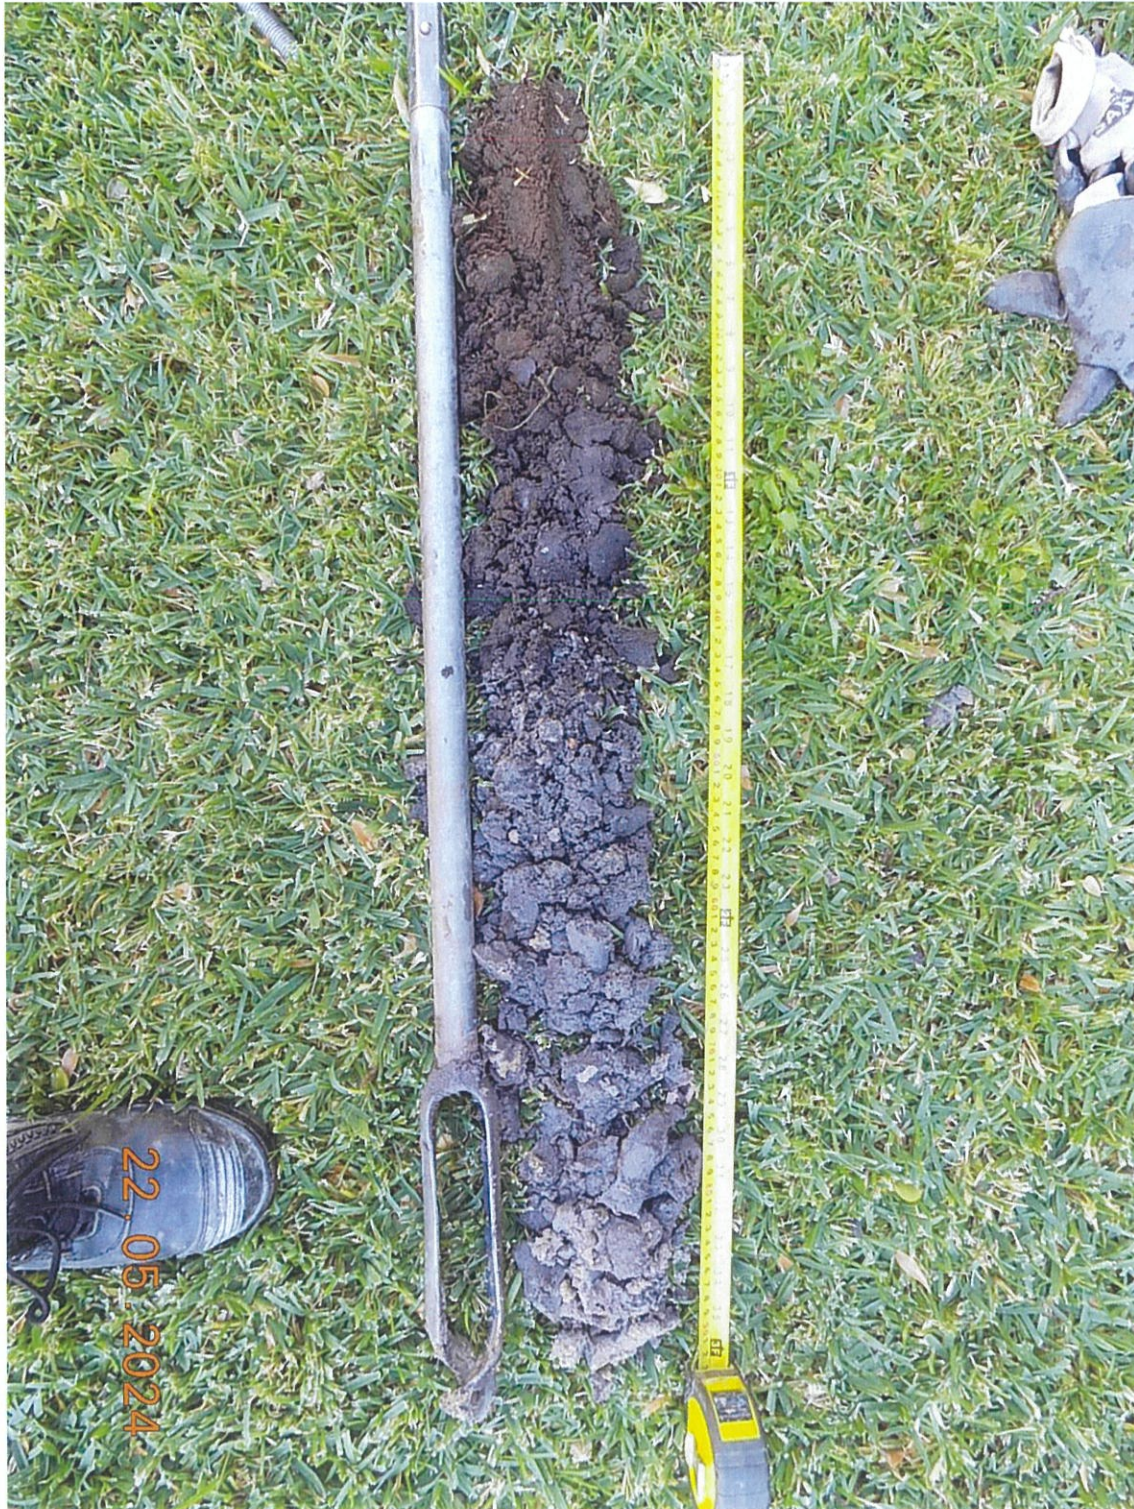
## AUGER HOLE 1 (~RL107.5) – AH1 (Photo 13)

Depth (m)	Material Encountered
0.0 to 0.5	<b>CLAYEY TOPSOIL</b> , dark brown, Very Soft, damp, fine to medium grained.
0.5 to 0.9	<b>SANDY CLAY</b> , dark to light grey, Firm, damp, fine to coarse grained, texture becomes sugary prior to refusal.

Refusal @ 0.9m on rock. Auger grinding. No water table encountered.

Photo 13 – AH1 – downhole is top to bottom

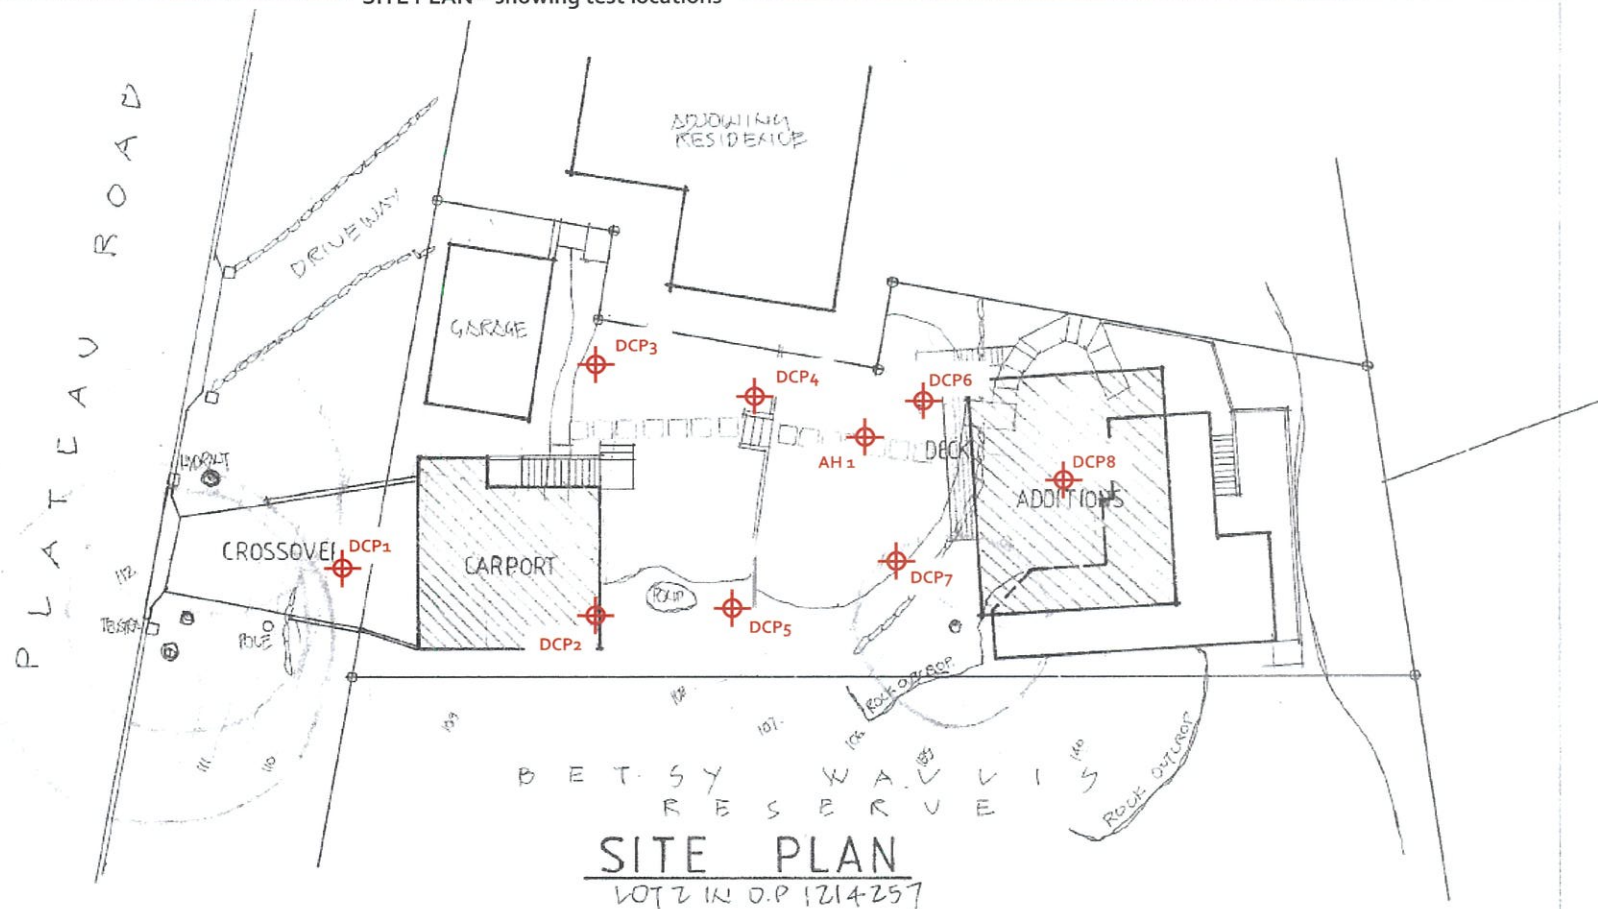
# SITE PLAN – showing test locations

One hand Auger Hole (AH) was put down to identify the soil materials. Eight Dynamic Cone Penetrometer (DCP) tests were put down to determine the relative density of the overlying soil and the depth to bedrock. The locations of the tests are shown on the site plan attached. It should be noted that a level of caution should be applied when interpreting DCP test results. The test will not pass through hard buried objects so in some instances it can be difficult to determine whether refusal has occurred on an obstruction in the profile or on the natural rock surface. This is not expected to have been an issue for this site. But due to the possibility that the actual ground conditions vary from our interpretation there should be allowances in
