# Geotechnical Assessment

**Project:** Alterations & Additions  
73 Telopea Street, Collaroy Plateau NSW

**Prepared for:**  
Mr & Mrs Berkhout

**Ref:** AG 25185  
9 May 2025

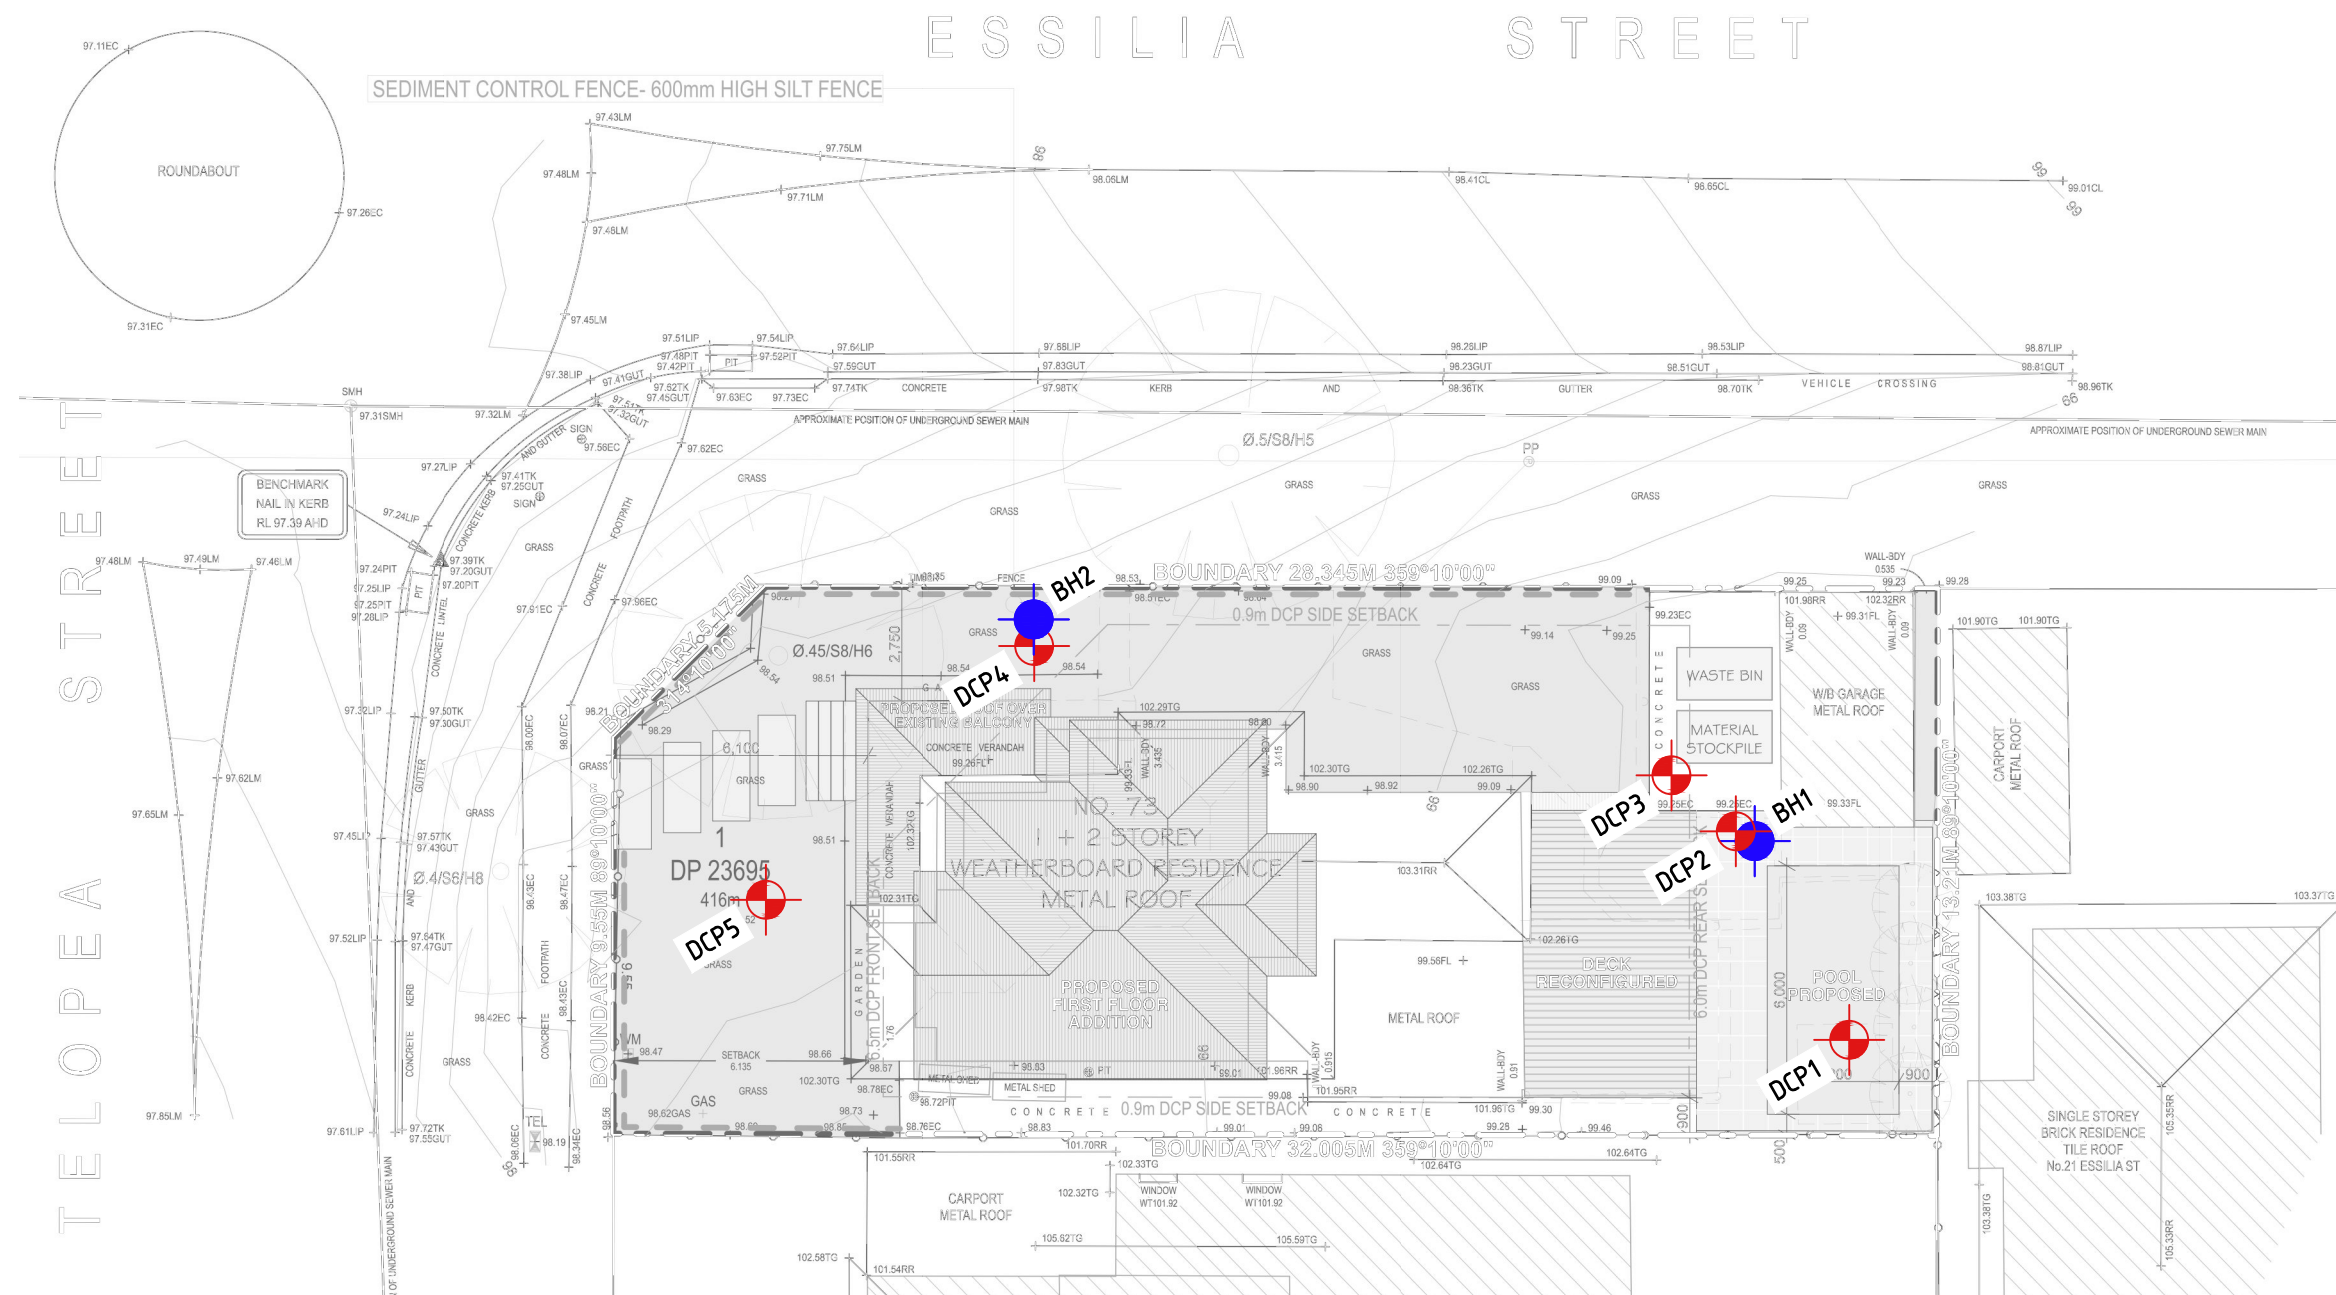
**SITE PLAN/GROUND TEST LOCATIONS**  
SCALE NTS

Test	Summary
DCP 1	Refusal @ 0.6m Bouncing on bedrock. Brown sand on moist tip.
DCP 2	Refusal @ 0.7m Bouncing on bedrock. Brown sand on moist tip.
DCP 3	Refusal @ 0.9m Bouncing on bedrock. Brown sand on moist tip.
DCP 4	Refusal @ 0.9m Bouncing on bedrock. Brown sand on moist tip.
DCP 5	Refusal @ 0.8m Bouncing on bedrock. Brown sand on moist tip.

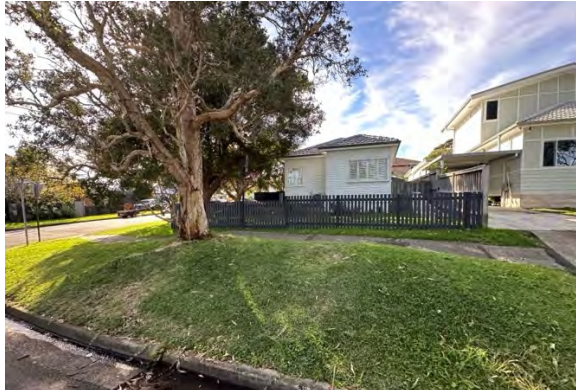
**Photo 1:** Site frontage, looking north.

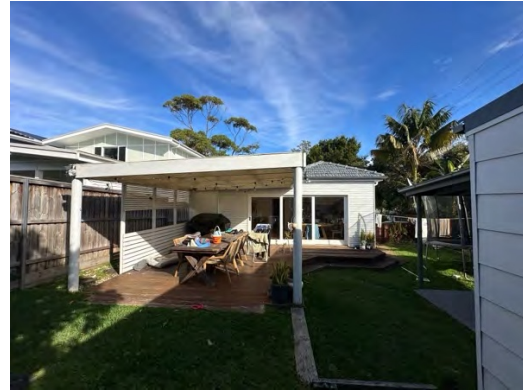
**Photo 2:** Photo taken from northern boundary, looking south.

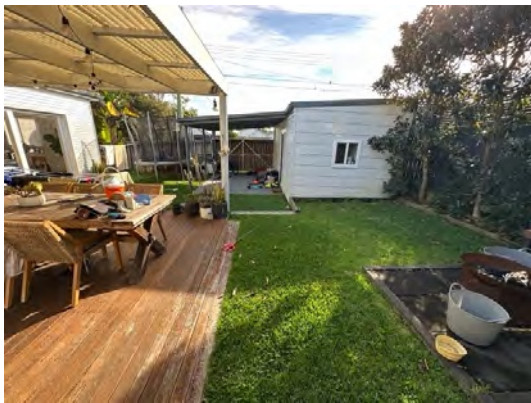
**Photo 3:** Photo taken from outside of northeastern corner of site, looking west.

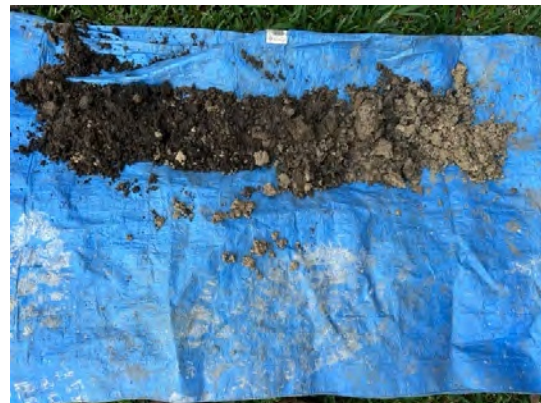
The soil profile consists of shallow uncontrolled fill and silty topsoil (O & A Horizons), silty sand (B Horizon) and weathered bedrock (C Horizon). Based on our observations and the results of testing on site, we would expect weathered sandstone bedrock to be found within 0.6 to 0.9 metres below current surface levels across the area of the proposed works and potentially deeper where filling has been carried out.

**Photo 4:** Subsurface soil profile of BH01.

<b>Footings</b>	<p>We recommend that all new footings are taken to and founded directly upon the underlying sandstone bedrock (Unit 3) using piers as required.</p> <p>The allowable bearing pressure for footings taken to competent weathered bedrock of at least low strength is <b>800kPa</b>. Higher allowable bearing capacities may be achievable subject to inspection and certification of excavated footings by AscentGeo.</p>
