Report Title: Geotechnical Report 187 Riverview Road, Avalon Beach

Report Date: 7/9/23

## **GEOTECHNICAL INVESTIGATION:**

New House and Pool at **187 Riverview Road, Avalon**

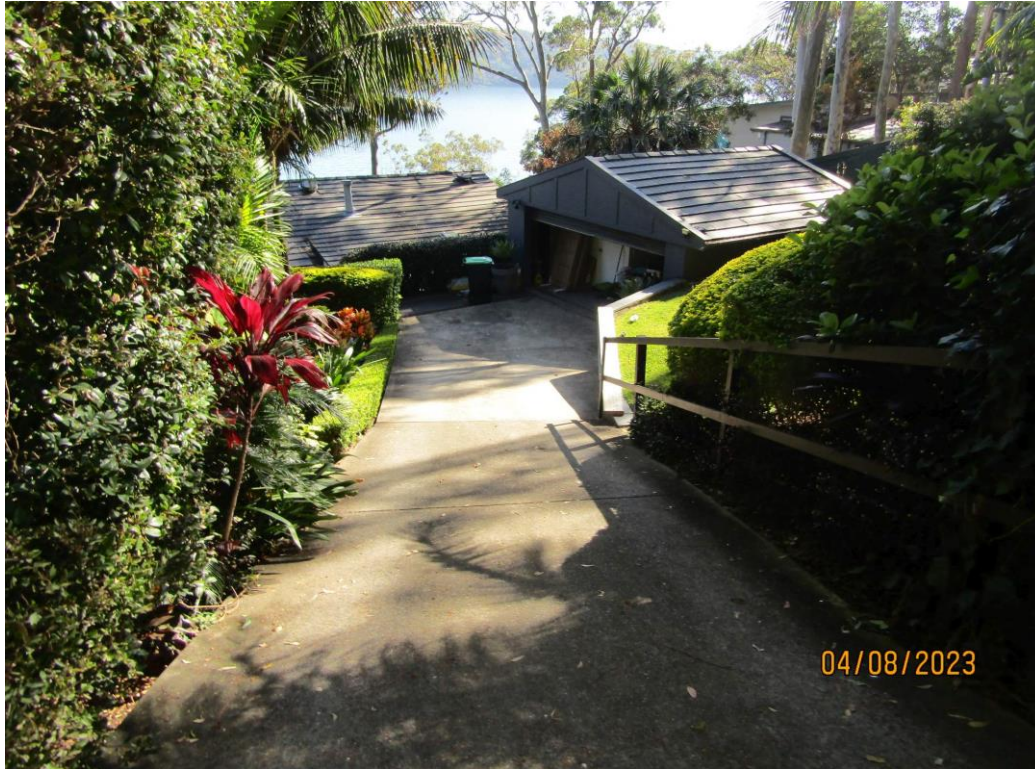
Photo 1

**2.3** At the road frontage, a concrete driveway runs down the slope to a rendered masonry garage that shows no significant signs of movement (Photo 1). Rendered masonry and concrete block retaining walls up to  $\sim 1.8\text{m}$  high beside and below the driveway support cuts and fills for lawn and garden areas (Photos 1 & 2). The upper retaining wall displays a vertical crack, but will be demolished as part of the proposed works. The two storey rendered brick house is supported on brick walls (Photos 3 & 4). The external supporting walls show no significant signs of movement.

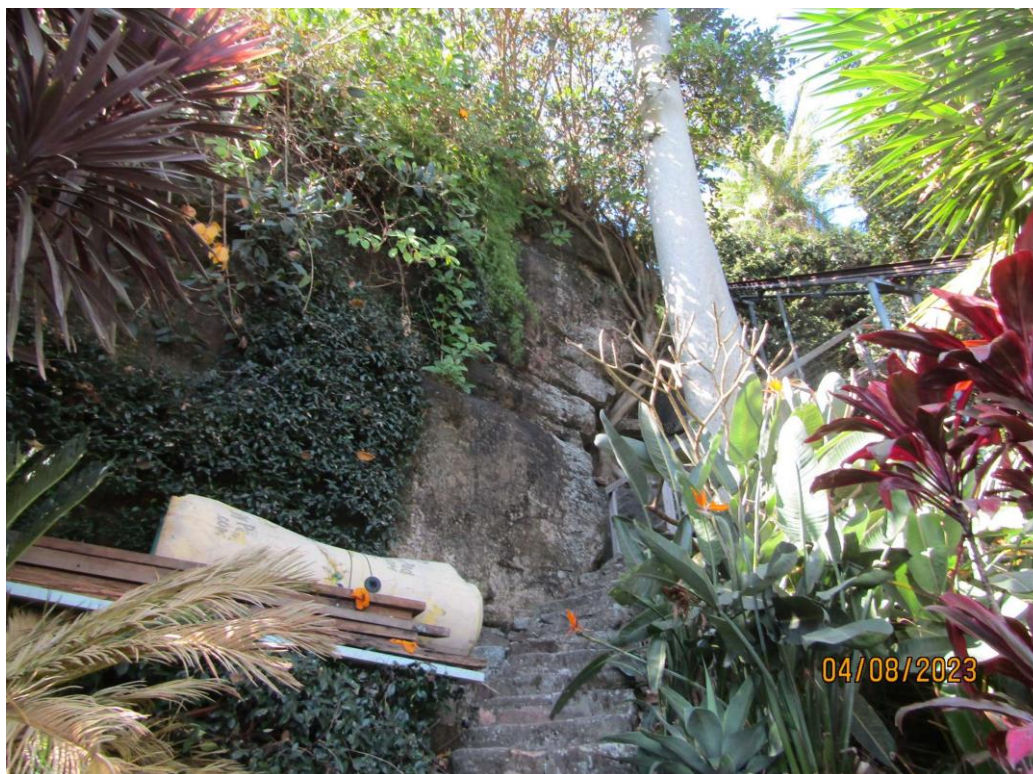
Photo 7

Excavations through Medium Strength Rock or better should be carried out to minimise the potential to cause vibration damage to the S and N neighbouring properties and jointed sandstone rock face (Photos 7 & 8). Allowing for backwall drainage, the excavation is set back ~3.0m from the S neighbouring house, ~1.0m from the S neighbouring garage, ~1.7m from the N neighbouring house (currently under construction), ~1.2m from the N neighbouring garage (currently under construction) and is estimated to be set back ~3.0m from a joint in the sandstone rock face (Photo 8).

Excavation methods are to be used that limit peak particle velocity to 5mm/sec at the neighbouring houses and at the jointed sandstone rock face (Photos 7 & 8). Vibration monitoring will be required to verify this is achieved. Vibration monitoring must include a light/alarm so the operator knows if vibration limits have been exceeded. The equipment is to log and record vibrations throughout the excavation works.

- Rock sawing the excavation perimeter to at least 1.0m deep prior to any rock breaking with hammers, keeping the saw cuts below the rock to be broken throughout the excavation process.
- Limiting rock hammer size.
- Rock hammering in short bursts so vibrations do not amplify.
- Rock breaking with the hammer angled away from the nearby sensitive structures.
- Creating additional saw breaks in the rock where vibration limits are exceeded, as well as reducing hammer size as necessary.
- Use of rock grinders (milling head).

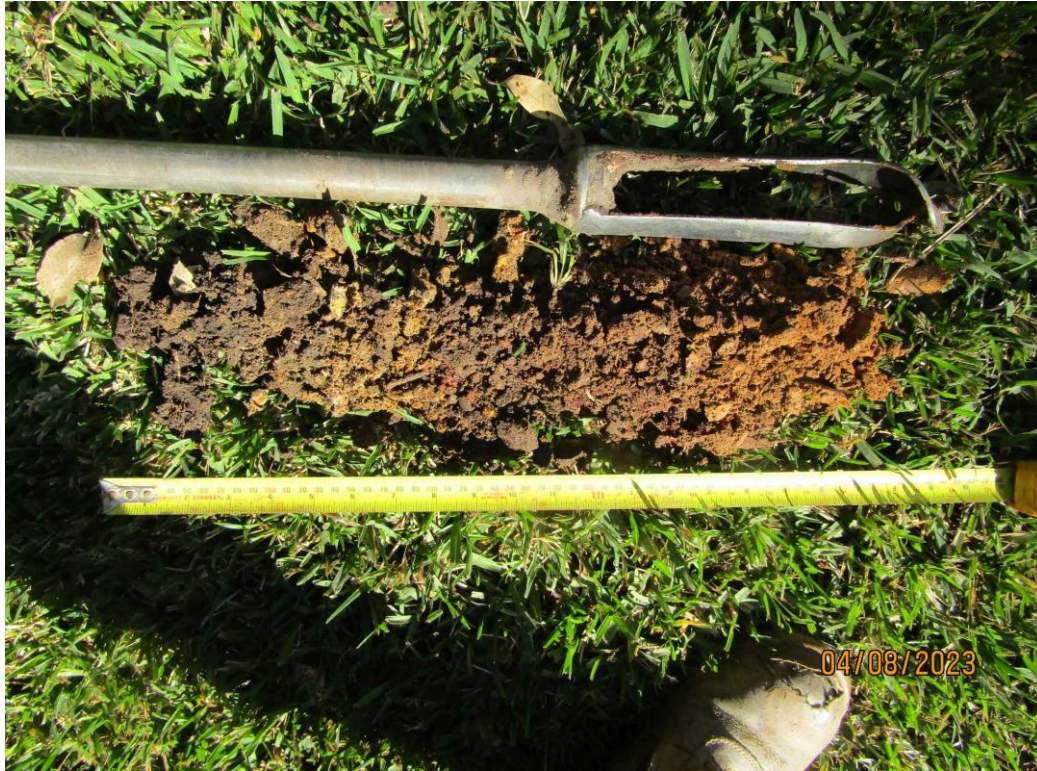
#### AUGER HOLE 1 (~RL31.0) – AH1 (Photo 13)

Depth (m)	Material Encountered
0.0 to 0.4	<b>FILL</b> , sandy soil and clay, dark brown, orange, grey, damp, fine to coarse grained.
0.4 to 0.5	<b>SANDY CLAY</b> , orange brown, firm to stiff, moist.

End of test @ 0.5m in firm to stiff sandy clay. No watertable encountered.

Photo 13: AH1 – Downhole is from left to right.

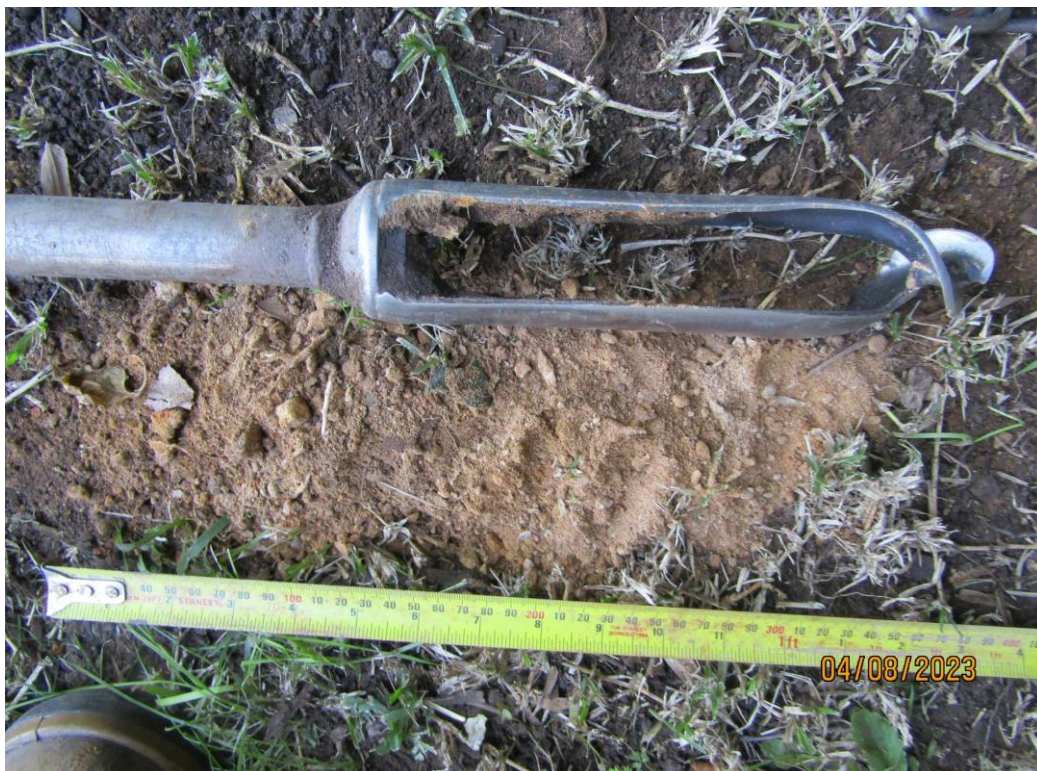
## AUGER HOLE 2 (~RL22.6) – AH2 (Photo 14)

0.0 to 0.35      **FILL**, sandy soil and clayey soil, with some rock fragments, brown, orange, grey white, dry, fine to coarse grained.

Refusal @ 0.35m in fill. No watertable encountered.

Photo 14: AH2 – Downhole is from left to right.

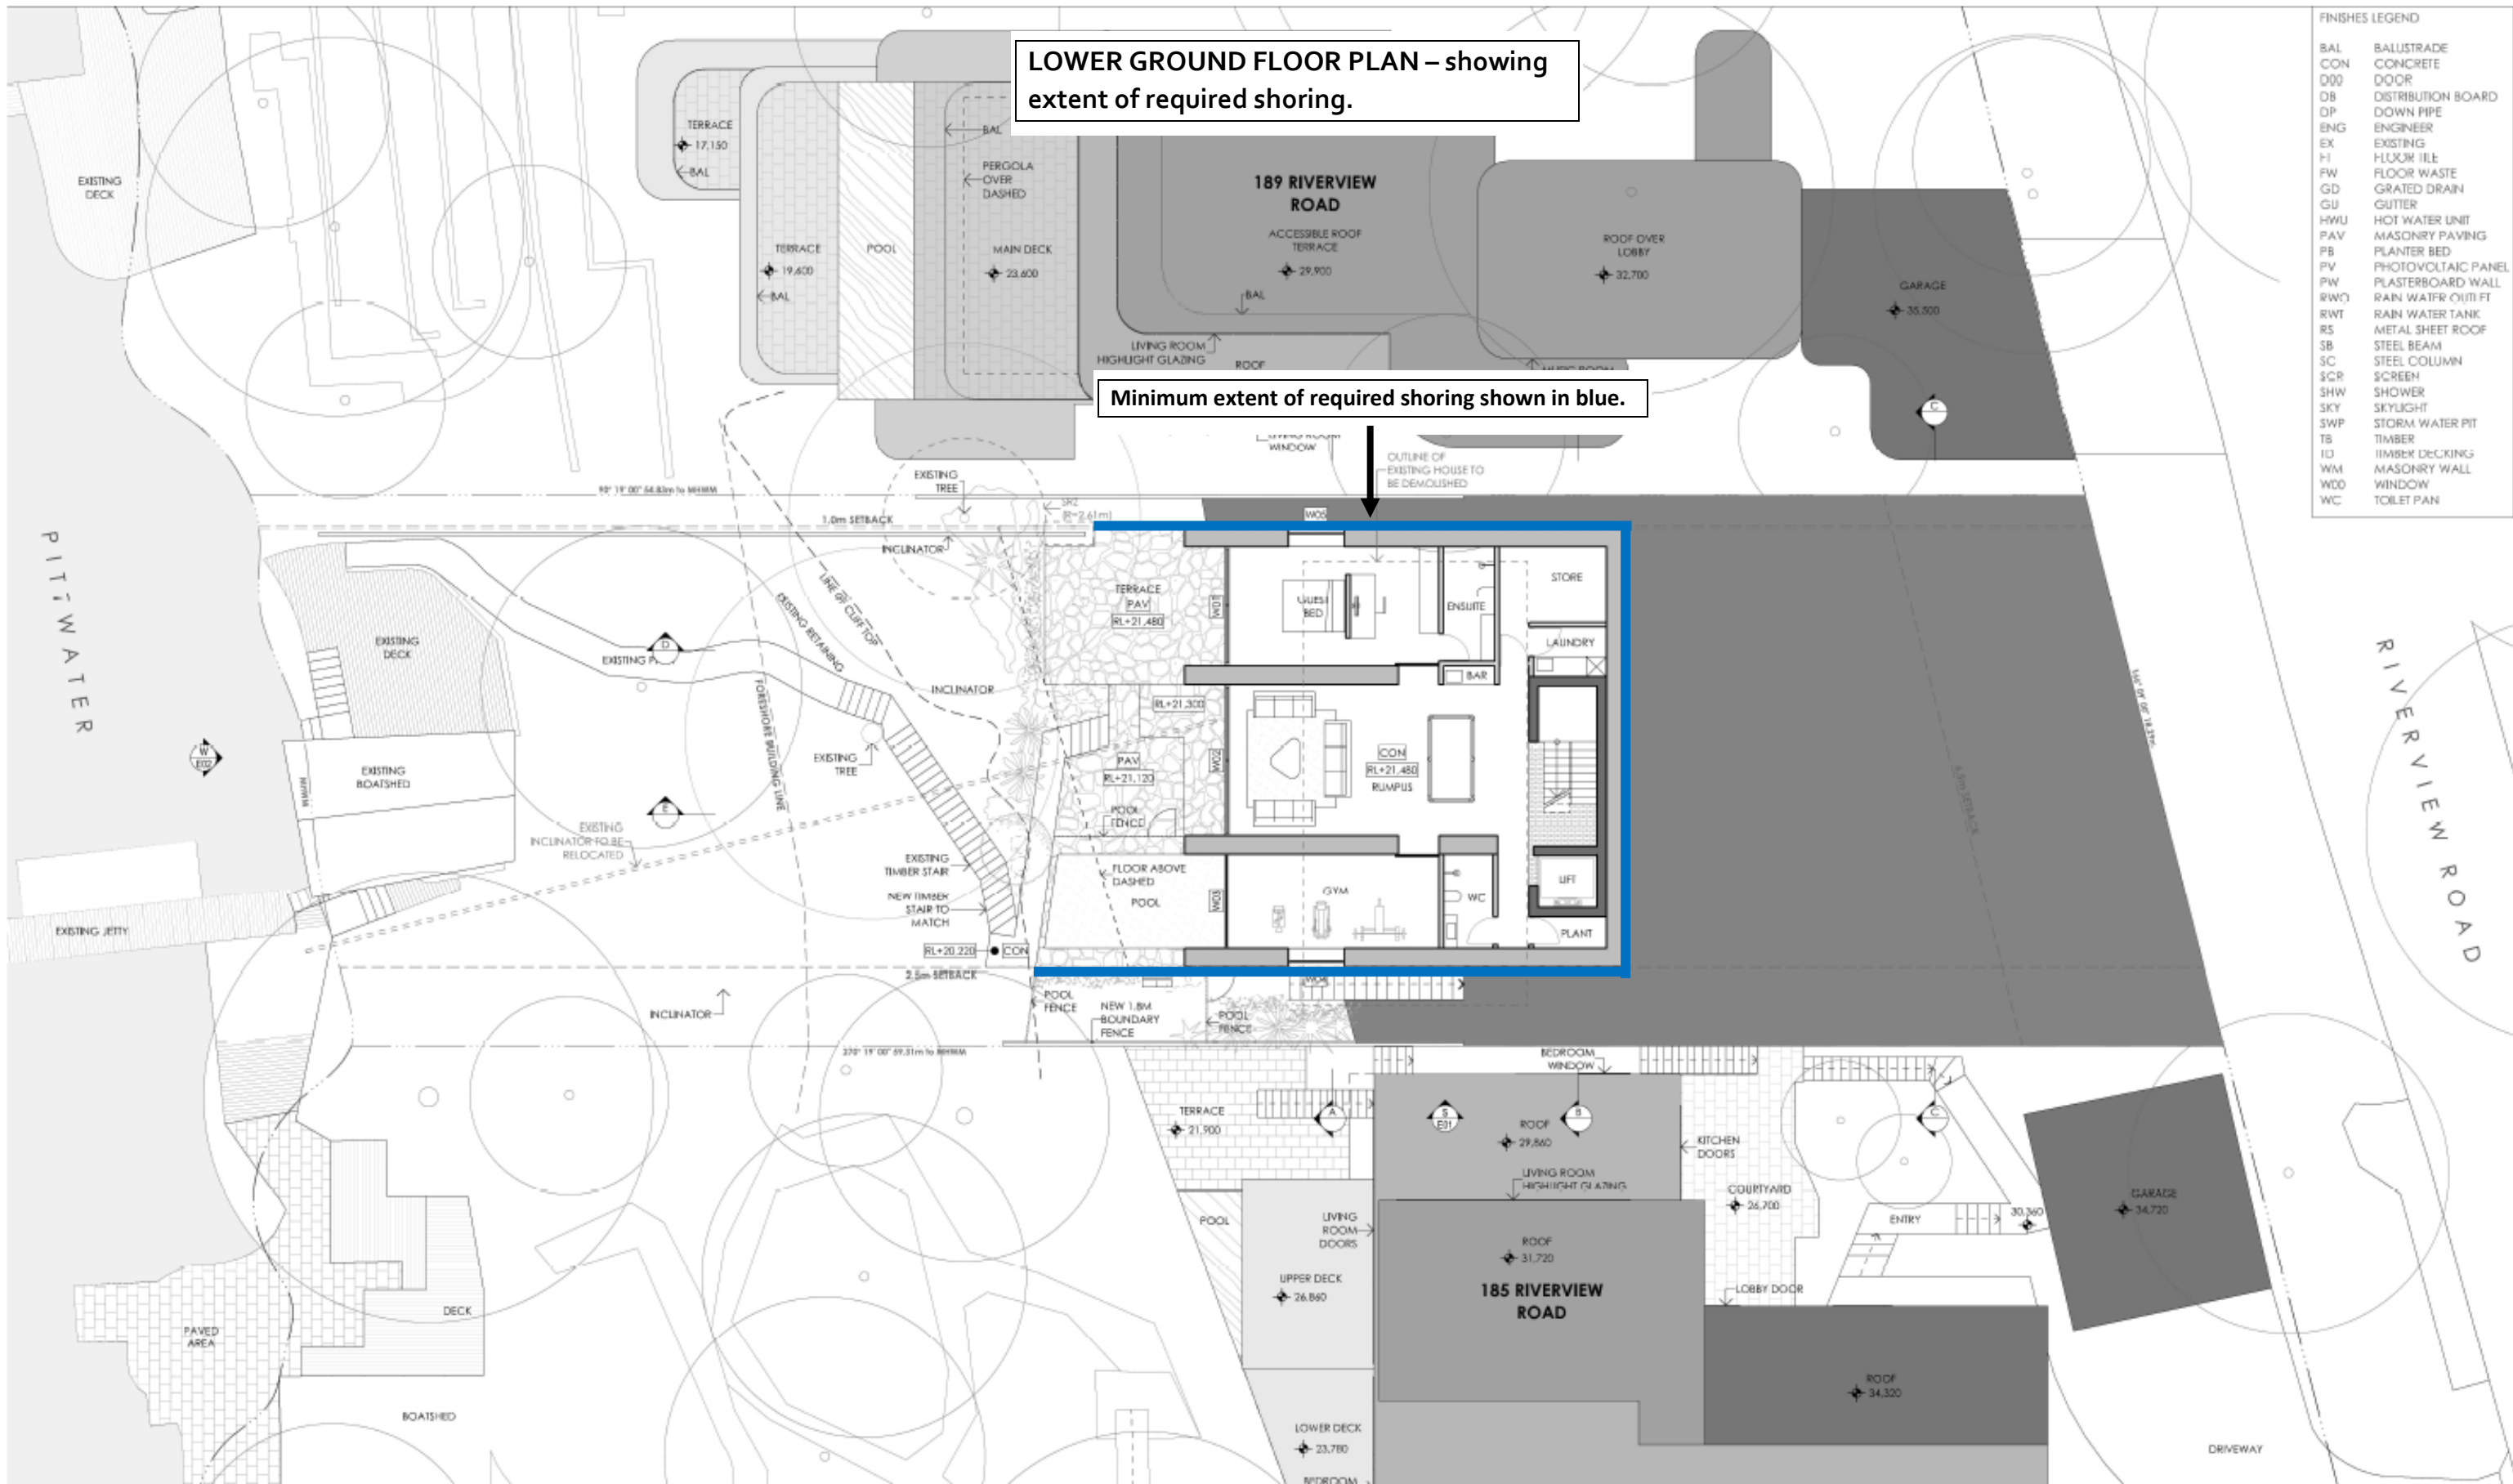
01 LOWER GROUND FLOOR PLAN  
1:200

- The lower ground floor portion of the excavation is set back ~2.0m from the S neighbouring concrete pathway that runs beside the common boundary, ~3.0m from the S neighbouring house and ~0.5m from the N common boundary.
- The pool portion of the excavation is set back ~3.0m from the S common boundary.
- The landscaping excavation comes flush with the S common boundary, ~1.0m from the S neighbouring garage, flush with the N common boundary and flush with the road reserve.

The above structures and boundaries will be within the zone of influence of the excavation. In this instance, the zone of influence is the area above a theoretical 30° line (from horizontal) through fill/soil and a 45° line through clay / weathered rock (Extremely Low to Low Strength Rock) from the base of the excavation or the top of Medium Strength, whichever comes first, towards the surrounding structures and boundaries.

Due to the depth of the excavation and its proximity to nearby structures and common boundaries, the perimeters of the excavation will require ground support installed prior to the commencement of the excavation. See the Lower Ground Floor and Ground Floor plans attached for the minimum extent of the required shoring shown in blue.
