Preliminary Geotechnical Assessment

Project: Alterations & Additions
8 Jendi Avenue, Bayview NSW

REF: AG 21144
17 May 2021

For Alterations and Additions at
8 Jendi Avenue, Bayview NSW

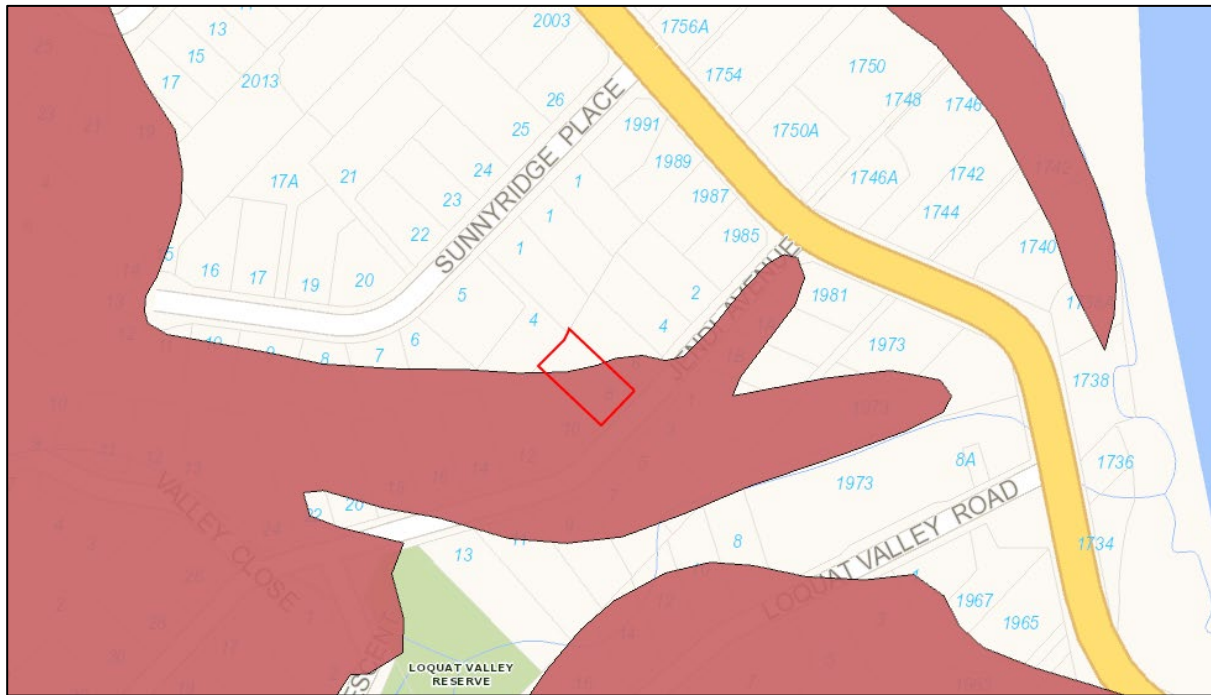
Image 1. Pittwater Geotechnical Hazard Risk Map:
8 Jendi Avenue, Bayview NSW (© NBC)

- The site is mapped as **Geotechnical Hazard H1** subject to specific landslip risk/geotechnical hazard mapping with reference to the Pittwater Geotechnical Hazard Map (**Image 1**).
