## **20 Sunrise Road, Palm Beach**

### Comments on Updates to Plans

## **GEOTECHNICAL INVESTIGATION:**

New Secondary Dwelling and Inclined Lift at **20 Sunrise Road, Palm Beach**

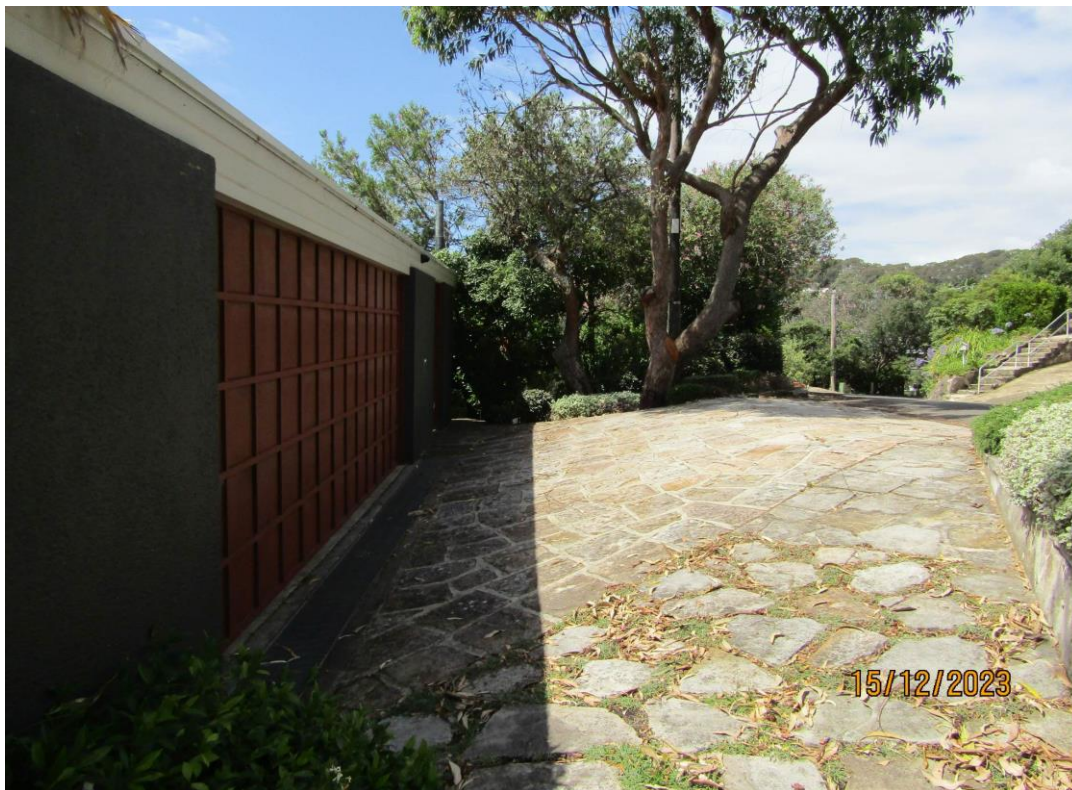
Photo 1

- 2.3** At the road frontage to Sunrise Road, a stone-paved driveway runs to a garage attached to the uphill side of the house (Photo 1). The part three-storey house is supported on brick and concrete block walls and concrete columns (Photo 2). The supporting walls display no significant signs of movement and the supporting columns

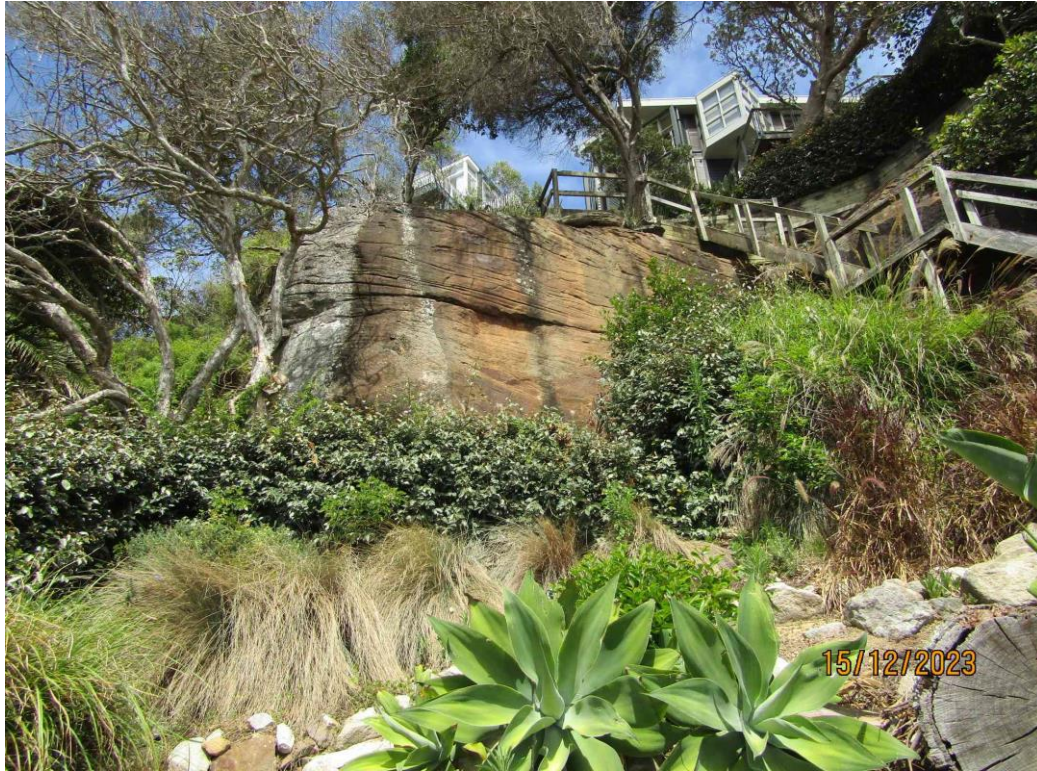
Photo 5

No geotechnical hazards were observed beside the property. The steeply graded slope that falls across the property and continues above and below is a potential hazard (**Hazard One**). The ~6.0m high sandstone rock face (Photo 5) is a potential hazard (**Hazard Two**). The proposed excavation is a potential hazard until retaining structures are in place (**Hazard Three**).

HAZARDS	Hazard One	Hazard Two	Hazard Three
TYPE	The steep slope that falls across the property and continues above and below failing and impacting on the property.	The ~6.0m high sandstone rock face (Photo 5) mass failing and impacting on the property and the proposed secondary dwelling.	The proposed excavation for the secondary dwelling collapsing onto the worksite and impacting the neighbouring properties during the excavation process.
LIKELIHOOD	'Unlikely' ( $10^{-4}$ )	'Rare' ( $10^{-5}$ )	'Possible' ( $10^{-3}$ )
CONSEQUENCES TO PROPERTY	'Medium' (12%)	'Medium' (30%)	'Medium' (15%)
RISK TO PROPERTY	'Low' ( $2 \times 10^{-5}$ )	'Low' ( $2 \times 10^{-6}$ )	'Moderate' ( $2 \times 10^{-4}$ )
RISK TO LIFE	$8.3 \times 10^{-7}$ /annum	$6.2 \times 10^{-7}$ /annum	$7.4 \times 10^{-5}$ /annum
COMMENTS	This level of risk is 'ACCEPTABLE', provided the recommendations in <b>Section 7 and 16</b> are carried out.	This level of risk is 'ACCEPTABLE'	This level of risk to life and property is 'UNACCEPTABLE'. To move the risk to 'ACCEPTABLE' levels, the recommendations in <b>Section 13</b> are to be followed.

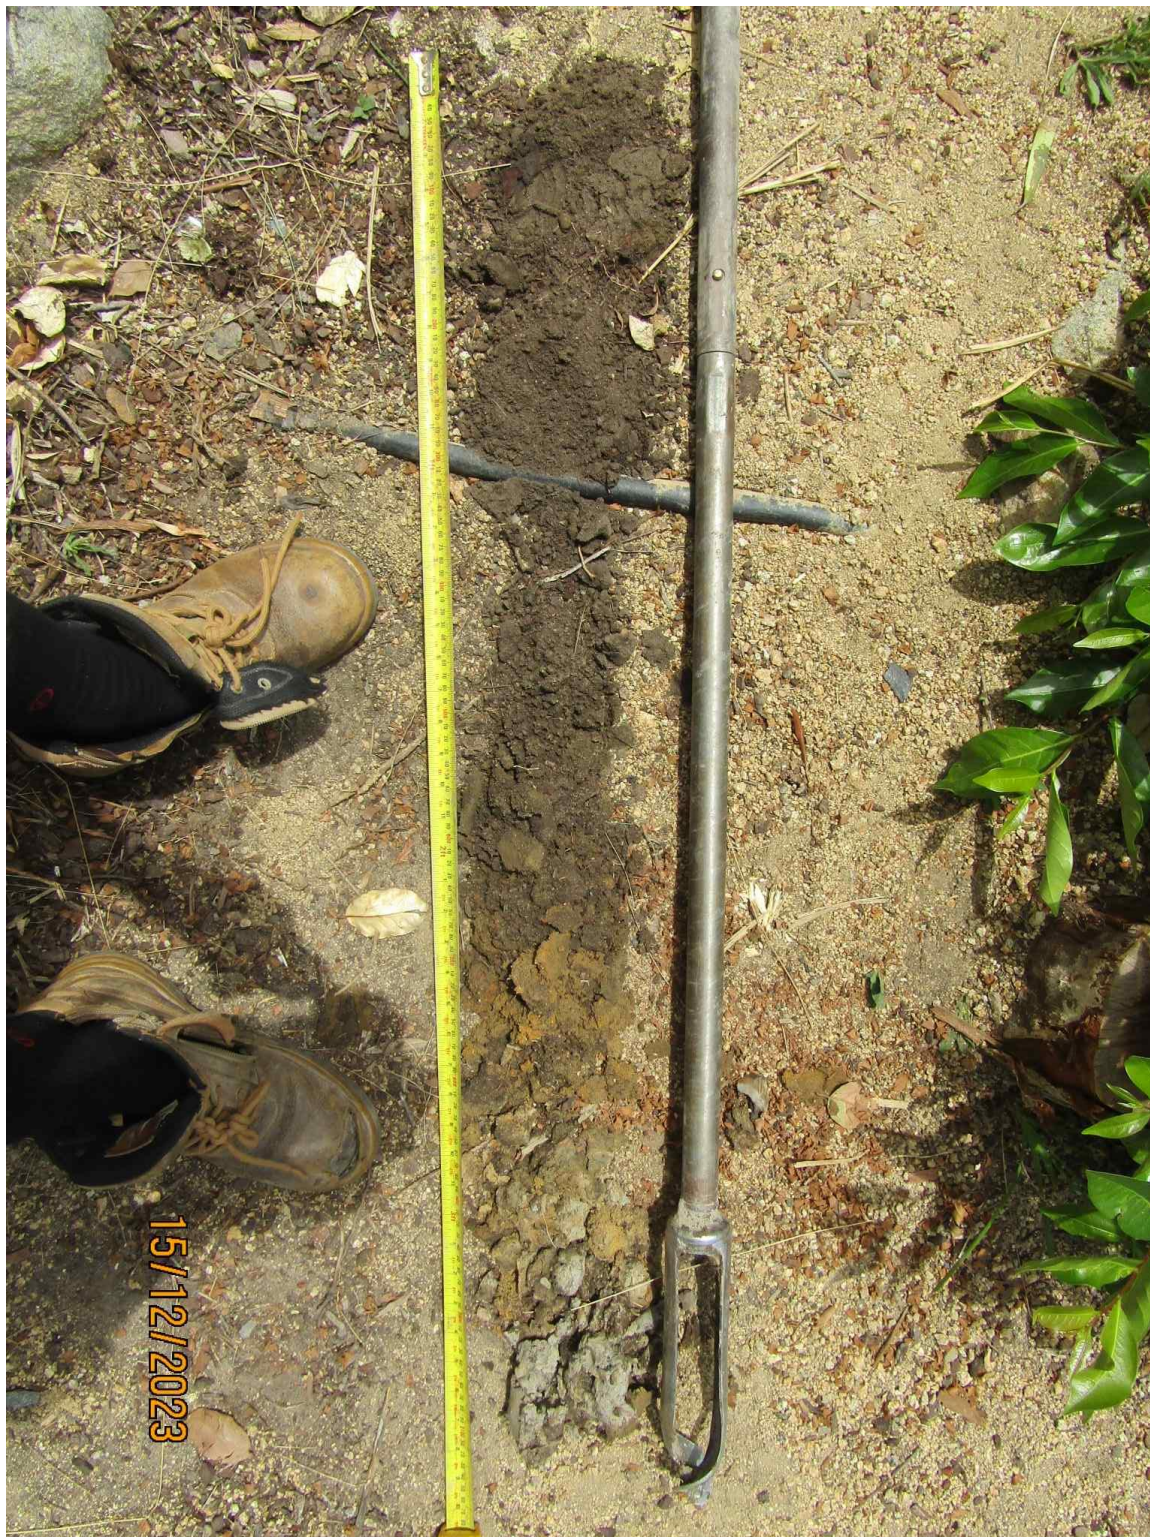
Depth (m)	Material Encountered
0.0 to 0.7	<b>FILL</b> , sandy soil, with some rock fragments, dark brown, dry to moist, fine to coarse grained.
0.7 to 0.9	<b>COLLUVIUM</b> , sand, brown orange, damp, fine to medium grained.
0.9 to 1.1	<b>CLAY</b> , grey, firm to stiff, moist.

End of hole @ 1.1m in firm to stiff clay. No water table encountered.

*Photo 8: AH1 – Downhole is from top to bottom.*
