Report Title: Geotechnical Report 39 Calvert Parade, Newport  
Report Date: 27/3/25

## **GEOTECHNICAL INVESTIGATION:**

New House and Garage at **39 Calvert Parade, Newport**

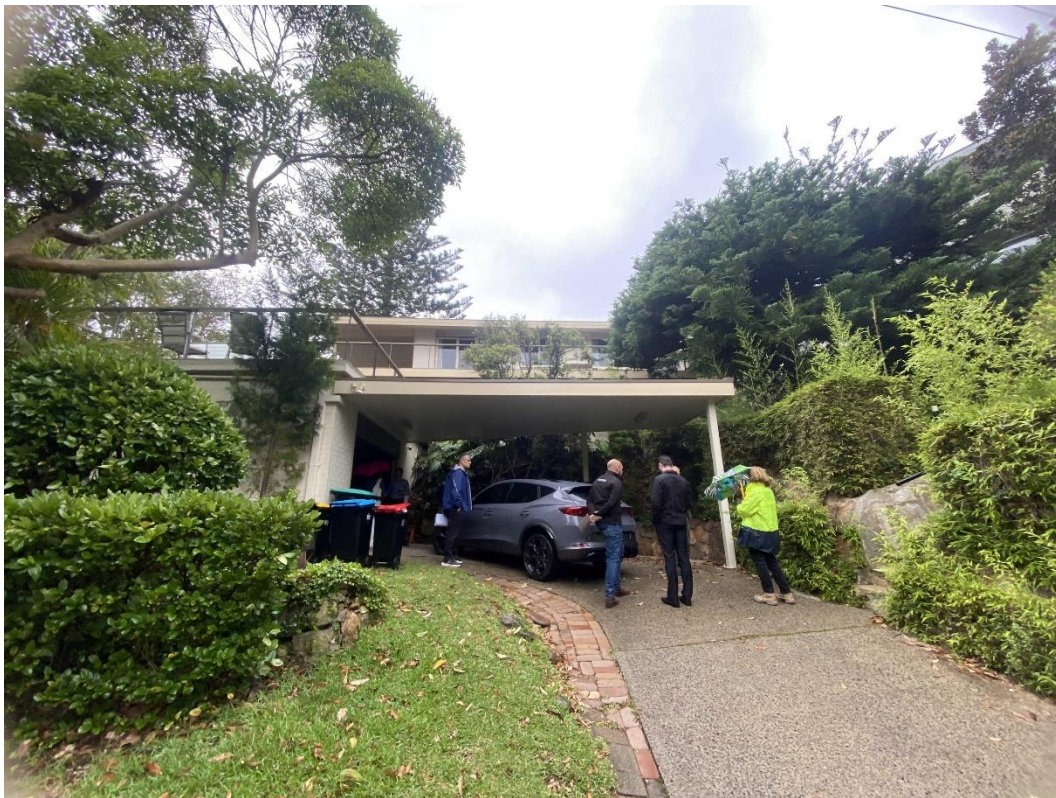
Photo 1

- 2.3** At the road frontage, a concrete driveway runs up the slope to a carport and garage on the downhill side of the property (Photo 1). In between the carport and the house is a steep and densely vegetated slope. Low to Medium Strength Rock outcrops at the toe of this slope (Photo 2). A stable ~0.8m high stack stone retaining wall supports a fill for a level area adjacent to the existing garage (Photo 3). The part two-storey brick house is supported on brick walls and brick piers. The house appears to be in good condition. Low to Medium Strength Rock outcrops in the foundation space of the house and some of the walls and piers are supported directly on this material

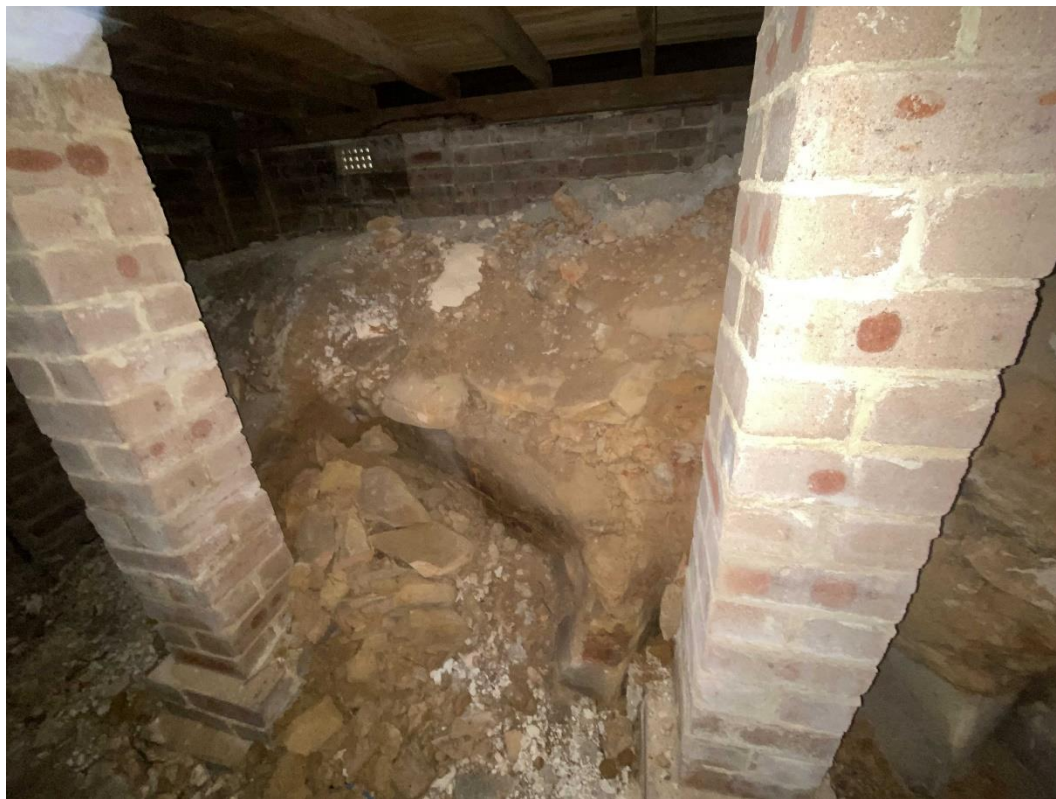
Photo 4

(Photo 4). The house is to be demolished as part of the proposed works. The cut for the house is lined by a mortared flagging wall reaching up to ~2.2m high (Photo 5). Low to Medium Strength Rock outcrops at the base of this wall. A moderately sloping lawn area extends off the uphill side of the house to the upper common boundary (Photo 6).

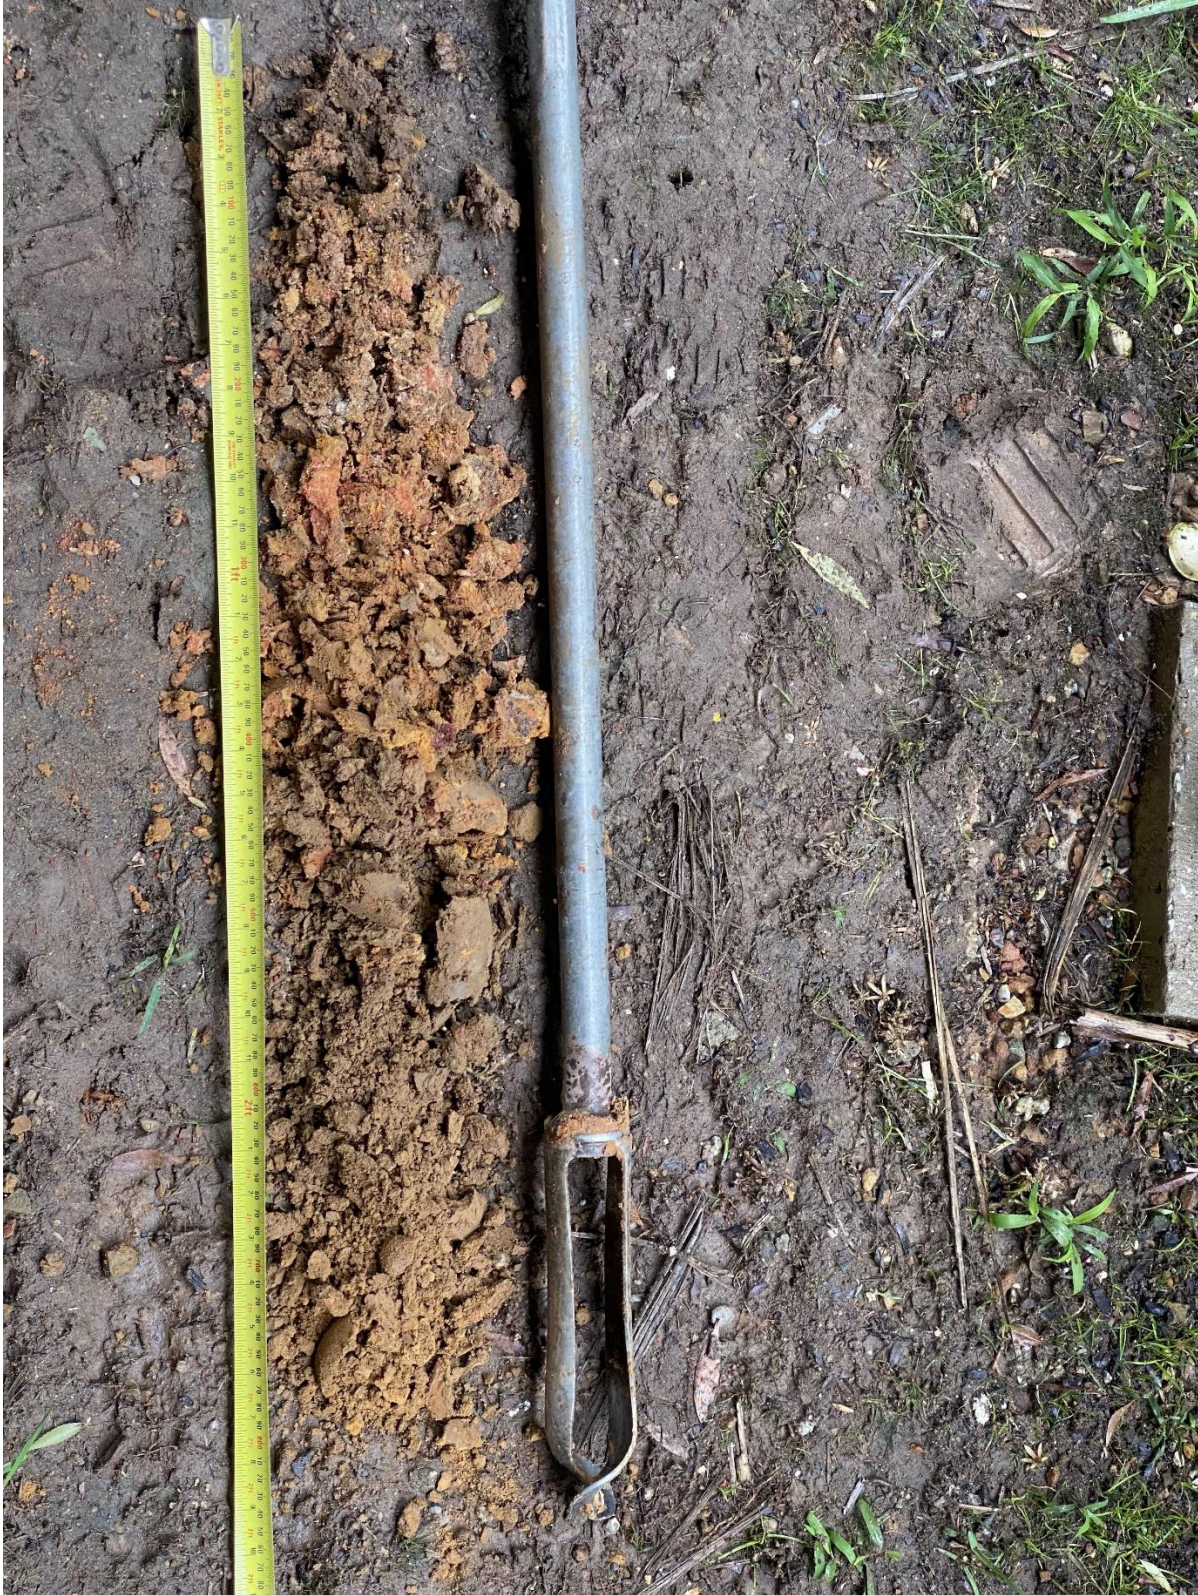
*Photo 7 (Top to Bottom)*

#### AUGER HOLE 1 (~RL41.4) – AH1 (Photo 7)

Depth (m)	Material Encountered
0.0 to 0.4	<b>FILL</b> , mottled orange, brown, red, white sandy clay, fine to medium grained, damp.
0.4 to 0.7	<b>CLAY</b> , brown, fine grained, firm to stiff, dry.
0.7 to 0.8	<b>CLAY</b> , yellow, fine grained, stiff, dry.

Refusal on rock @ 0.8m. Auger grinding. No water table encountered.
