GEOTECHNICAL INVESTIGATION:

New Garage and Alterations and Additions at **45 Marine Parade, Avalon**

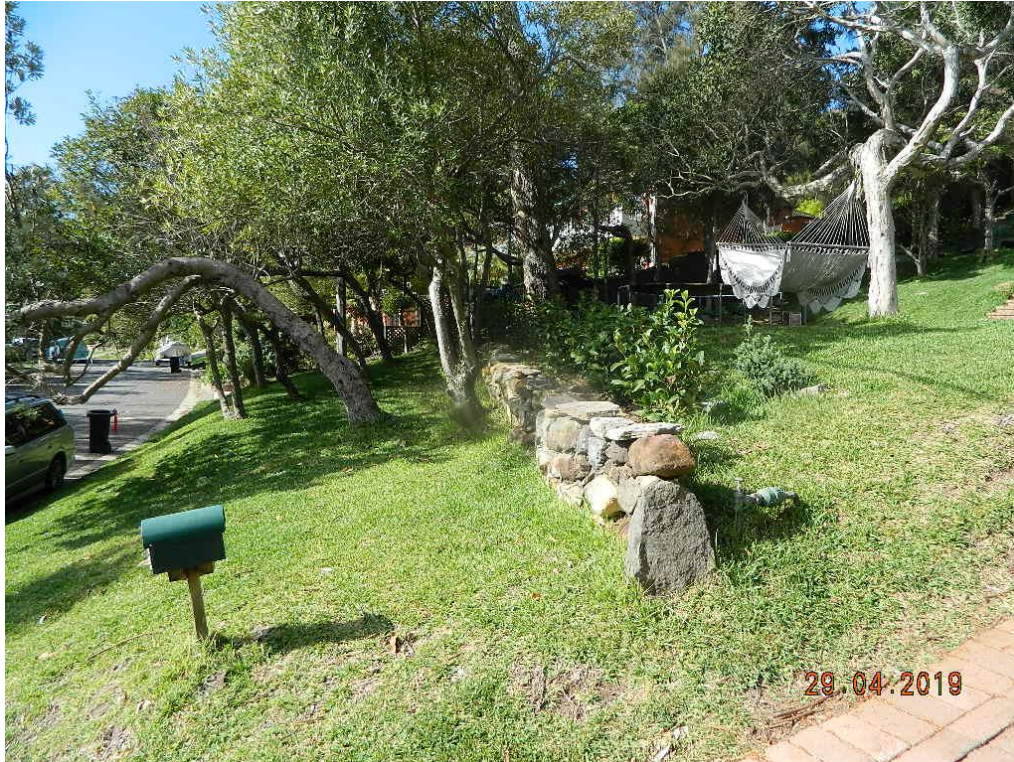
Photo 3

a moderately sloping stable bank rises from the road to a low dry stack rock retaining wall reaching a maximum height of ~0.4m (Photo 3). The retaining wall supports a garden bed above. From the wall a level lawn extends to another stable bank that rises ~2.5m at steep angles to the house and a lawn area to the NE (Photo 4). The part two storey timber framed and clad house is supported on brick walls and brick and dimensioned sandstone block piers (Photo 5). No significant signs of cracking or movement were observed in the supporting brick walls and the supporting brick and dimensioned sandstone block piers stand vertical. An excavation to a maximum height of ~1.8m has been made to level an area for the house. The excavation is supported by a stable mortared stack rock retaining wall (Photo 6). An excavation to a maximum depth of ~1.0m has been made on the uphill side of the property to level an area for a part two-storey studio. The cut is supported by a stable stack rock retaining wall. Medium Strength Sandstone outcrops on the slope that rises from the uphill side of the house to the uphill boundary and is also scattered with detached joint blocks (Photos 8 & 9). The joint blocks have been in place over a geological time scale and are currently seated in stable positions. No significant signs of movement were observed on the property. No geotechnical hazards that could impact on the subject property were observed on the neighbouring properties as seen from the subject property and the road.

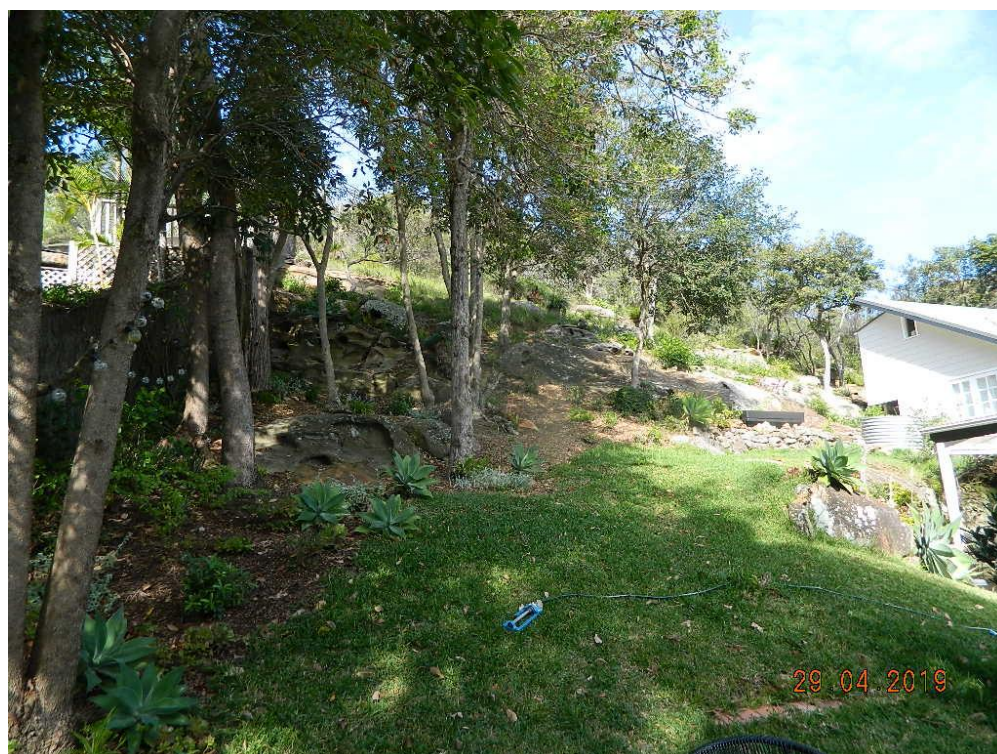
Photo 8

Sandstone bedrock outcrops at the sea cliff face to the E of the property and is visible outcropping down the slope to the house (Photos 8, 9 & 10). This is an unusually thick sandstone bed within the Narrabeen Group of rocks. The rock is overlain by natural sandy soils and clay. In the test locations, rock was encountered at depths of between ~0.4 to ~1.9m due to the variable nature of the rock. As the majority of the tests bounced on refusal we expect the band of sandstone outcropping above the house to continue down the slope beneath the testing. This underlying rock is interpreted to be of Low to Medium Strength. See Type Section attached for a diagrammatical representation of the expected ground materials

HAZARDS	Hazard One	Hazard Two	Hazard Three
TYPE	The steep slope that rises above the house and continues above failing onto the house and proposed works (Photos 8 & 9).	The vibrations produced during the proposed excavation impacting on the subject and neighbouring house to the NE.	The proposed garage and courtyard excavations undercutting The NE common boundary.
LIKELIHOOD	'Unlikely' (10^{-4})	'Possible' (10^{-3})	'Possible' (10^{-3})
CONSEQUENCES TO PROPERTY	'Medium' (10%)	'Medium' (15%)	'Medium' (20%)
RISK TO PROPERTY	'Low' (2×10^{-6})	'Moderate' (2×10^{-4})	'Moderate' (2×10^{-4})
RISK TO LIFE	1.4×10^{-7} /annum	6.6×10^{-7} /annum	1.6×10^{-5} /annum
COMMENTS	This level of risk to life and property is 'ACCEPTABLE'	This level of risk to property is 'UNACCEPTABLE'. To move risk to 'ACCEPTABLE' levels the recommendations in Sections 12 are to be followed.	This level of risk to life and property is 'UNACCEPTABLE'. To move risk to 'ACCEPTABLE' levels, the recommendations in Section 13 are to be followed.

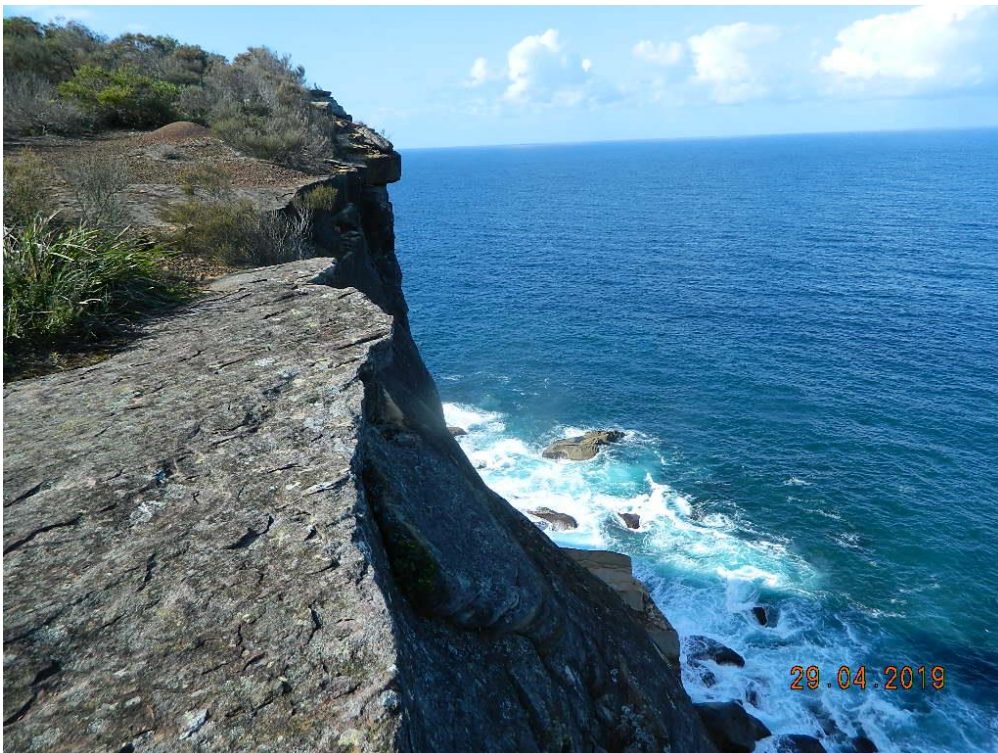
Photo 10

The Sydney 1:100 000 Geological sheet indicates the site is underlain by the Newport Formation of the Narrabeen Group. The observed outcropping sandstone encompassing the steep slope above the house is an unusually thick band of sandstone that extends through the otherwise shale-dominated profile (Photo 10).

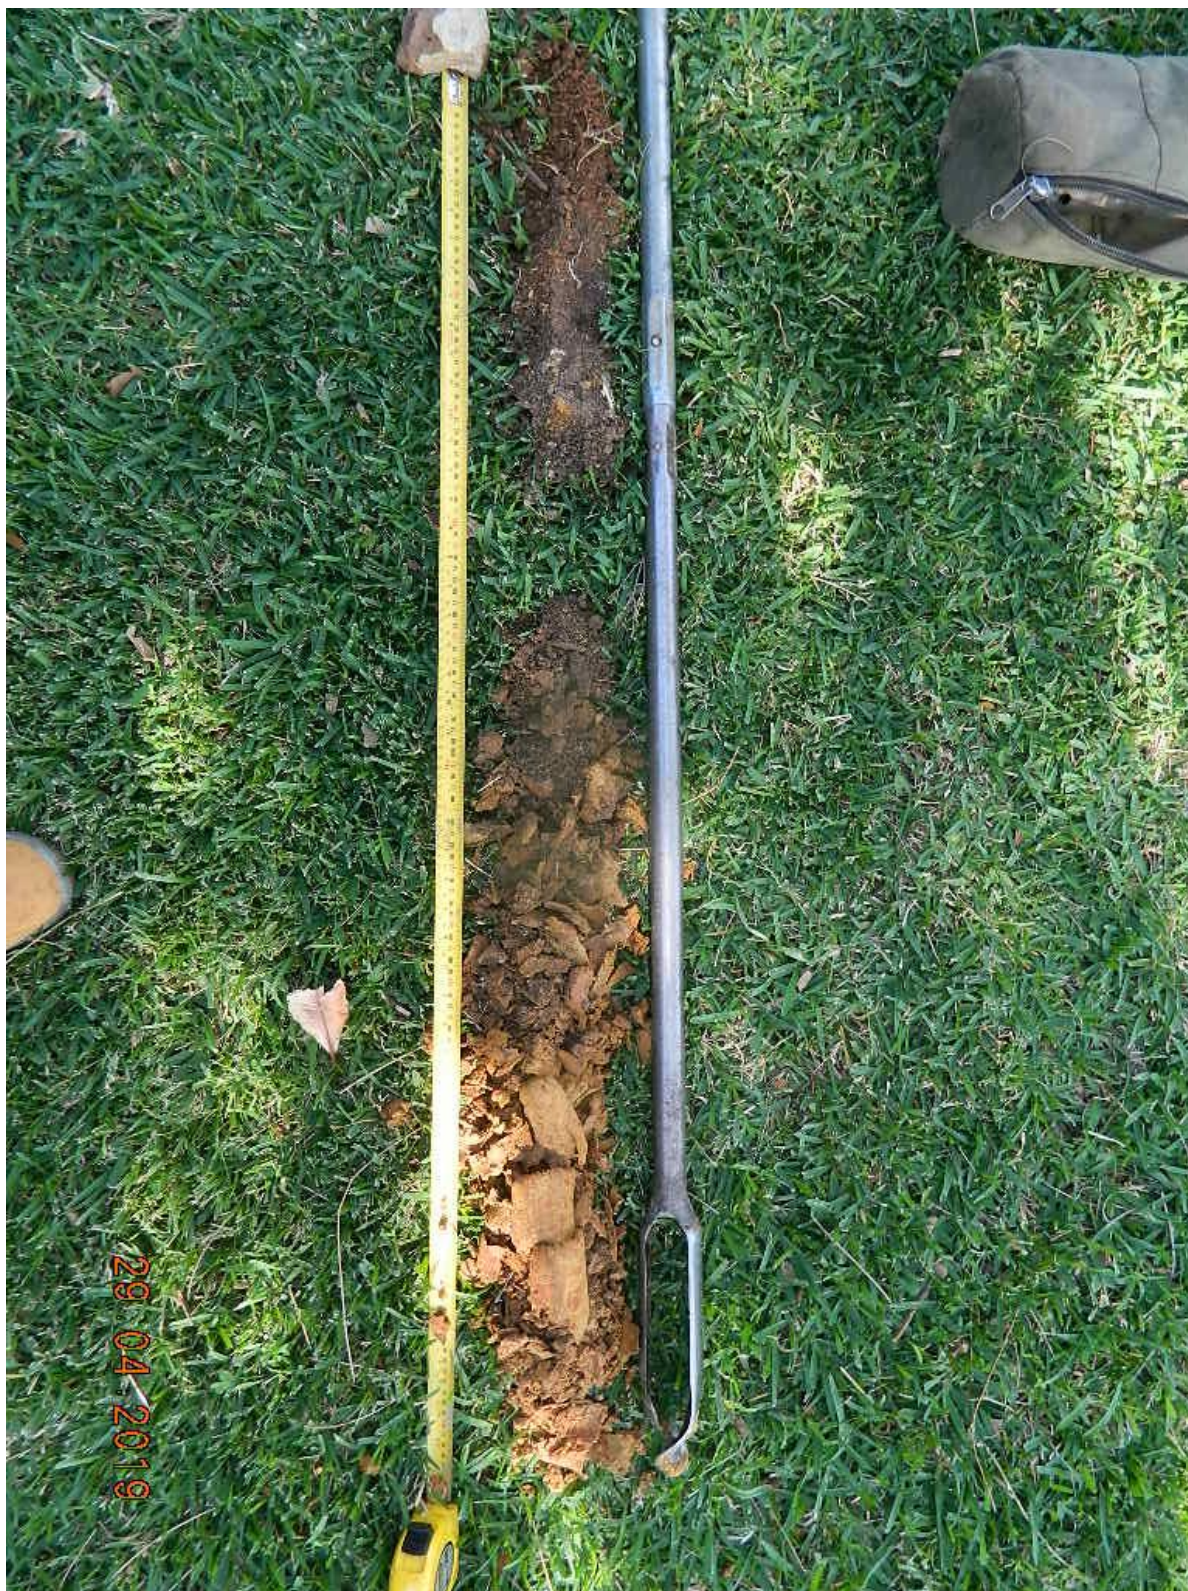
AUGER HOLE 1 (~RL36.3) – AH1 (Photo 11)

Depth (m)	Material Encountered
0.0 to 0.2	TOPSOIL , sandy soil, orangey brown, loose, rock fragments, roots, fine to medium grained, dry.
0.2 to 0.4	SANDY SOIL , brown, loose, roots, rock fragments, fine to medium grained, dry.
0.4 to 0.5	VOID
0.5 to 0.6	SANDY SOILS , brown, loose, roots, rock fragments, fine to medium grained, dry.
0.6 to 1.2	CLAY , orange with red mottling, firm to stiff, fine to medium grained, fine grained, dry.

End of hole @ 1.2m in firm to stiff clay. No watertable encountered.

Photo 11: AH1 – Downhole is top to bottom
