Arboriculture Assessment & Hazard Management Statement

March 2020

Site:	Lot 1 in DP 571975 48-50 Lawrence Street FRESHWATER, NSW
Client:	Life Property group PO Box 1097 DEE WHY, NSW Email: ClaudioM@lifepropertygroup.com.au
Commissioned:	Claudio Minns
Author:	Kyle A Hill Registered (Arb Aus #1884) Practising & Consulting Arborist Post Graduate Certificate in Arboriculture, Melbourne University Diploma of Horticulture-Arboriculture TAFE, Grow SA Certificate of Horticulture, TAFE Certificate Advanced Tree Care TAFE Founder -Growing My Way Tree Services (1977) Member of International Society of Arboriculture Member of Arboriculture Australia

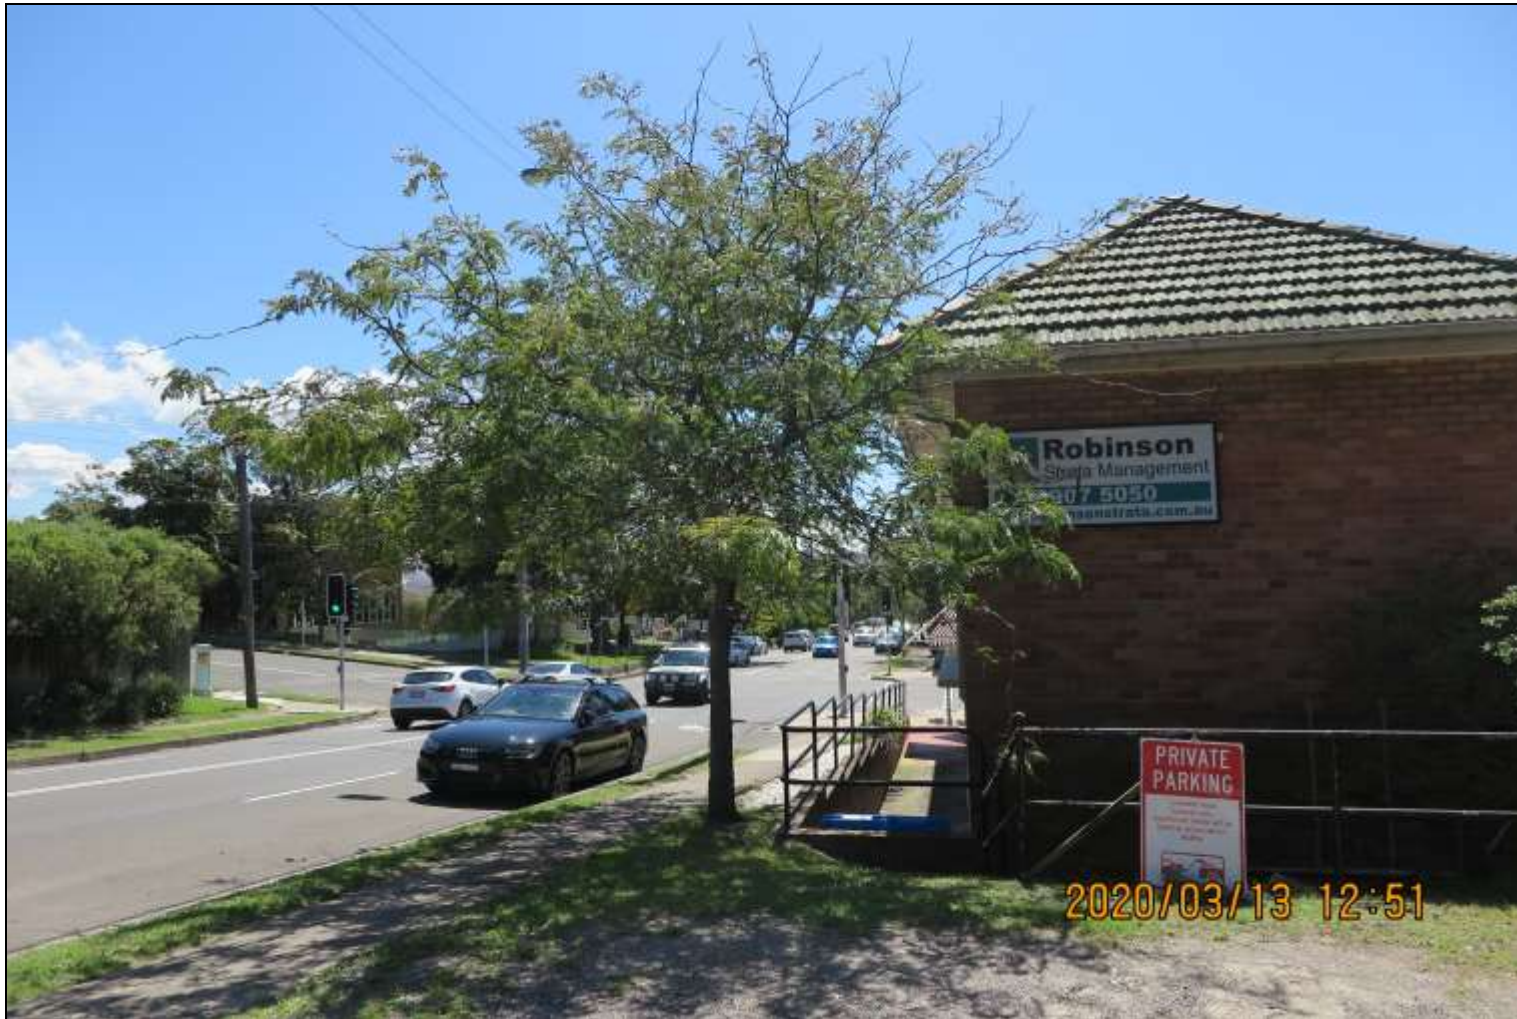
Figure 3: Illustrates Tree #1 location & canopy outline.

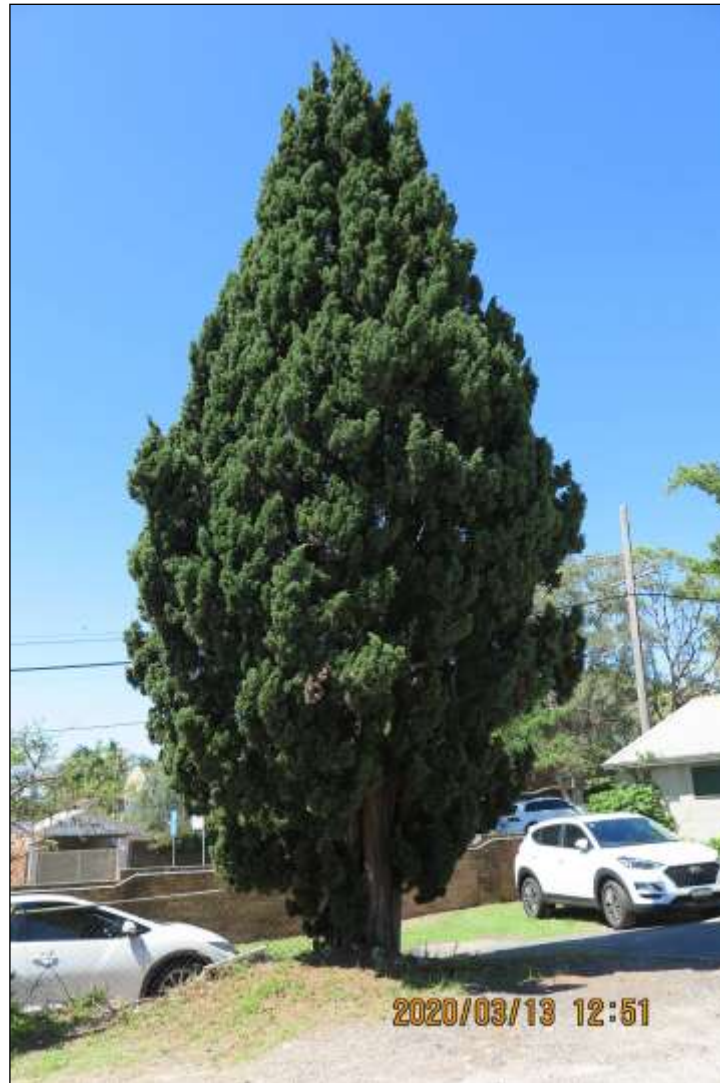
Figure 4: Illustrates Tree #2 location & canopy outline.

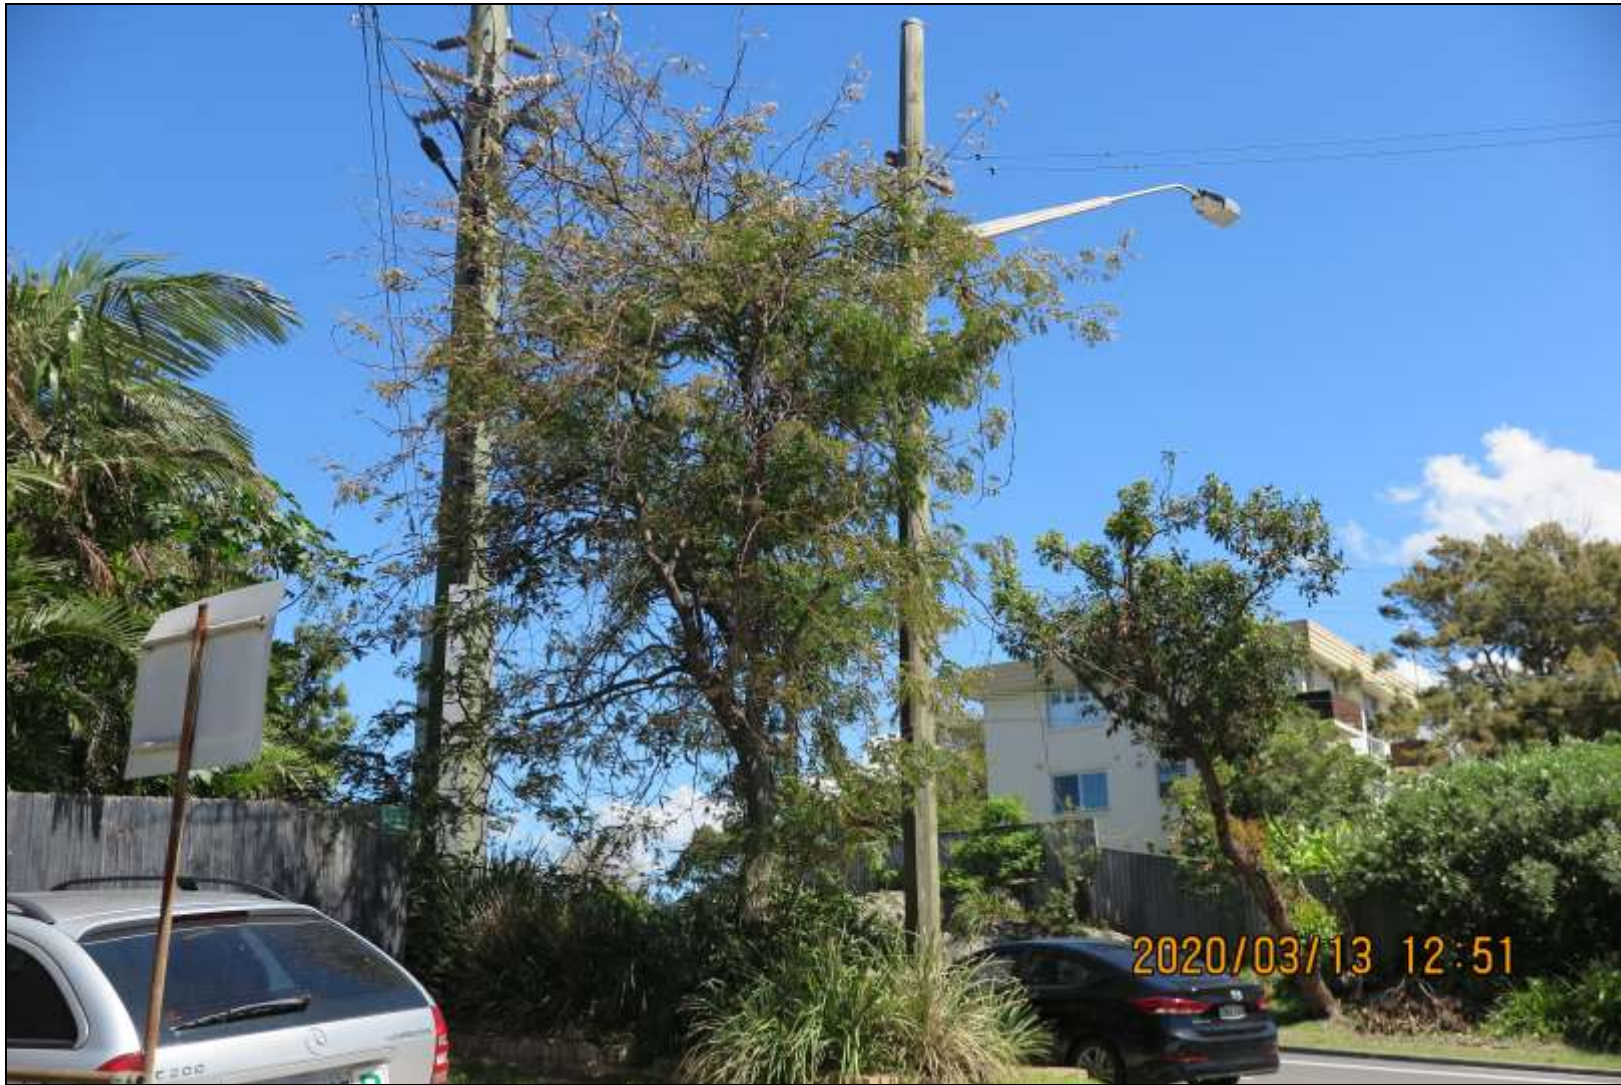
Figure 5: Illustrates Tree #3 location & canopy outline.
