SITE INSPECTION REPORT - # 1

PROJECT: 60 Prince Alfred Parade, Newport

JOB No: 22-229

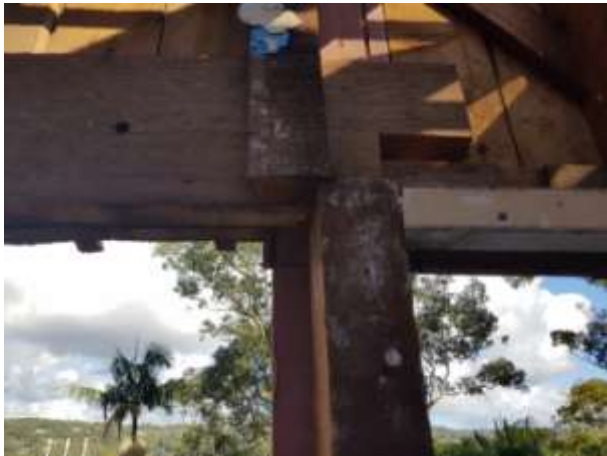
Photo 1: Inadequate stud framing adjacent window opening.

We would recommend removal of the vast majority of the poorly built timber framing and that it be reconstructed in line with current Australian Standards (AS1684 Timber Framing Code & AS1720 Timber Structures Code) and the National Construction Code (NCC).

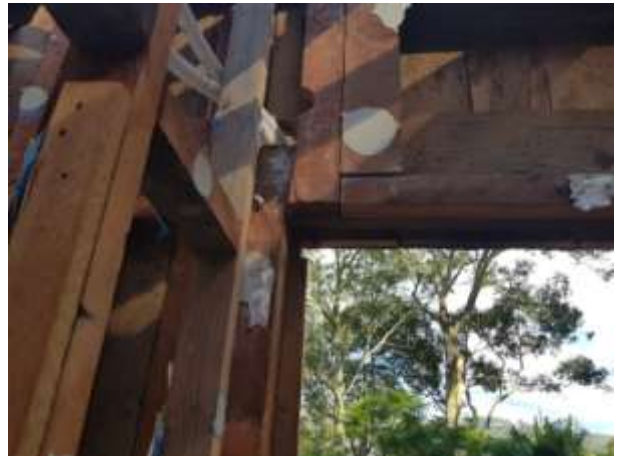
Photo 2: Inadequate stud framing adjacent window opening.

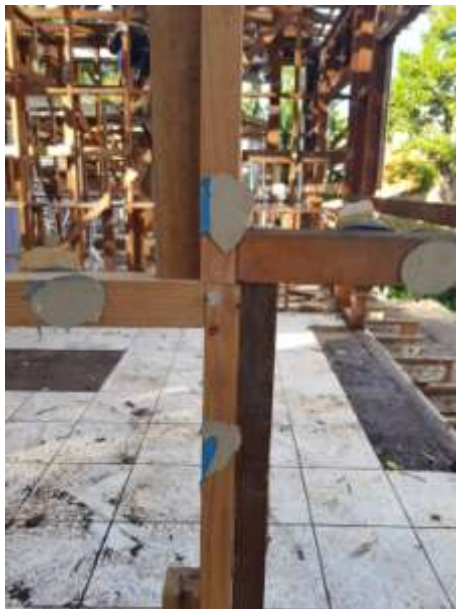
Photo 3: Example of stud cut in two separate pieces

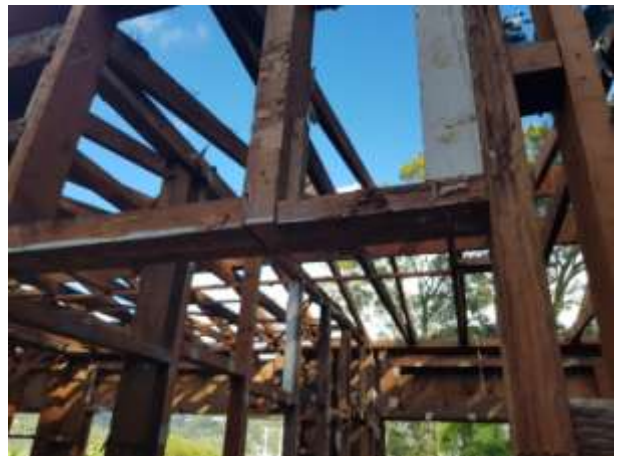
Photo 4: Inadequate timber framing over door opening.

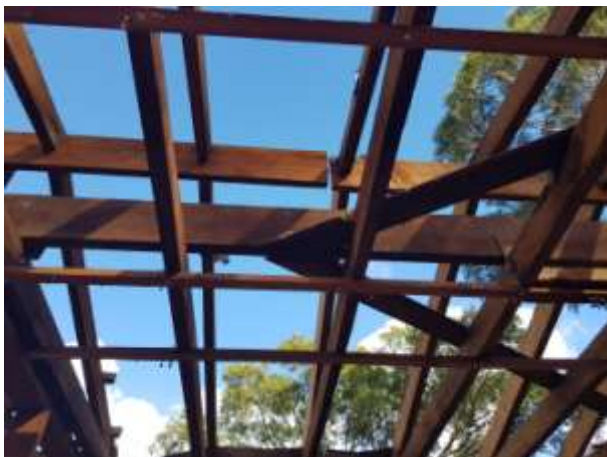
Photo 5: Discontinuous roof ridge member.

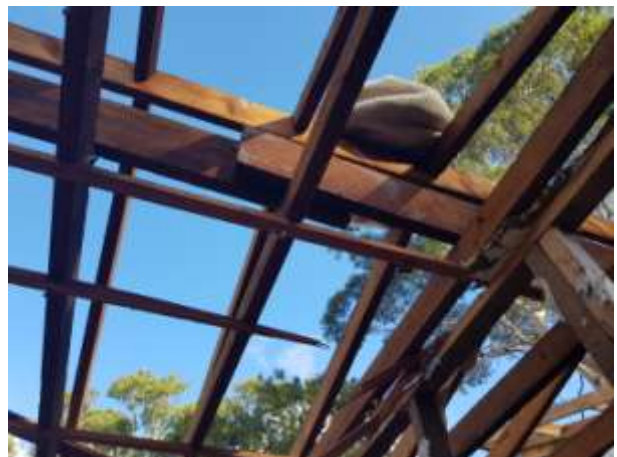
Photo 6: Ceiling hanging beams not adequately supported.

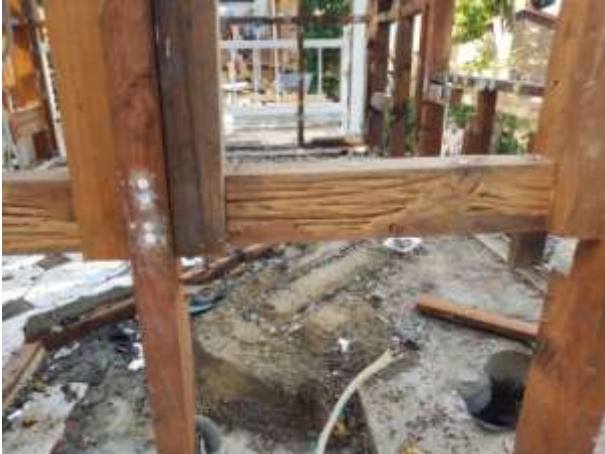
Photo 7: Example of termite damage to framing.
