Report Title: Geotechnical Report 114 Whale Beach Road, Whale Beach
Report Date: 14/9/20

GEOTECHNICAL INVESTIGATION:

Alterations and Additions at 114 Whale Beach Road, Whale Beach

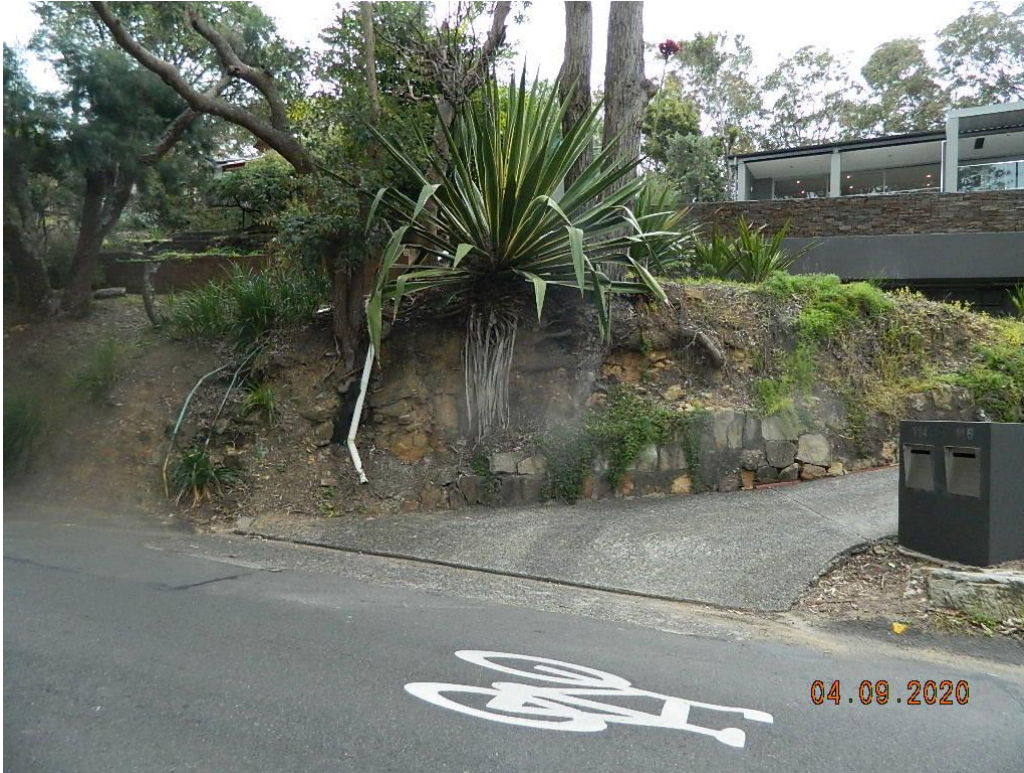
Photo 1

- 2.3** The property is accessed by a concrete right of carriageway (ROW) (Photos 1 & 2). The upper portion of the cut for the driveway is unsupported and the lower portion of the cut is supported by a low sandstone flagging retaining wall in poor condition. A portion of the wall has partially collapsed but the wall will be replaced as

(**Hazard Three**). The proposed excavation undercutting the tree above the existing driveway (Photos 1 & 3) is a potential hazard (**Hazard Four**).

An excavation to a maximum depth of ~1.5m will be required to extend the driveway. The excavation will come close to a tree above the existing driveway (Photos 1 & 3). For safety reasons and to ensure the ongoing durability of the proposed retaining wall for the driveway, the tree is to be removed prior to the excavation commencing.

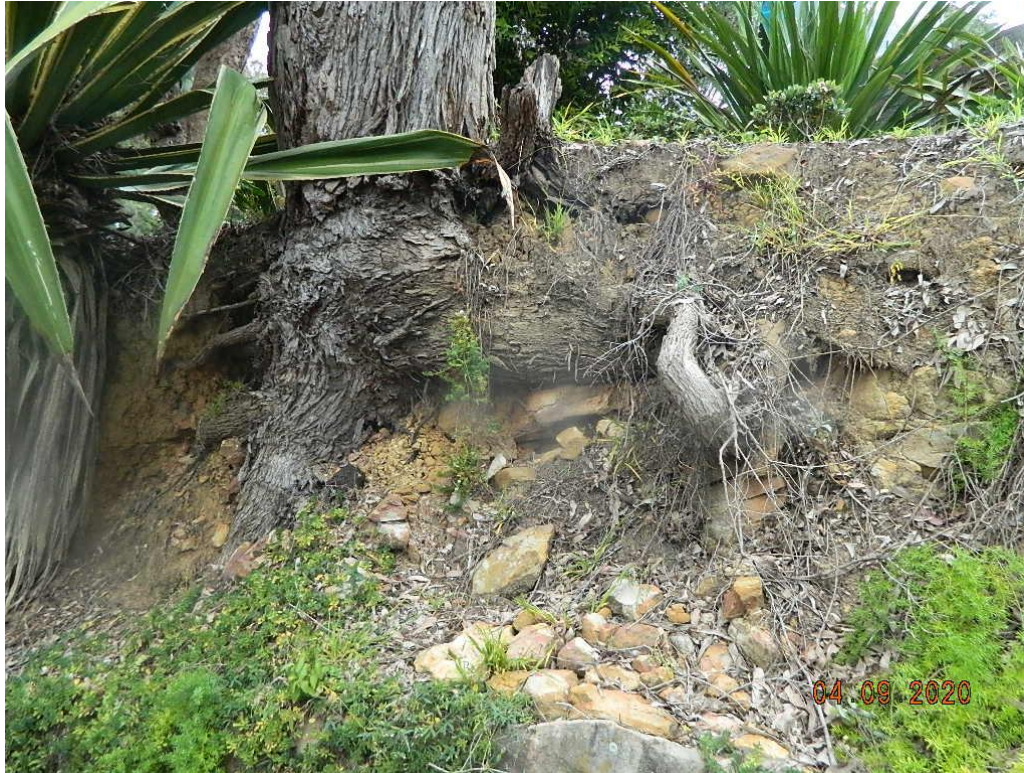
Photo 3

part of the proposed works. A large tree is located directly above the cut. Parts of the tree's roots are exposed near the base of the tree. Clay and weathered sandstone is visible below and beside the exposed roots (Photo 3).

HAZARDS	Hazard Three	Hazard Four
TYPE	The proposed excavation collapsing onto the worksite during the excavation process.	The proposed excavation undercutting the tree above the existing driveway causing failure (Photos 1 & 3).
LIKELIHOOD	'Possible' (10^{-3})	'Possible' (10^{-3})
CONSEQUENCES TO PROPERTY	'Medium' (15%)	'Minor' (8%)
RISK TO PROPERTY	'Moderate' (2×10^{-4})	'Moderate' (5×10^{-5})
RISK TO LIFE	8.3×10^{-6} /annum	5.3×10^{-3} /annum
COMMENTS	This level of risk to life and property is 'UNACCEPTABLE'. To move the risk to 'ACCEPTABLE' levels, the recommendations in Section 13 are to be followed.	This level of risk to life and property is 'UNACCEPTABLE'. To move risk to 'ACCEPTABLE' levels, the recommendations in Section 13 are to be followed.

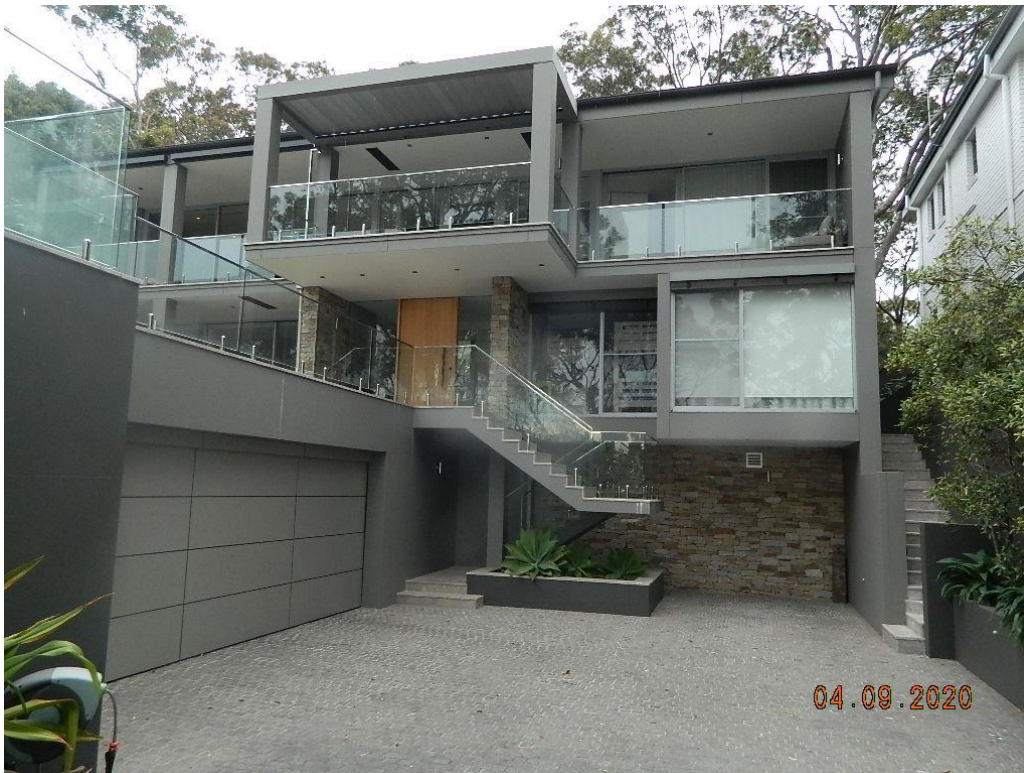
Photo 4

The driveway runs to a paved parking area and garage (Photo 4). The cut for the parking area is supported by a rendered retaining wall up to ~3m high in good condition (Photo 5). Next to the parking area is an above ground pool and terrace/lawn area in good condition (Photo 6). The garage is located below the terrace. The part three storey house is supported by rendered walls and stone dressed concrete walls (Photos 4 & 7). The external supporting walls show no significant signs of movement. Fill provides level lawn and garden areas on the SW side of the property (Photos 8 to 10). The fill is supported by low timber retaining walls and a stable ~1.6m high concrete block retaining wall. Overall the slope across the property is considered stable. The adjoining neighbouring properties pose no risk of instability to the subject property as seen from the street and subject property.

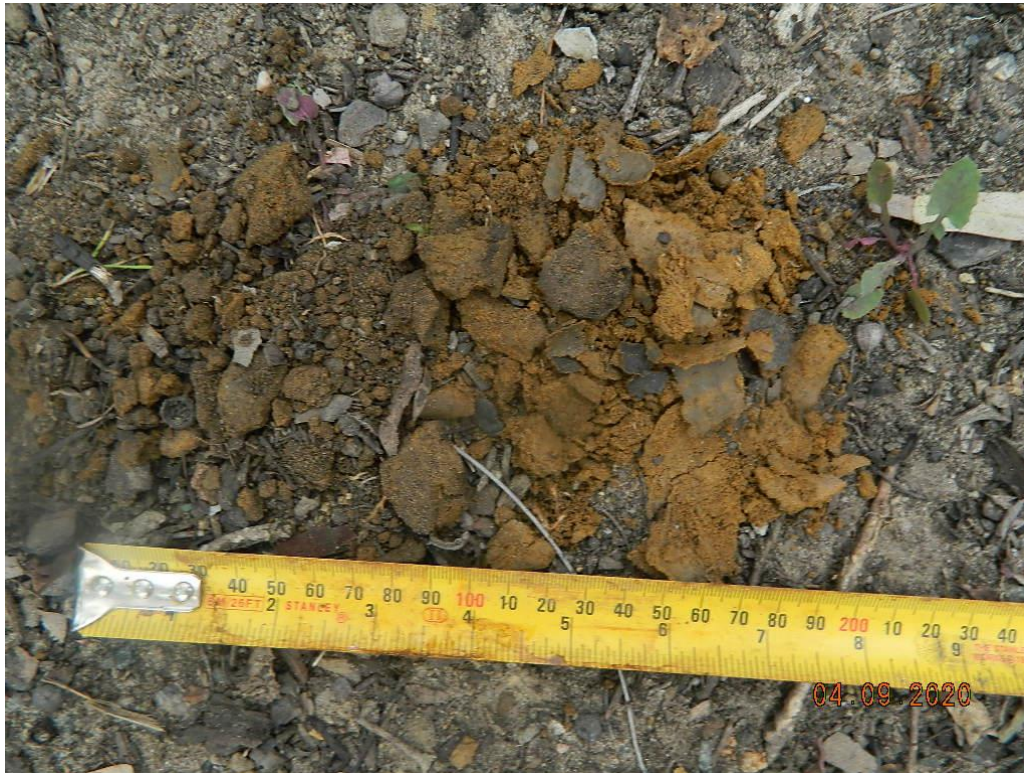
AUGER HOLE 1 (~RL55.1) – AH1 (photo 11)

Depth (m)	Material Encountered
0.0 to 0.1	TOPSOIL , sandy soil, brown, dry, fine to medium grained.
0.1 to 0.2	SANDY CLAY , orange brown, stiff to very stiff, dry.

Refusal @ 0.2m in stiff to very stiff clay. No watertable encountered.

Photo 11: AH1 – Downhole is from left to right.

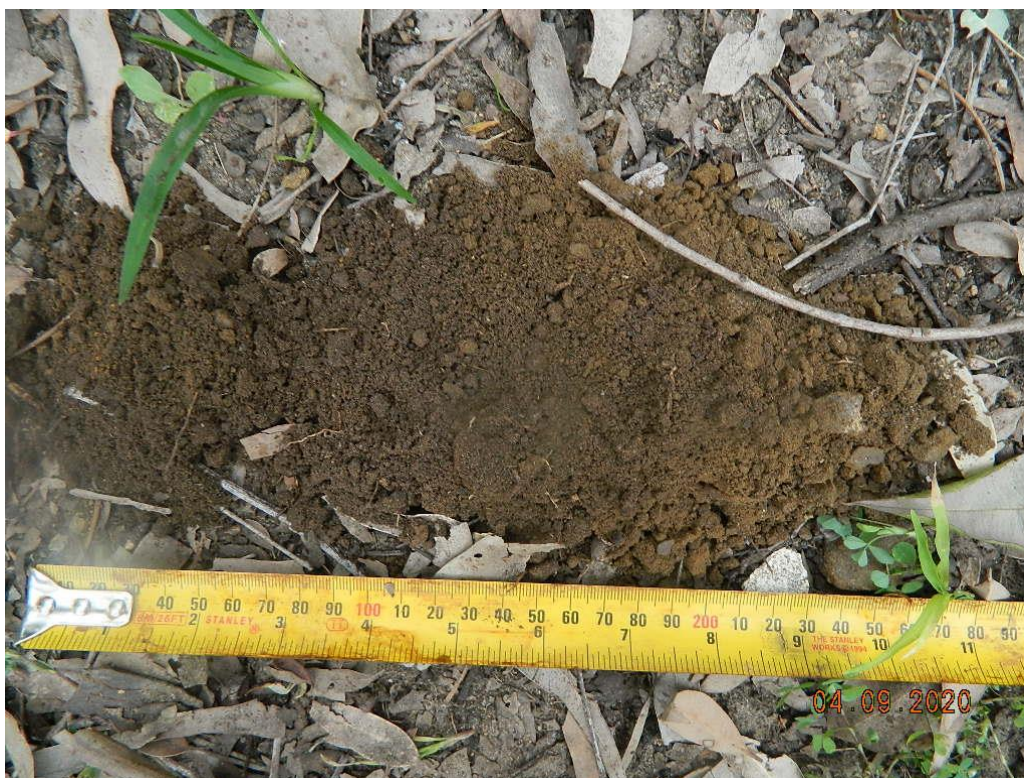
AUGER HOLE 1 (~RL55.4) – AH1 (photo 12)

Depth (m)	Material Encountered
0.0 to 0.1	TOPSOIL , sandy soil, brown, dry, fine to medium grained.
0.1 to 0.2	SANDY CLAY , orange brown, stiff to very stiff, dry.

Refusal @ 0.2m in stiff to very stiff clay. No watertable encountered.

Photo 12: AH2 – Downhole is from left to right.

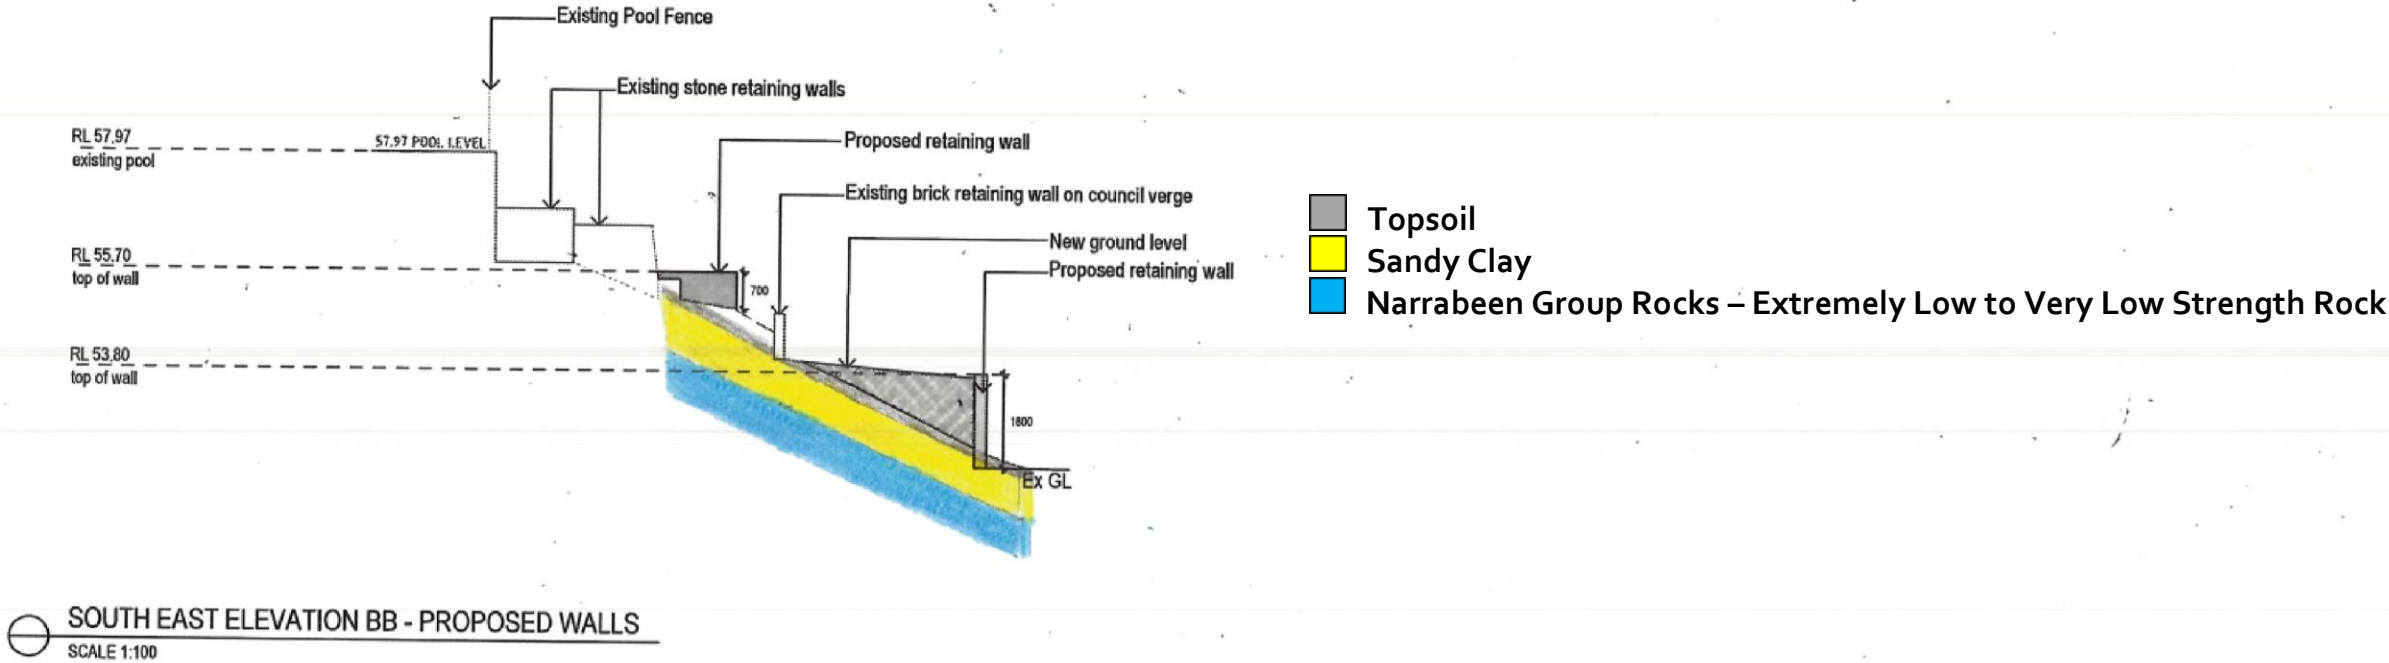
TYPE SECTION – Diagrammatical Interpretation of expected Ground Materials

Weathered sandstone is exposed across the existing cut for the driveway. The sandstone is interpreted to be a band of sandstone through the otherwise shale-dominated profile. Manmade fill has been placed across SW side of the property for landscaping. Below the fill, the rock is overlain by a thin sandy topsoil and sandy clays. In the test locations, the depth to rock ranged from depths of between ~0.6m to ~1.0m below the current surface. We conservatively estimate the strength of the rocks underlying the property to be of Extremely Low to Very Low Strength. It is to be noted that this material can appear as a mottled stiff clay when it is cut up by excavation equipment. See Type Section attached for a diagrammatical representation of the expected ground materials.
