Project name
2018_09_06

Section Inspection - 6/09/2018 - Line 1

Date of inspection 6/09/2018	Time of inspection 7:28 AM	Asset Owner Sydney Water	Pipe Asset ID Line 1	Nr. 1
Project name 2018_09_06	Contract No.	Coding Standard WSA 05-2008 2.2	Name of operator Matt	Job Number 4251

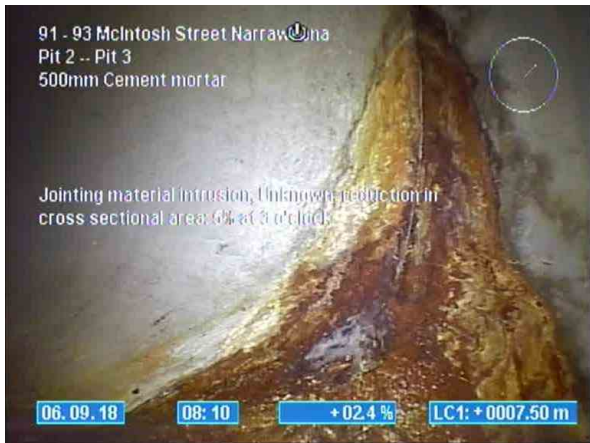
7.50	JIZ	Jointing material intrusion, Unknown, reduction in cross sectional area: 5% at 3 o'clock
3

, 00:03:16, 7.50
Jointing material intrusion, Unknown, reduction in cross sectional area: 5% at 3 o'clock

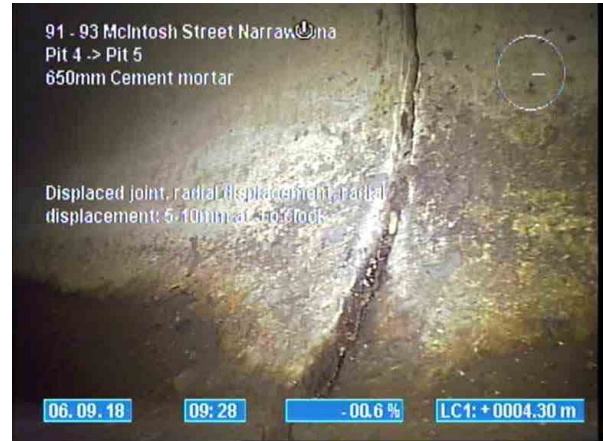
, 00:01:53, 4.90
Displaced joint, radial displacement, radial displacement: 5-10mm at 3 o'clock

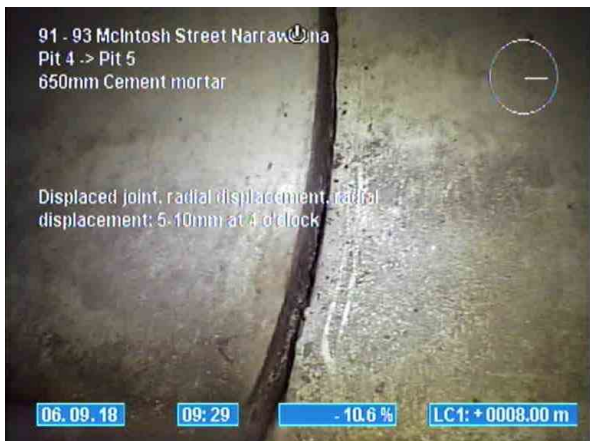
, 00:02:54, 8.00
Displaced joint, radial displacement, radial displacement: 5-10mm at 4 o'clock

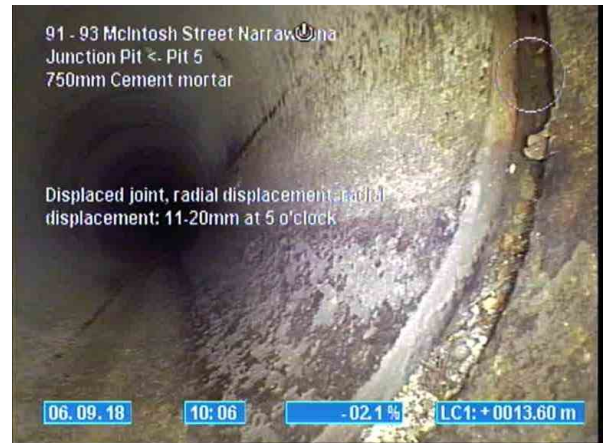
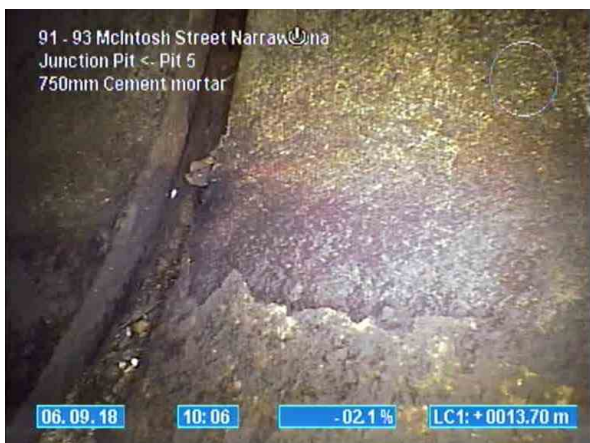
1:281	[m]	Code	Observation Text	MPEG	Photo	Grade
	0.00	STMH	Start node, maintenance hole, Nodename:, Pit 5	00:00:14		
	13.60	JDR	Displaced joint, radial displacement, radial displacement: 11-20mm at 5 o'clock	00:04:47		2

, 00:04:47, 13.60
Displaced joint, radial displacement, radial displacement:
11-20mm at 5 o'clock

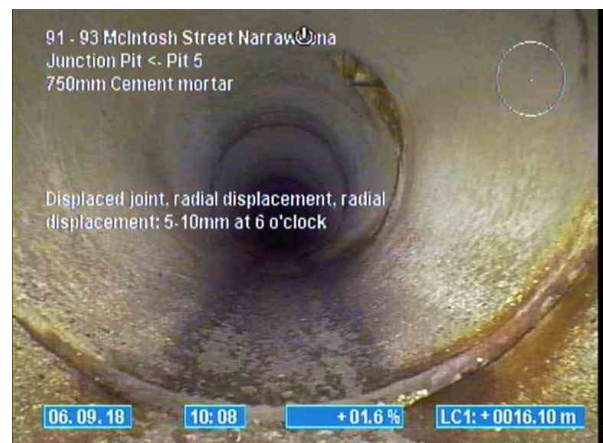
, 00:06:23, 16.10
Displaced joint, radial displacement, radial displacement:
5-10mm at 6 o'clock

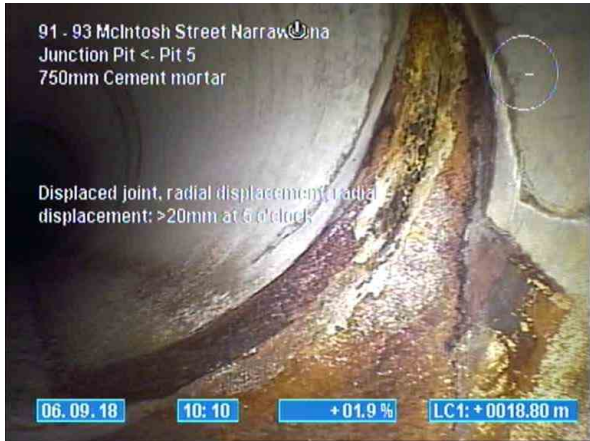
16.10	JDR	Displaced joint, radial displacement, radial displacement: 5-10mm at 6 o'clock	00:06:23		1
	18.80	JDR	Displaced joint, radial displacement, radial displacement: >20mm at 5 o'clock	00:07:20		3

, 00:07:20, 18.80
Displaced joint, radial displacement, radial displacement: >20mm at 5 o'clock

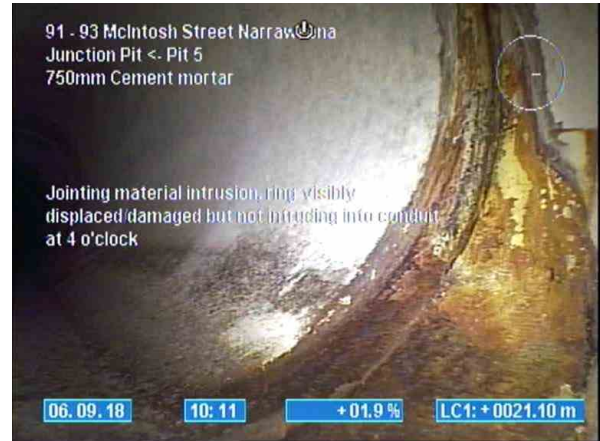
, 00:08:23, 21.10
Jointing material intrusion, ring visibly displaced/damaged but not intruding into conduit at 4 o'clock

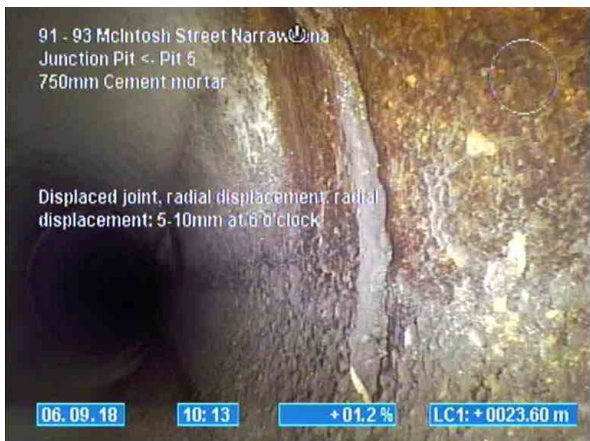
, 00:09:27, 23.60
Displaced joint, radial displacement, radial displacement: 5-10mm at 6 o'clock

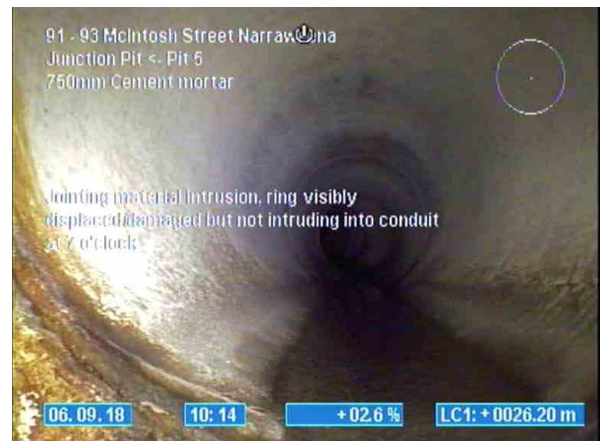
, 00:10:09, 26.20
Jointing material intrusion, ring visibly displaced/damaged but not intruding into conduit at 7 o'clock

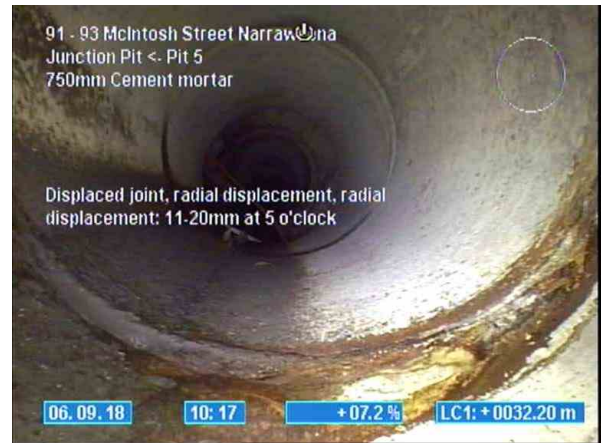
32.20	JDR	Displaced joint, radial displacement, radial displacement: 11-20mm at 5 o'clock	00:12:07		2
	34.20	FHJ	Finish node, junction or connection with another conduit, Nodename:, Junction Pit	00:13:03

, 00:12:07, 32.20
Displaced joint, radial displacement, radial displacement: 11-20mm at 5 o'clock

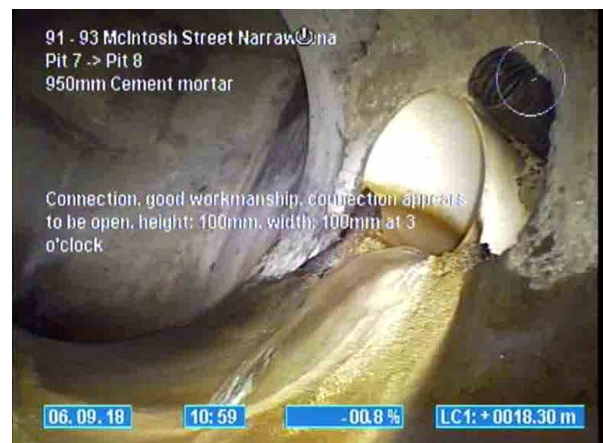
, 00:03:40, 18.30
Connection, good workmanship, connection appears to be open, height: 100mm, width: 100mm at 3 o'clock / Water Leak
