Report Title: Geotechnical Report 87 Alexandra Crescent, Bayview

Report Date: 15/12/22

## **GEOTECHNICAL INVESTIGATION:**

Alterations and Additions at **87 Alexandra Crescent, Bayview.**

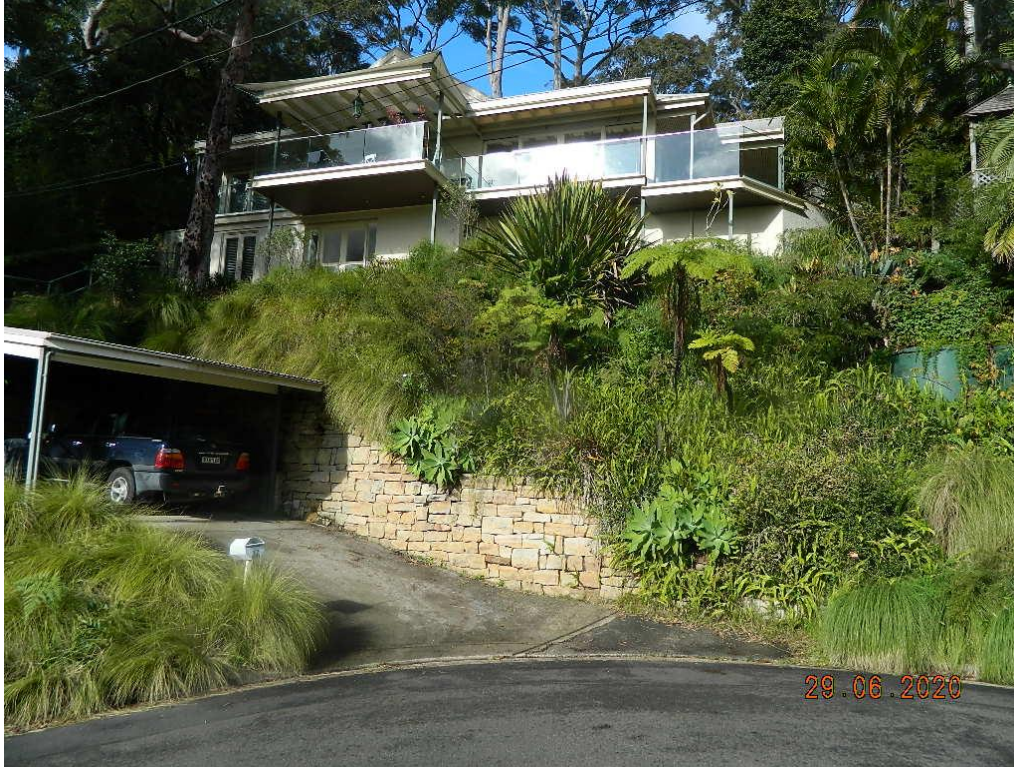
Photo 1

**2.3** At the road frontage a concrete driveway runs to a carport cut into the slope (Photo 1). The cut is supported by sandstone block, brick and concrete block retaining walls up to ~3.4m high (Photos 1 to 3). The highest portion of the sandstone block wall is supported by a brick wall in front of the base of the retaining wall (Photo 2). The retaining walls are considered to be stable. Between the carport and the house is a steep and thickly vegetated slope (Photo 1). The part three storey rendered brick and weatherboard clad house is supported by brick walls and brick piers Photos (1 & 4). The supporting walls and piers stand vertical and show no significant signs of movement (Photo 5). Uphill of the house a cut in the slope provides a level platform for the house. The cut is supported by concrete block and sandstone flagging retaining walls up to ~2.7m high. (Photos 6 & 7). The W portion of the concrete block retaining wall is tilting at up to ~4° from vertical. See 'Section 16 Ongoing Maintenance'. A Medium Strength Sandstone bedrock cliff face up to ~7m outcrops above the cut for the house (Photo 8). A portion of the cliff face is undercut by up to ~4.4m (Photo 9). The undercut is considered stable. No geotechnical hazards were observed on the neighbouring properties that could impact on the subject property as seen from the street and subject property.

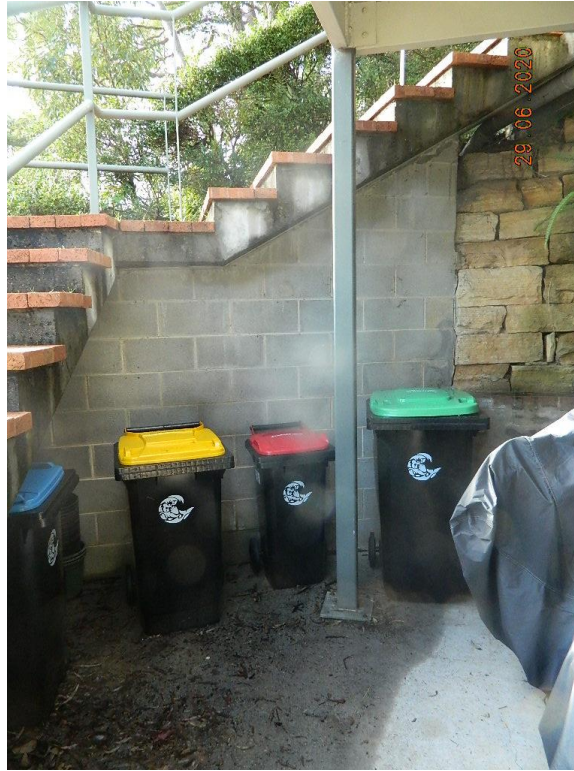
Photo 3

The excavation requires the demolition of part of the existing sandstone block, brick and concrete block retaining walls (Photo 3).

The existing retaining walls (Photo 3) are to be demolished from the top down as the excavation is progressed.

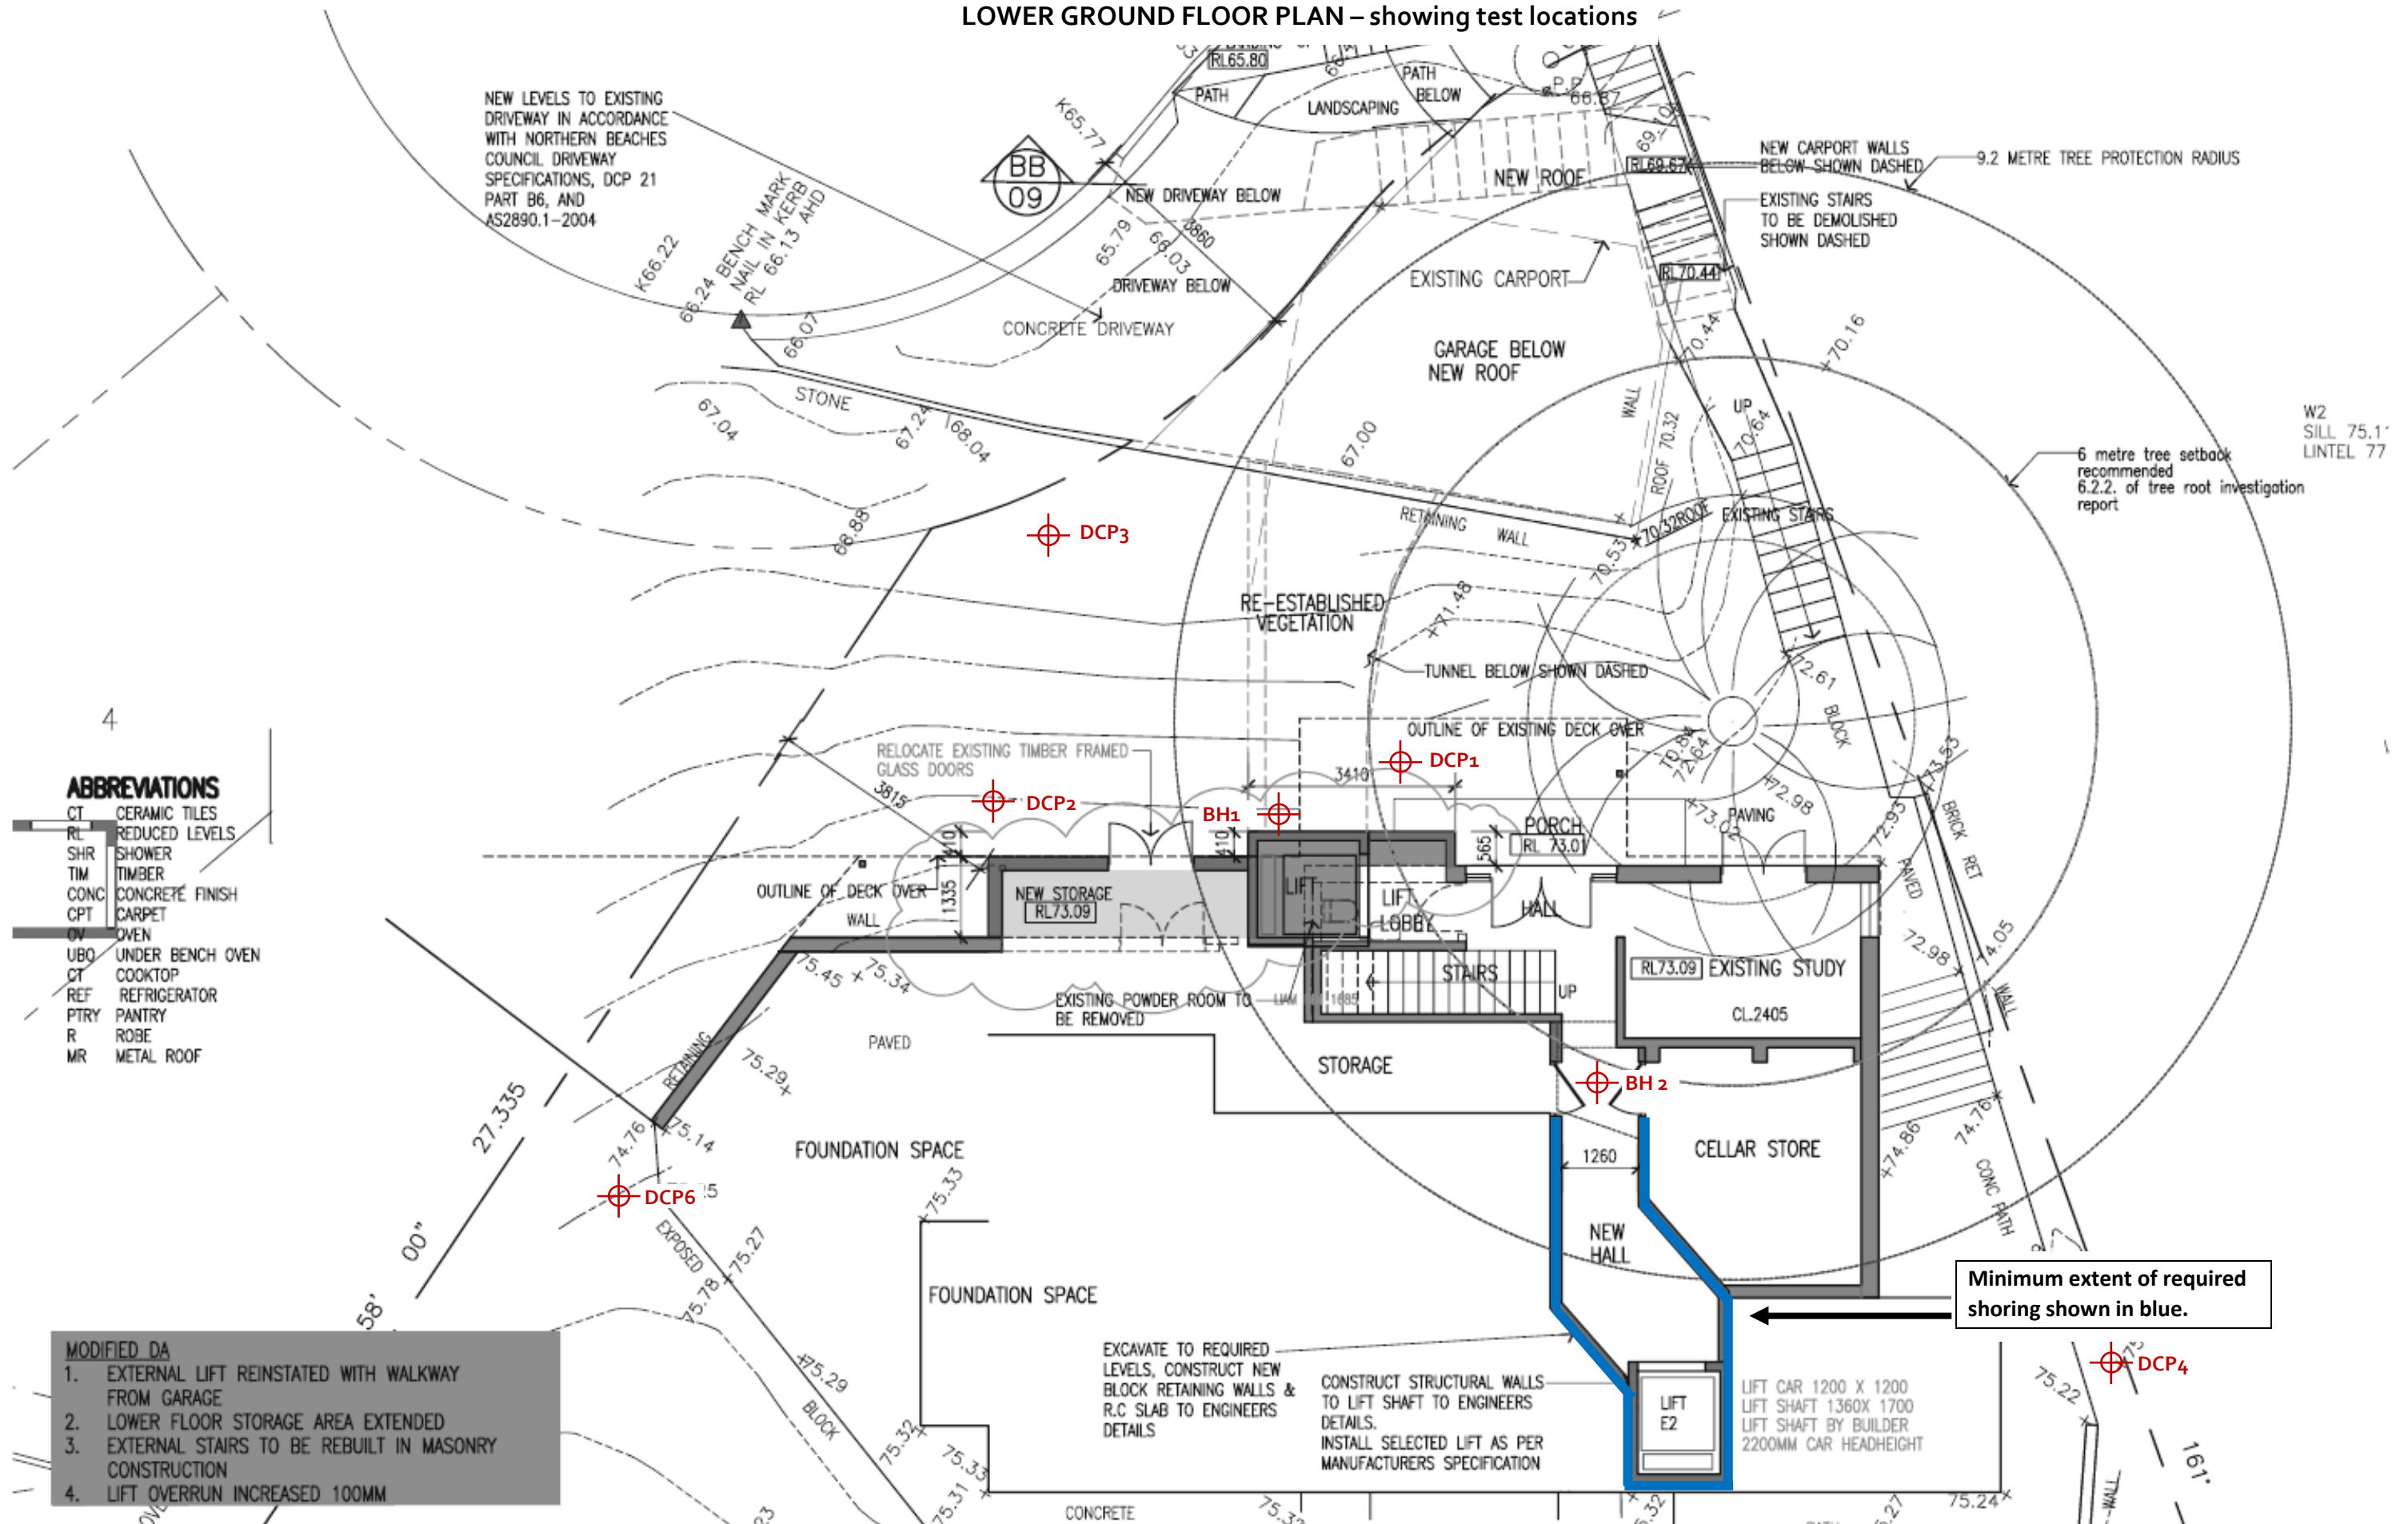
# LOWER GROUND FLOOR PLAN – showing test locations

Minimum extent of required shoring shown in blue.

Due to the depth of the excavation and its proximity to the E common boundary all sides of the excavation will require ground support installed prior to the commencement of the excavation and demolition of the existing retaining walls. See the Carport Plan attached for the minimum extent of the required shoring shown in blue.
