REPORT ON GEOTECHNICAL SITE INVESTIGATION

PROPOSED ALTERATIONS AND ADDITIONS

2 DIXON AVENUE, FRENCHS FOREST

Project No.: 2021-002

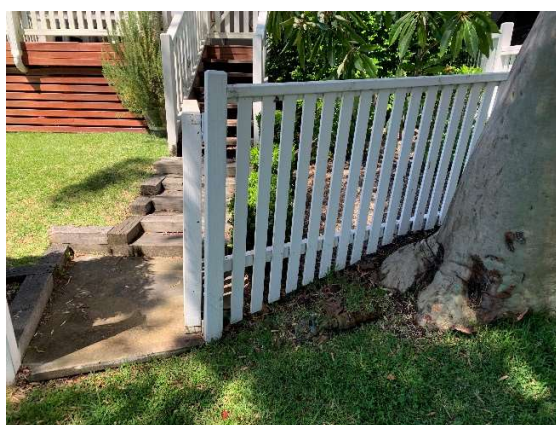
Photograph 3: View of the gum tree adjacent to the front entrance of the site, facing south

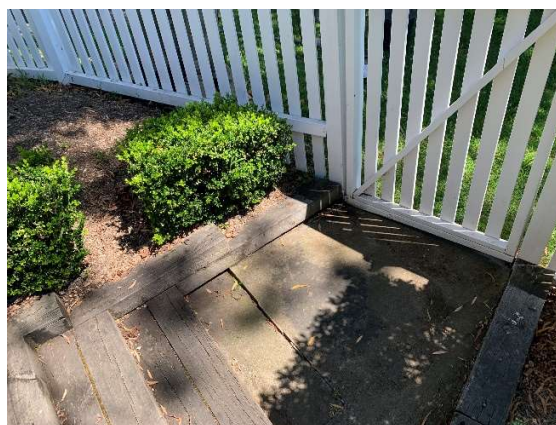
The site contains a one and two storey rendered house positioned centrally within the site, vehicle access is provided to the north western carport via a concrete driveway which connects to Dixon Avenue. A ground floor timber verandah extends along the northern and eastern sides of the structure, with the first floor level only occupying the northern half of the structure. Grassed lawns surround the house with a hedge-line continuing around the northern and eastern boundaries of the site. Two large trees (gum tree and paperbark tree) are located adjacent to the front entrance to the site, the gum tree is situated approximately 1.0m from the front gate. It appears the root system of the gum tree has lead to root jacking and movement of the front pavers and fence, as shown in Photographs 3 and 4.

Photograph 4: Movement within the pavers due to underlying roots of the adjacent gum tree, facing north west

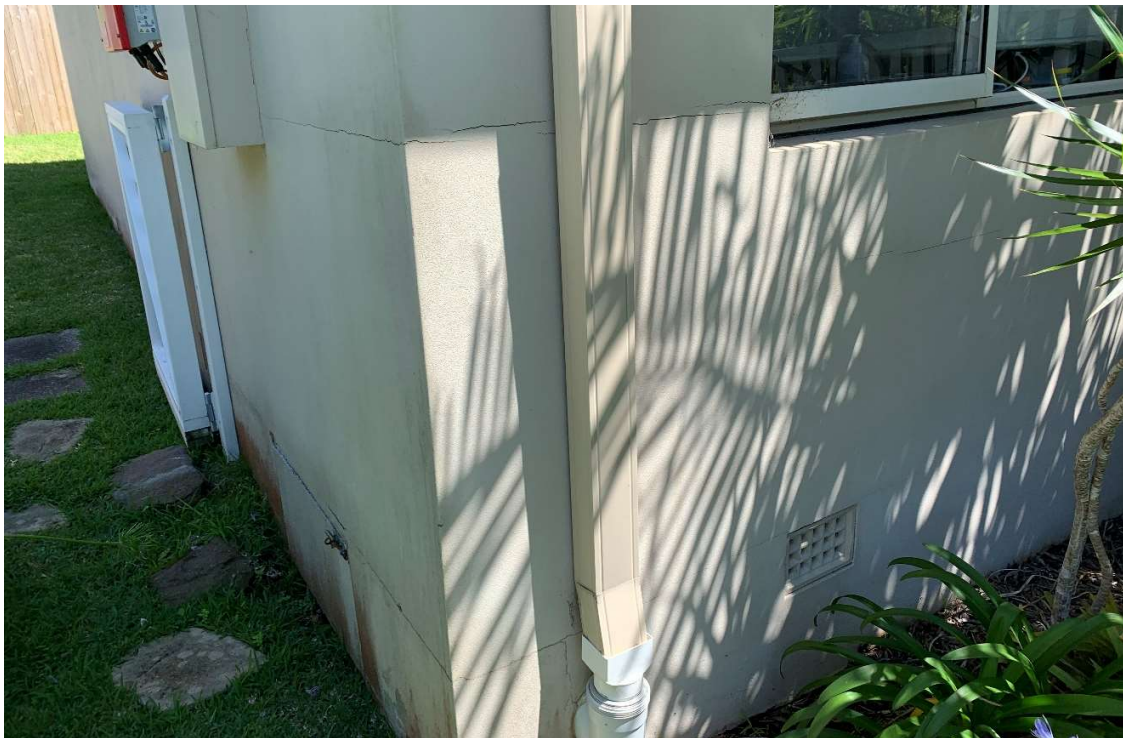
The main structure appeared to be in good condition, however some cracks were observed on the exterior walls of the southern half of the structure. Horizontal cracks within the render were noted on the south eastern corner of the structure, extending up to 3.0m long and up to 1mm wide. Further horizontal cracking was observed within the south western corner and western side of the structure, up to 3.0m long and up to 0.5mm wide. Some of these cracks are shown in Photographs 5 – 7. The planar formation of the cracks observed within the southern portion of the structure indicate that the cracks are most likely due to shrinkage issues within the render and not related to any movement within the underlying geology.

Photograph 5: Horizontal cracking within south eastern corner of structure, facing north west

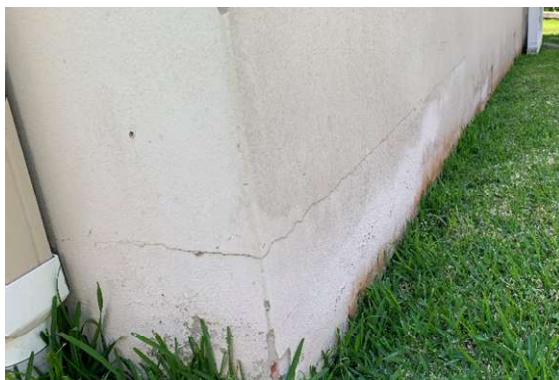
Photograph 6: Cracking within south western corner of structure, facing north east

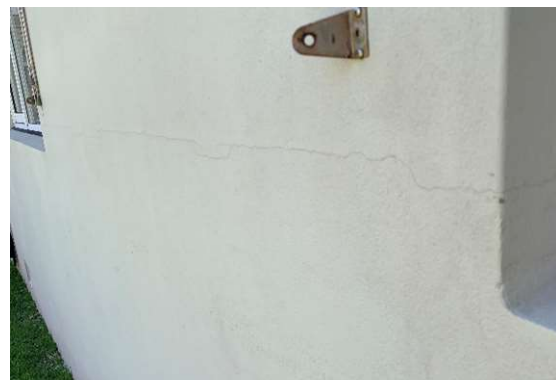
Photograph 7: Cracking within western wall of structure, facing north east
