Construction Impact & Management Statement: Lodged DA2021/0395

November 2020, updated June 2021

Site:	Lot 5 in DP 16260 1 Yachtview Avenue NEWPORT, NSW
Client:	Paul Godfrey & Vanessa Naderi c/ Michael Finch 1 Yachtview Avenue NEWPORT, NSW 2106
Author:	Kyle A Hill Registered (Arb Aus #1884) Practising & Consulting Arborist Post Graduate Certificate in Arboriculture, Uni of Melb Diploma of Horticulture-Arboriculture TAFE, Grow SA Certificate of Horticulture, TAFE Certificate Advanced Tree Care TAFE Founder -Growing My Way Tree Services (1977) Member of International Society of Arboriculture Member of Arboriculture Australia

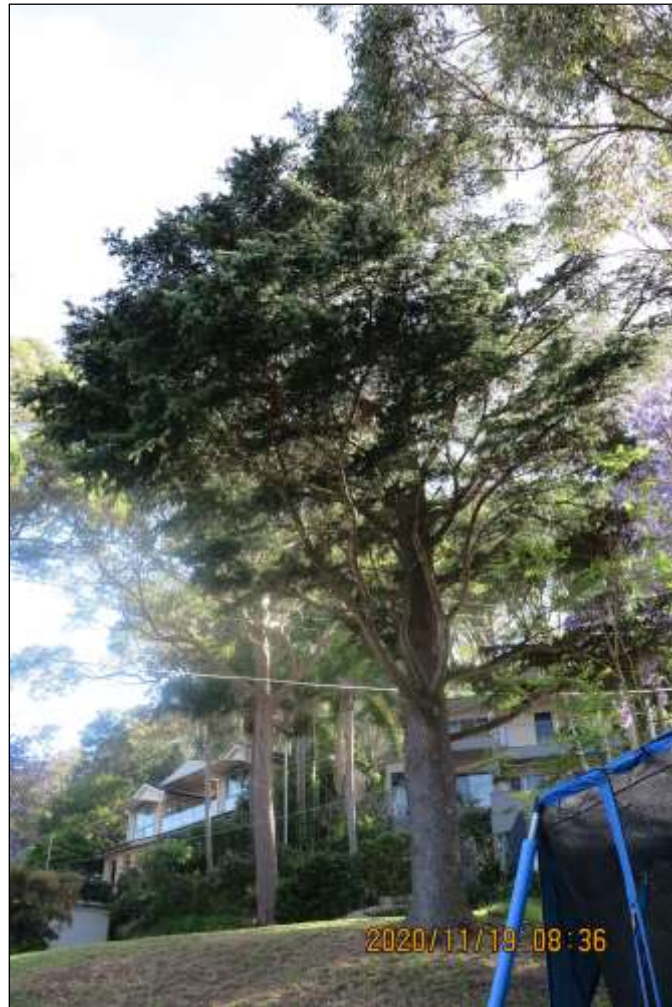
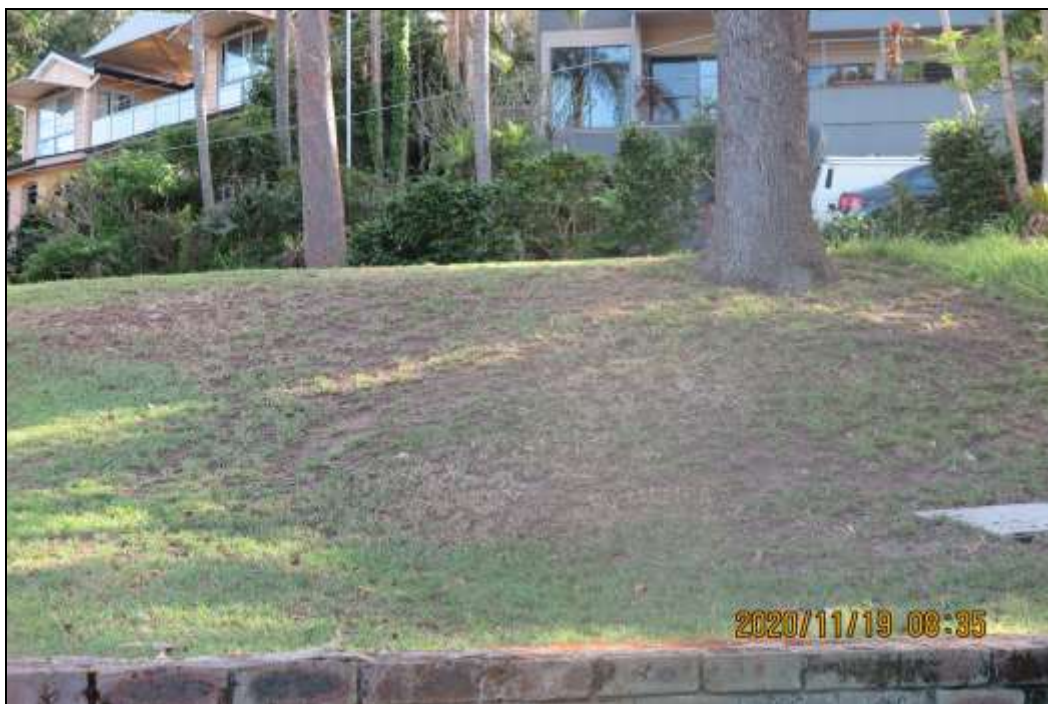
Figure 6: Illustrates condition & location of discussed Tree #1.

Identification	Height (m)	Crown (m)	DBH (m)	TPZ (m)	SRZ (m)	Age	Health/Vigour	Structure	Significance/Retention Values	Comments
1	<i>Cedrus deodara</i> Himalayan Cedar	<14.00	<9.00	0.58	6.96	2.78	Mature	Good & Good	Typical/ Crown Raised Pruned	Moderate/ Moderate	<u>Replace:</u> The as proposed works equate to a reduced mathematical ‘encroachment’ of the total TPZ surface area. This is considered as very unlikely to adversely impact upon the ULE of this tree. As such, with any excavation within its 6.96m TPZ radial distance completed manually management of any exposed ‘live root’ of a ‘significant diameter (>50mm) is considered as routine. Note: stairs to the main dwelling entrance are proposed to be above/on existing ground levels.
2	<i>Viburnum odoratissimum</i> (x3) Viburnum <i>Radermachera sinica</i> (x1) China Doll	<3.50 <5.00	N/A	N/A	N/A	N/A	Mature	Good & Good	Typical	Moderate/ Moderate	<u>Retain, Protect & Manage:</u> Tree/Shrubs within adjoining lands. Located significantly lower than the existing/proposed subject site ground level changes. No TPZ fencing is specified as existing masonry common boundary retaining wall isolates these plants from the as proposed works.

Discussed Tree #1 is confirmed to be approximately 2.40m from the as modified location of the as proposed new entry stairs. This is well outside of its SRZ radial distance of 2.78m & built on existing ground level. The modified proposed works equate to an *Australian Standard (AS4970-2009 Protection of trees on development sites)* '*Minor Encroachment*', i.e., way less than a potentially acceptable 10% of total Tree Protection Zone surface area (152.18m²).

Taking the modified proposed works & the discussed tree Genus/species into consideration; it is confirmed Tree #1 is now able to be viably retained (with management) with respect to the as proposed works & the NBC objective of over the long term preserving & increasing the total 'Green Footprint' within the NBC local government area.

Standard TPZ isolation (within the subject site) 'temporary metal mesh fencing panels with above ground supports' are specified to be instated prior to the commencement of any works.

In the event a 'live root' from Tree #1 of a 'significant diameter' (>50mm) is exposed during the manual excavation process for the new driveway profile the sites retained Project Arborist must determine the strategy able to be adopted relative to 'best practice'. Only the Project Arborist can oversee, instruct & document with supporting photographic evidence the strategy adopted. Any 'live root' <50mm in diameter can be cleanly pruned without any input from the retained Project Arborist. The site manager must have documented evidence (with supporting photographs) confirming no 'significant diameter live roots' were exposed.

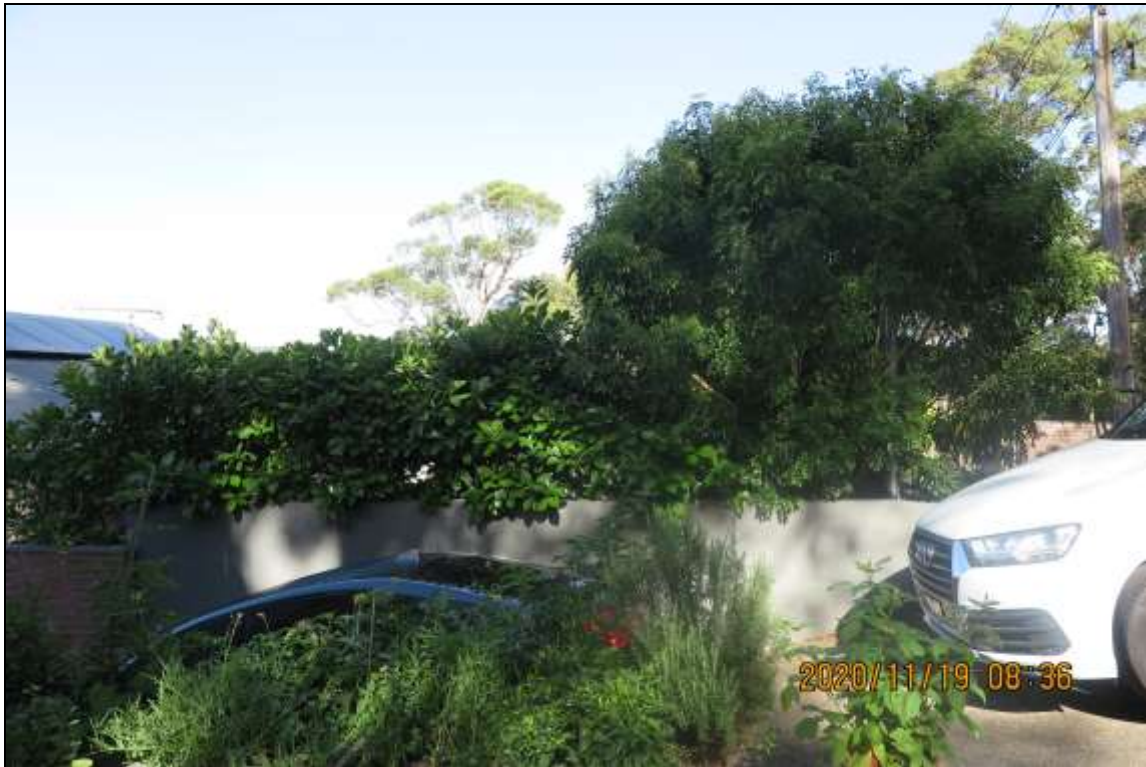
Figure 7: Illustrates adjoining property trees/shrubs. Note: existing damage to common boundary masonry retaining wall/subject site concrete driveway.

Tree/Shrubs located within the adjoining 2 Yachtview Avenue property are confirmed to be totally separated/isolated from the subject site as proposed works by the existing common boundary masonry retaining wall. As such, no management specification or further discussion is required.
