Report Title: Geotechnical Report 9 Wakooka Avenue, Elanora Heights

Report Date: 25/6/19

## **GEOTECHNICAL INVESTIGATION:**

### **New Secondary Dwelling at 9 Wakooka Avenue, Elanora Heights**

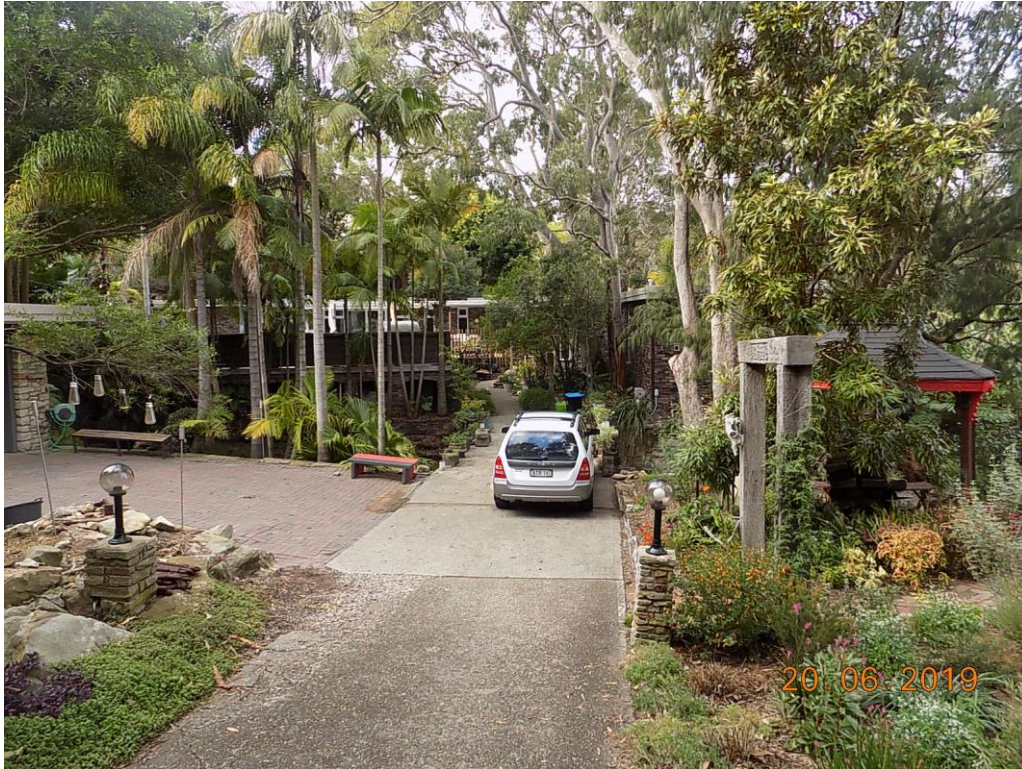
Photo 1

- 2.3** At the road frontage, a concrete driveway runs down the slope to a bridge over a creek channel that cuts through the property from N to S (Photos 1 & 2). On the W side of the creek, the driveway diverts to a stable masonry garage (Photo 3). Between the road frontage and the garage is a gentle, moderately vegetated slope (Photo 4). The bed of the creek consists of stable, competent Medium Strength Sandstone (Photo 7). The creek encounters a waterfall that flows over a ~4.0m high rock face that is close to the S boundary (Photo 5). The rock face is undercut ~5.0m at the base. However, the rock face is thickly bedded and the undercut is bridged at both ends by competent rock. Thus, we consider the undercut to currently be stable. Filling has been placed on both banks of the creek to level the property. The fills are supported

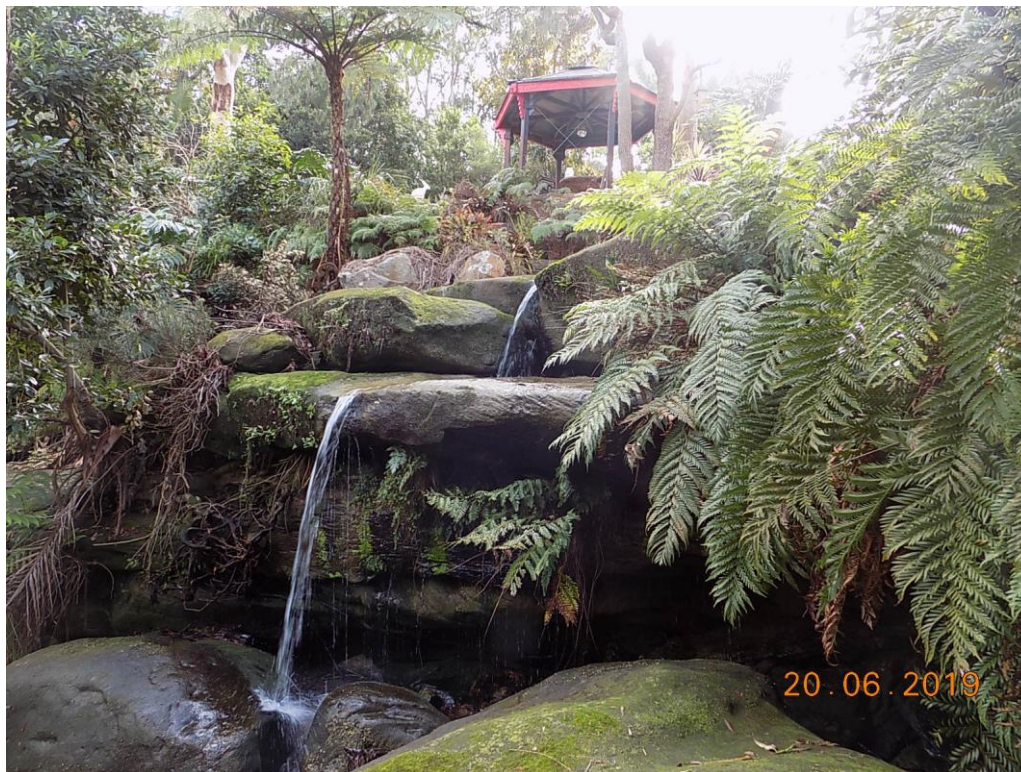
Photo 5

No geotechnical hazards were observed beside the property. The gently graded slope that falls across the property and continues above and below is a potential hazard (**Hazard One**). The undercut rock face below the property is a potential hazard (**Hazard Two**).

HAZARDS	Hazard One	Hazard Two
TYPE	The gentle slope that falls across the site and continues above and below failing and impacting on the proposed works.	The undercut rock face failing and impacting on the subject property (Photo 5).
LIKELIHOOD	'Unlikely' ( $10^{-4}$ )	'Rare' ( $10^{-5}$ )
CONSEQUENCES TO PROPERTY	'Medium' (12%)	'Major' (60%)
RISK TO PROPERTY	'Low' ( $2 \times 10^{-5}$ )	'Low' ( $6 \times 10^{-5}$ )
RISK TO LIFE	$5.5 \times 10^{-7}$ /annum	$8.3 \times 10^{-7}$ /annum
COMMENTS	This level of risk is 'ACCEPTABLE'.	This level of risk is 'ACCEPTABLE'.

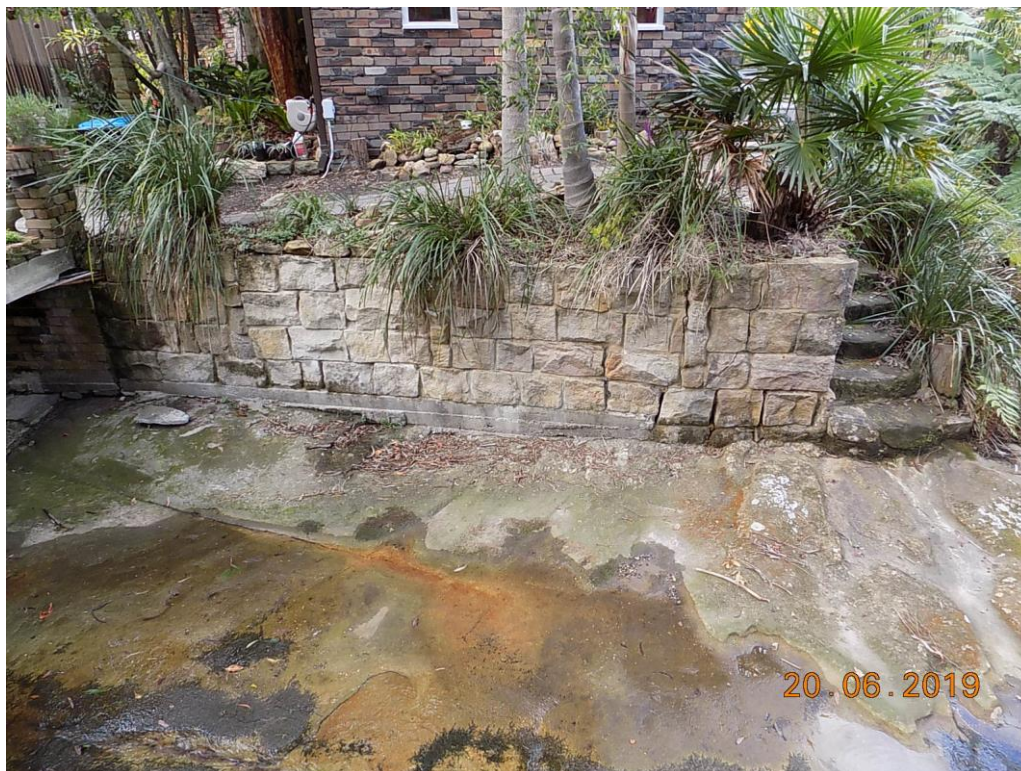
Photo 6

by stable sandstone block retaining walls (Photos 6 & 7). A pool has been constructed on the E side of the creek (Photo 8). No signs of movement were observed in the concrete shell of the pool. The single-storey brick house is supported on brick walls (Photo 9). No significant signs of movement were observed in the supporting brick walls. An excavation has been made in the slope to create a level platform for the house. The cut is supported by a brick retaining wall reaching ~1.2m high (Photo 10). This wall was observed to be directly supported off an outcrop of competent Medium Strength Sandstone bedrock.

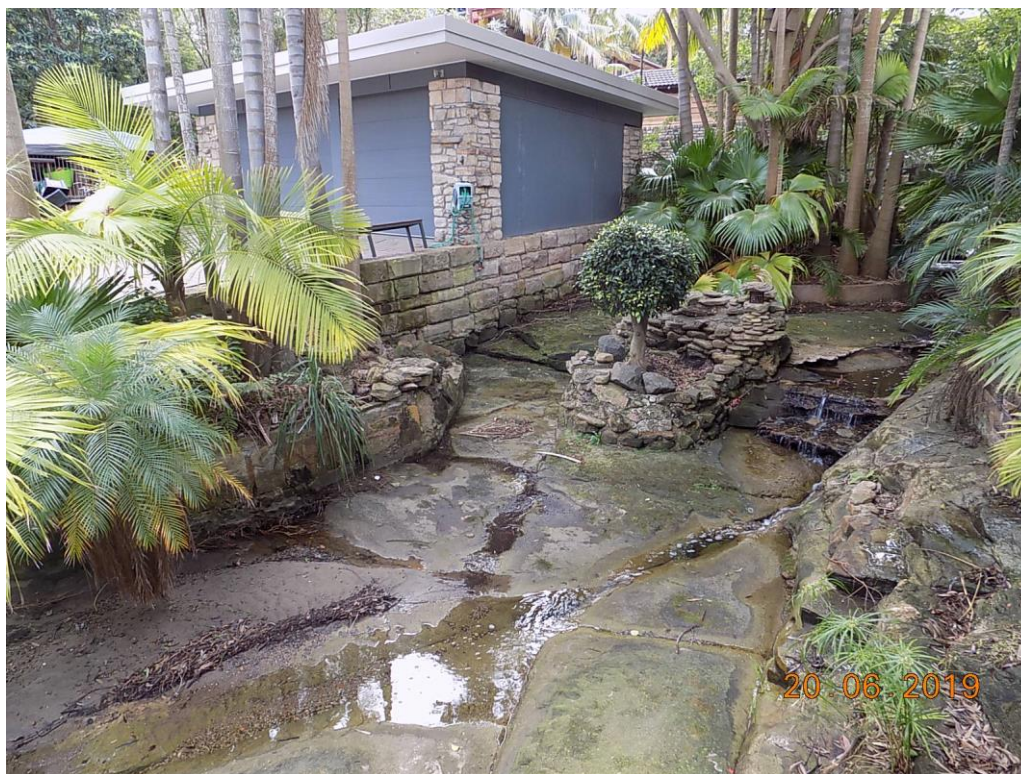
Photo 7

Ground water seepage is expected to move over the buried surface of the rock and through the cracks. As a creek flows down the centre of the block (Photo 7), we expect groundwater seepage to be slightly higher across the block as slope seepage will move toward the creek. Due to the slope and elevation of the block, the water table is expected to be many metres below the base of the proposed excavation.

Apart from the flowing creek down the centre of the site (Photo 7), no evidence of surface flows were observed on the property during the inspection. It is expected that normal sheet wash will move onto the site from above the property during heavy down pours.

There is fall to the creek that cuts through the property (Photo 7). Roof water from the development is to be piped to the creek through any tanks that may be required by the regulating authorities.

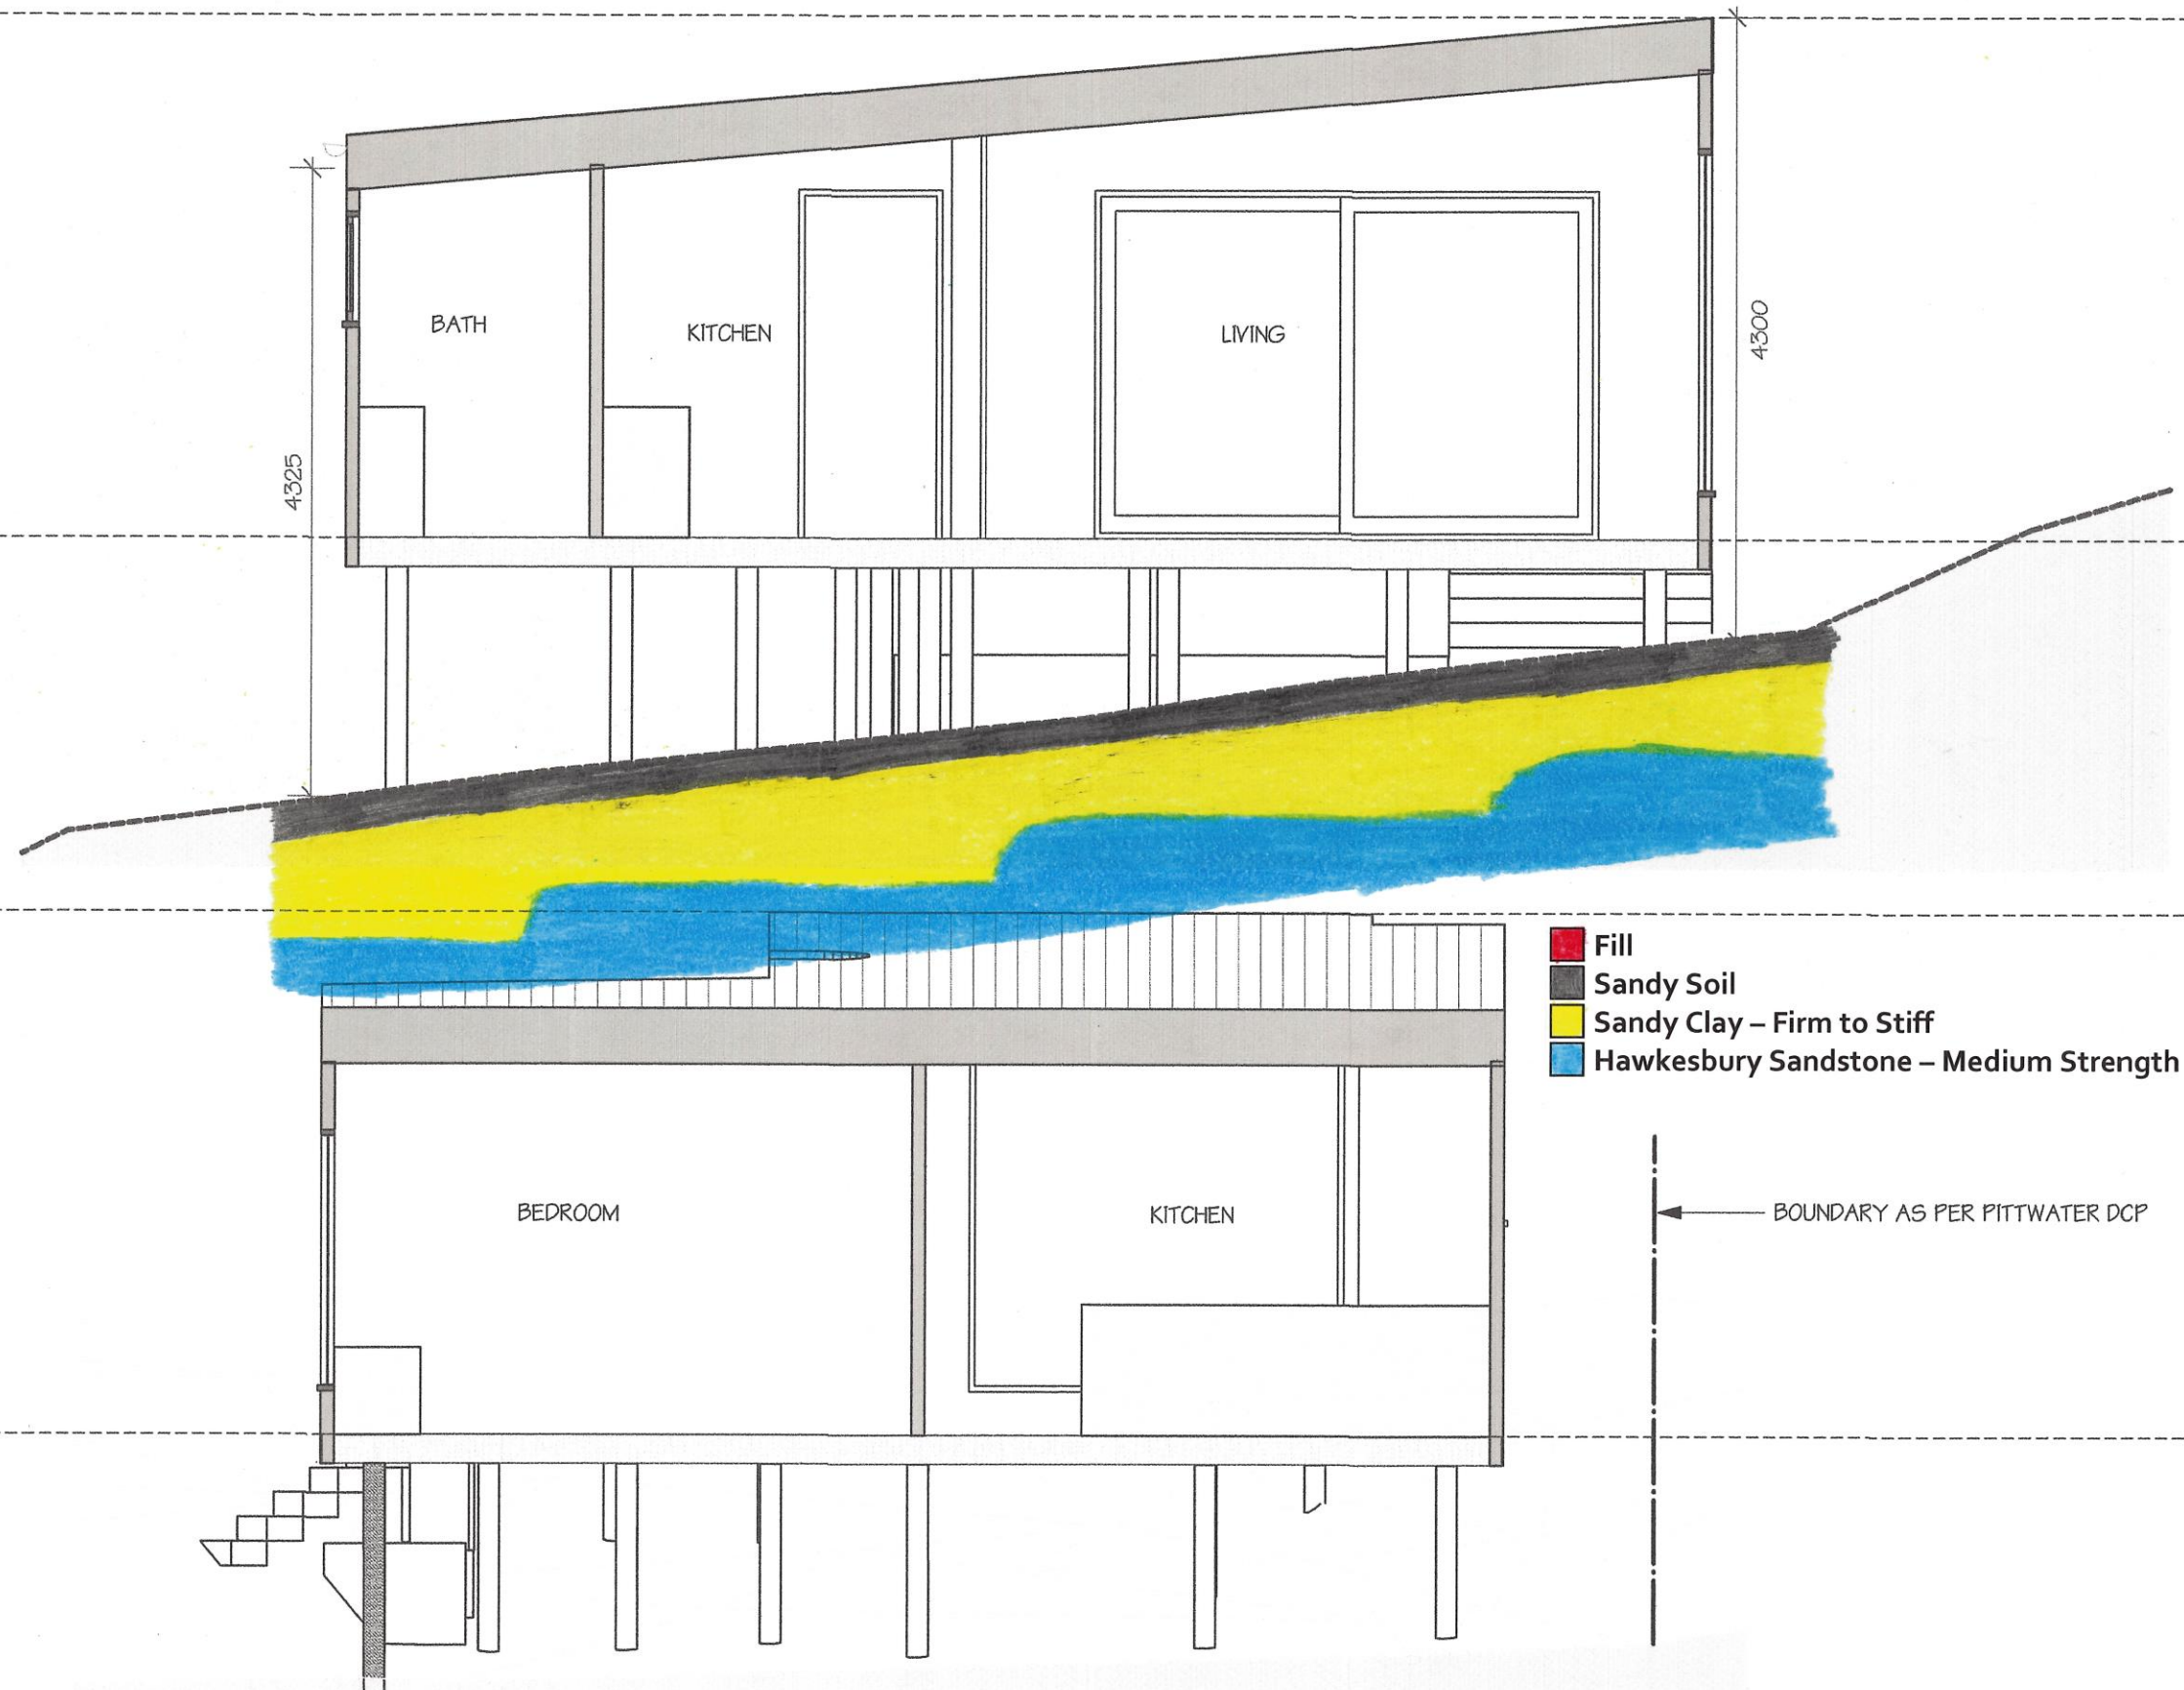
# TYPE SECTION – Diagrammatical Interpretation of expected Ground Materials

The surface features of the block are controlled by the outcropping and underlying sandstone bedrock that steps down the property forming sub-horizontal benches between the steps. Where the grade is steeper, the steps are larger, and the benches narrower. Where the slope eases, the opposite is true. The rock is overlain by sandy soils and firm to stiff sandy clays that fill the bench-step formation. In the test locations, the depth to Medium Strength Sandstone ranged between 0.4 to 1.3m below the current surface, being deeper due to the stepped nature of the underlying rock. See Type Section attached for a diagrammatical representation of the expected ground materials.

- Fill
- Sandy Soil
- Sandy Clay – Firm to Stiff
- Hawkesbury Sandstone – Medium Strength
