Proposed Alterations & Additions 9 Lolita Avenue, Forestville NSW

Preliminary Geotechnical Assessment

Our ref: 5860-G1
25 November 2019

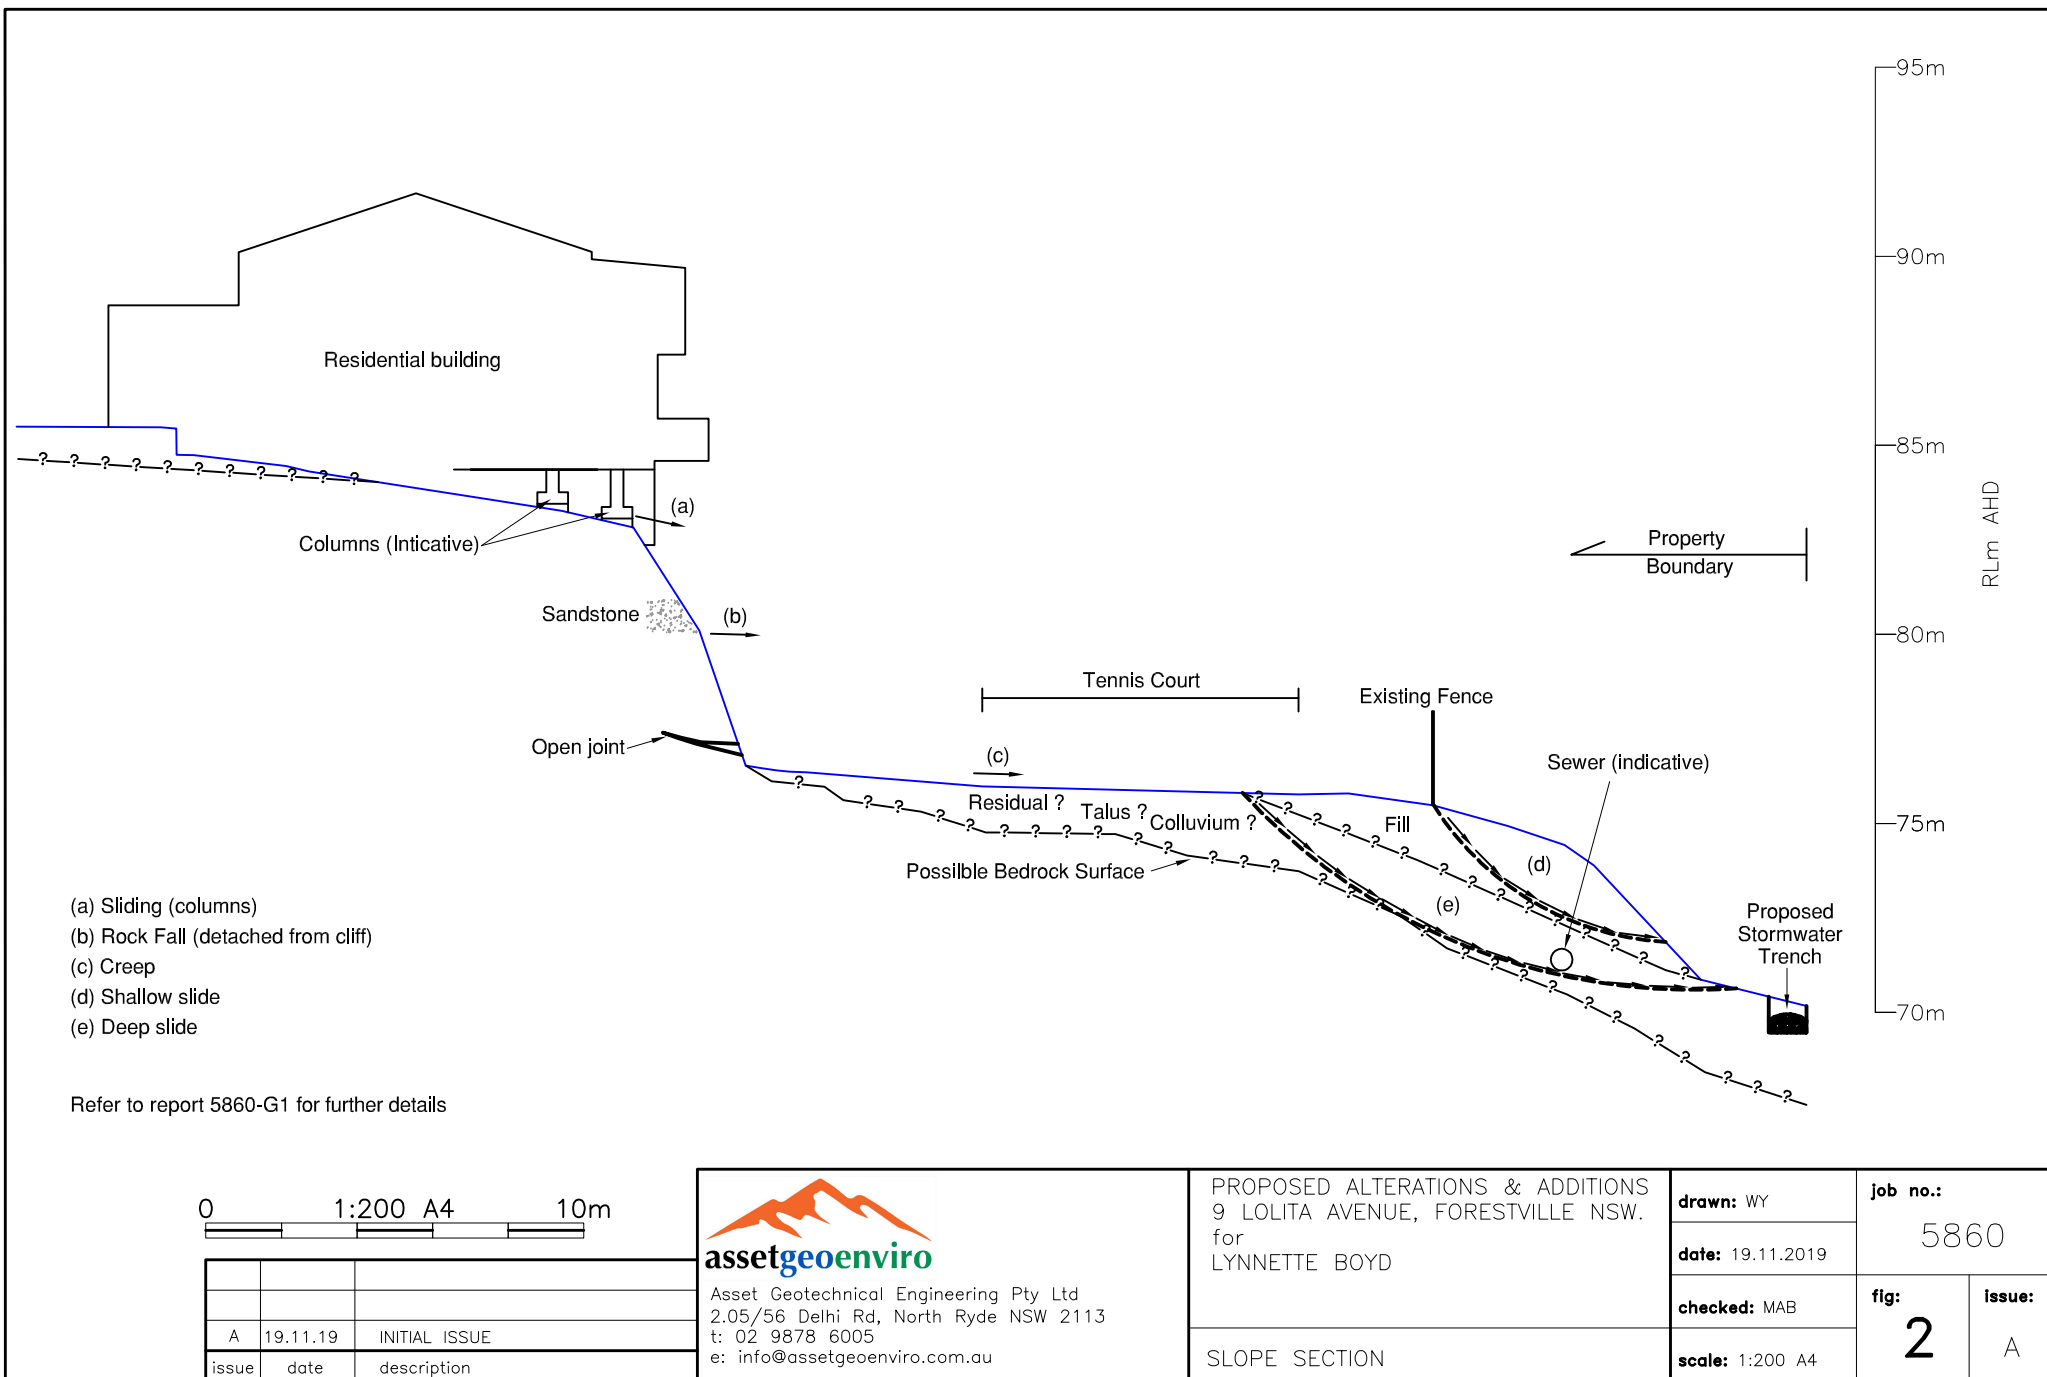
The following general potential hazards/events are identified for this site and relate to slope instability (refer Figure 2 for an illustration of the hazards):

- A. Sliding columns on sloping rock surface.
- B. Rock fall failure detached from cliff.
- C. Creep failure within soil layer.
- D. Shallow slide above the rock.
- E. Deep slide near the rock and soil interface.

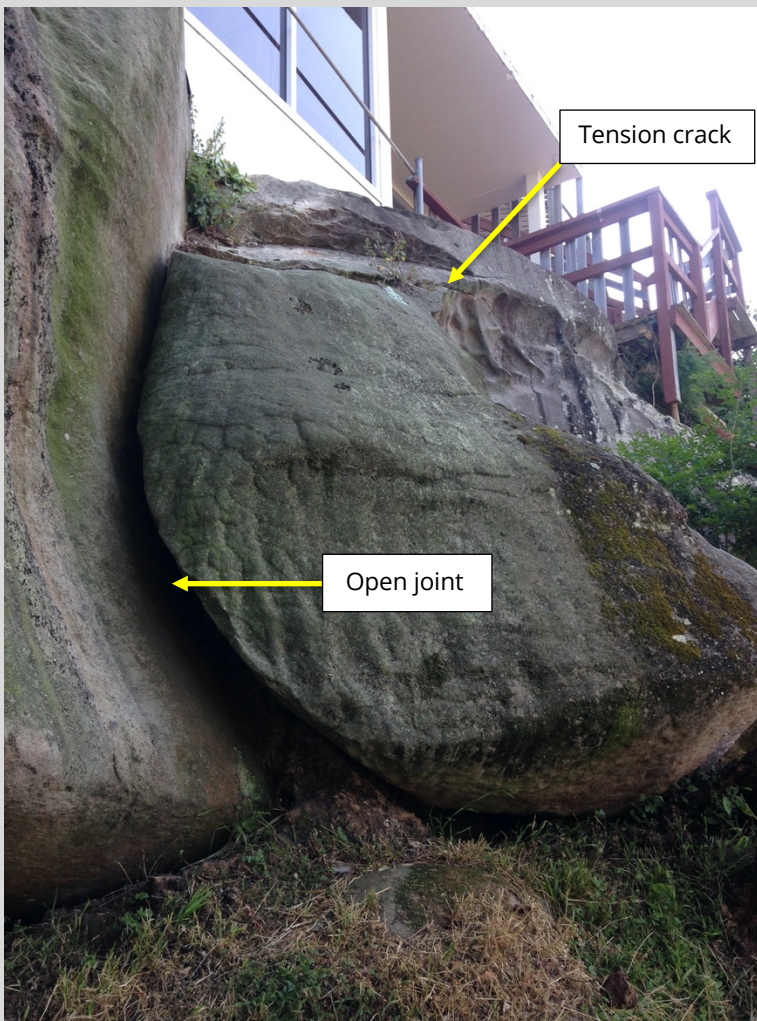
3

The surface of the rock cliff is generally highly weathered and rounded from rainfall and is assessed Class 2 Sandstone or better². A detached rock block has been observed with a tension crack near and a large open vertical joint with dip and dip direction at 70° – 85° / 192° , as shown Photo 3.

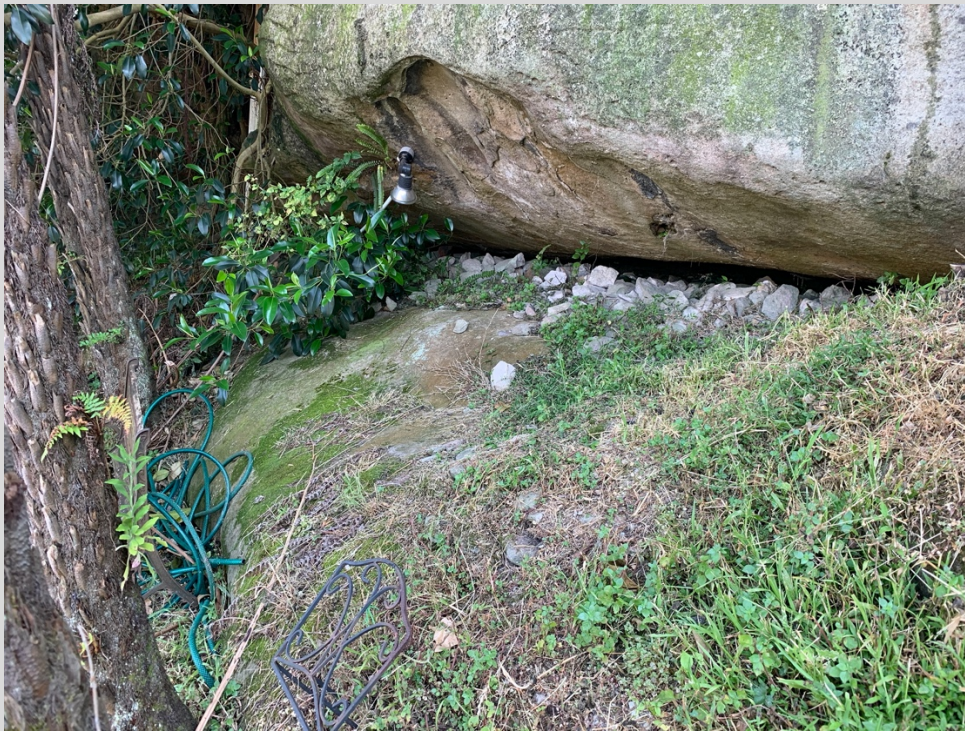
4

An open sub-horizontal joint or parting was observed near the bottom portion of the cliff with a gap measured to be about 150mm-200mm and extending about 1.5m deep in from the cliff face, as shown in Photo 4.

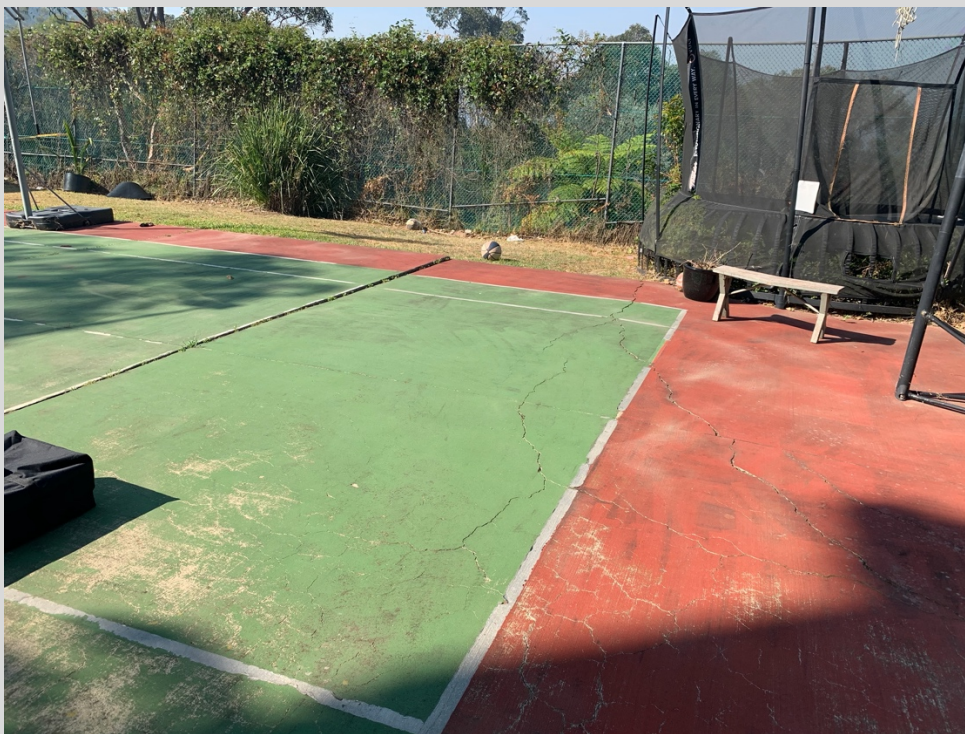
5

A tennis court constructed of concrete is located on a flat area at the base of the cliff as shown in Photo 5. The western corner of the concrete slab is cracked and has settled up to about 150mm.

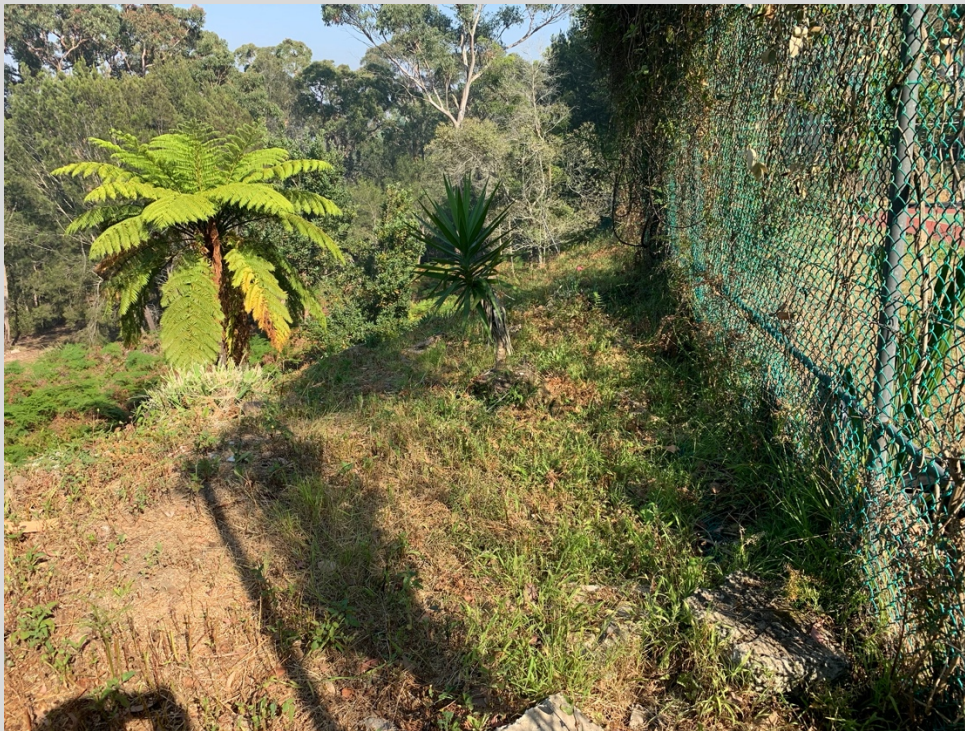
6

There is fence behind of tennis court and a fill batter slopes down from the fence to the rear edge of the property at about 37° – 40° as shown in Photo 6. Construction waste, including concrete pieces, were observed on the surface of the batter.

The fill batter at the rear of the site could impact and be impacted by the existing sewer pipe that runs diagonally across the site and the proposed stormwater disposal trench that is to be located at the south western end of the site. Slope movement could cause the services to break resulting in saturation of the soils. The stormwater trench could cause excessive local saturation of soils near the toe of the slope, potentially triggering slope movement.

We recommend that consideration be given to flattening the fill batter slope by removing some material.

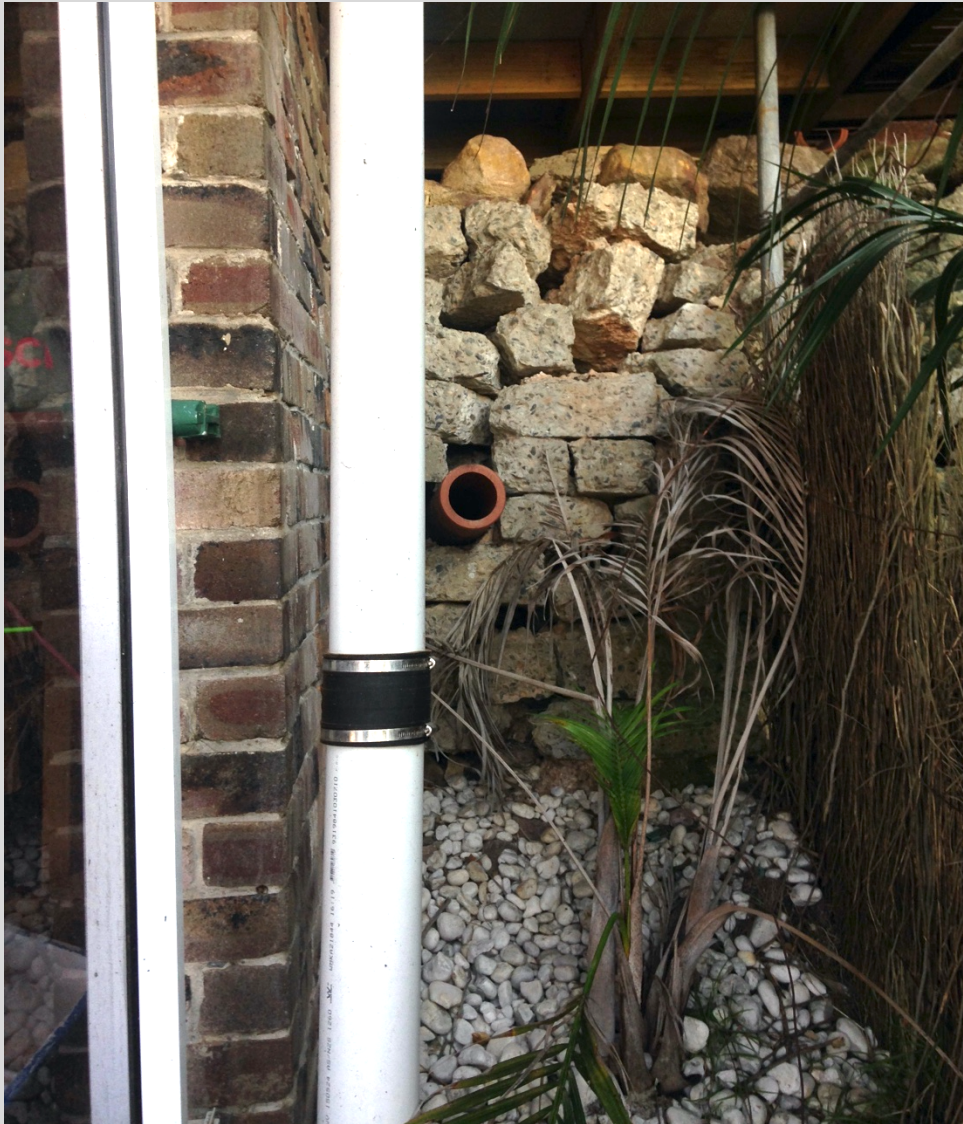
8

An open stormwater pipe was observed at the rear of the house, exiting a concrete block filled area (see Photo 8). It is not known if the pipe is for subsoil drainage or water building up within the filled area, or for disposal of collected surface water.
