Mr Christian Stevens (c/o A Grade Pools),
19A Philip Road,
Mona Vale
NSW 2103

Preliminary Geotechnical Assessment – Swimming Pool 19A Philip Road, Mona Vale, NSW 2103

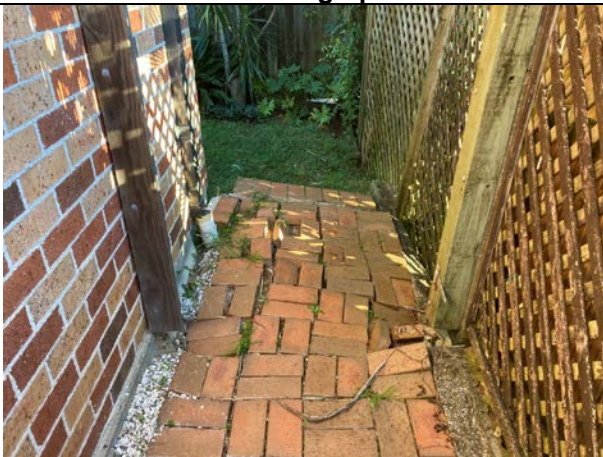
- The residence is founded on a platform which has been cut about 1.3m into surrounding land along the southern boundary. There is evidence of minor filling settling around the northern corner of the house and along a sloping easement boundary between the northern brick-paved path which is about 600mm above an adjacent concrete driveway to the north. We understand that the path and retaining wall shown in Photograph 1 (above) are to be reinstated and upgraded as part of landscaping work.

<p>1 – Path and low wall to be reinstated</p>	<p>2 – View across pool footprint</p>

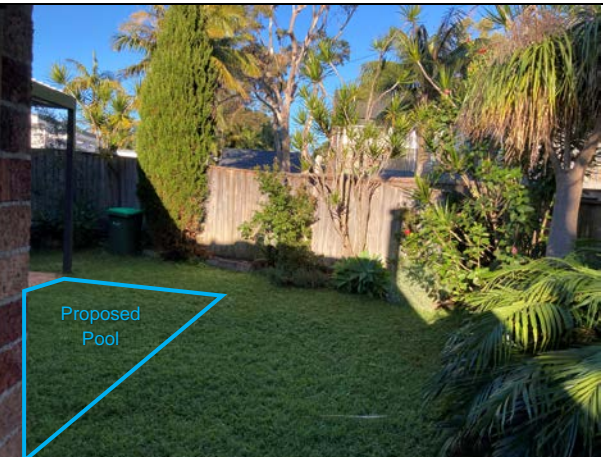
- The location of the proposed pool is currently surface by a near level turfed lawn area, surrounded on three sides (South, West, North) by garden beds retained by low sandstone wall edging (to 200mm height) and 1.8m high timber fencing in fair condition. The Eastern edge of the pool will be

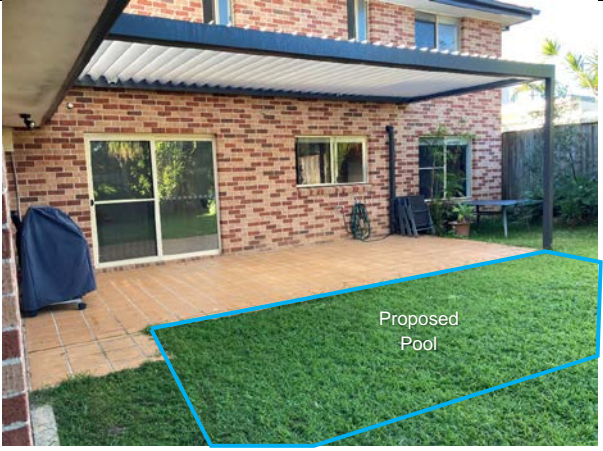
- The house is in generally good condition with no evidence of external cracking or movement. A concrete slab under the existing pergola is paved with terracotta tiles and one minor existing crack was observed extending across several tiles near the centre of the tiled area.

<p>3 – View across pool footprint towards paving</p>	<p>4 – Historic fill settlement surrounding house</p>

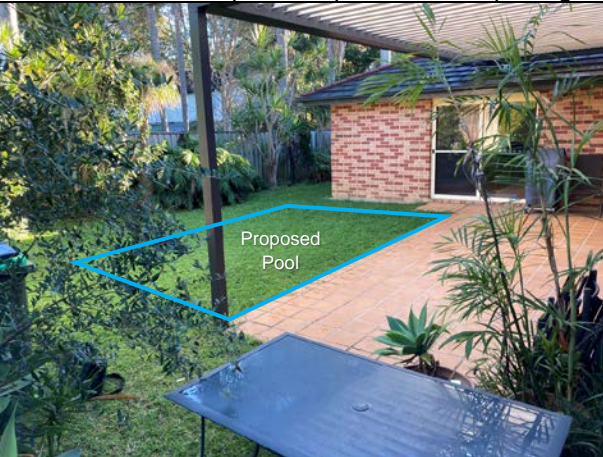
<p>5 – View across paving towards pool area</p>	<p>6 – Concrete wall beside house</p>
<p>Photographs 1 to 6 – Site Photos</p>
