REPORT ON GEOTECHNICAL ASSESSMENT

PROPOSED NEW DRIVEWAY AND CARPORT

81 RIVERVIEW ROAD, AVALON BEACH, NSW

Project No.: 2024-177

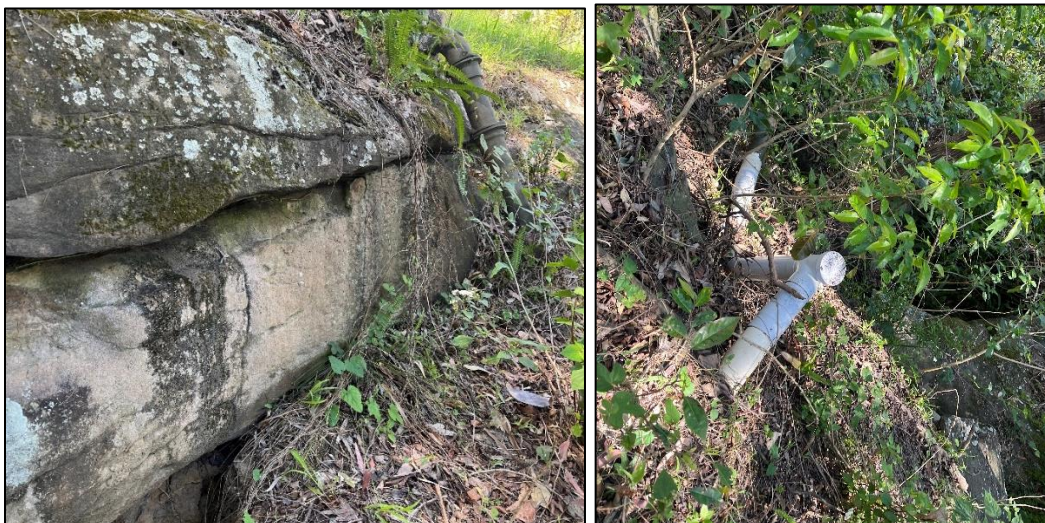
A bedrock outcrop was observed within the rear garden of the site located approximately 18m east of the west boundary and comprised a broadly north-south trending outcrop of low to medium strength sandstone (See Photograph 2).

Photograph 2 and 3: View of the bedrock outcrop and functioning stormwater pipe within the rear garden of the site.

No indications of instability within the outcrop were observed. A stormwater pipe appears to be functioning and channelling stormwater to (at least) the base of the property however the outlet of the stormwater system could not be determined due to access conditions.

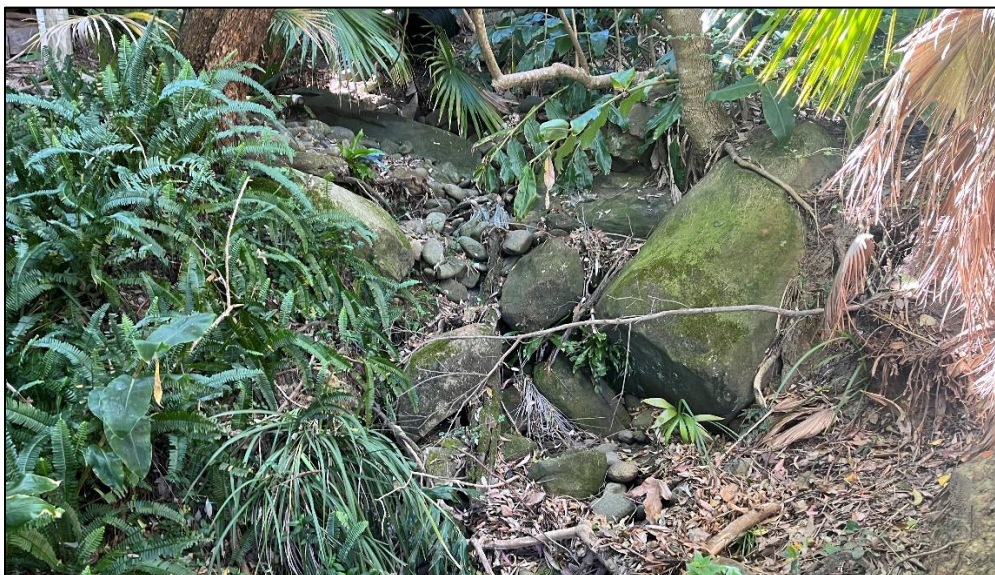
An open stormwater channel was also observed adjacent to the north boundary of the site and contained loose cobbles and boulders of sandstone which did not appear at risk of imminent failure/boulder roll. A view of the stormwater channel is provided in Photograph 3.

Photograph 3: View of the east side of the house and adjacent sandstone outcrop looking south

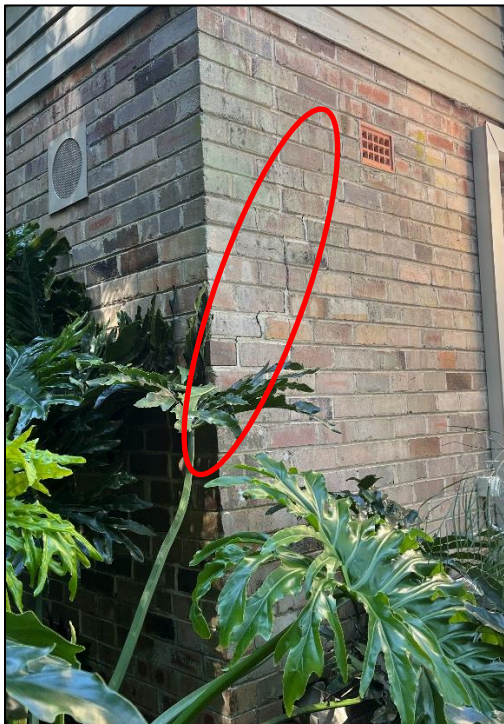
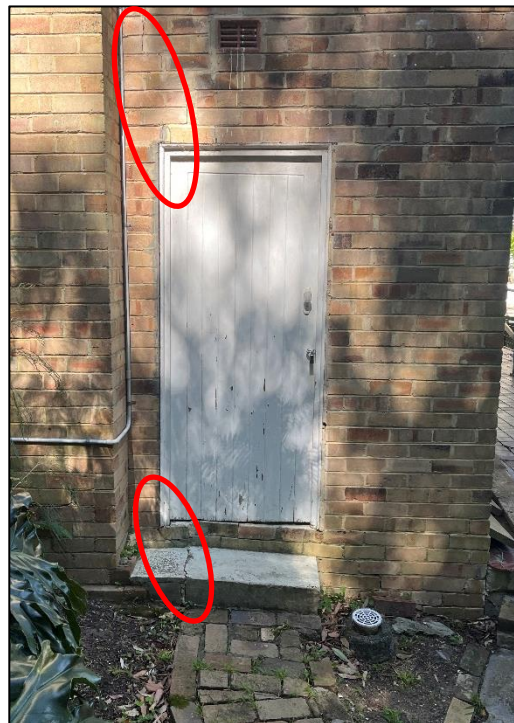
Some evidence of cracking was observed within the rear (west) section of the property which are indicated in Photographs 4 and 5.

Photographs 4 and 5: Cracking within the rear of the site residence.

The inspection and assessment identified no obvious credible landslip hazards within the site or adjacent properties. The existing residence appears to be approximately 40 – 60 years old and is in generally good condition, with the exception of some cracking in the brickwork within the rear of the site residence, interpreted to be related to age of the structure rather than a deep-seated geotechnical issue.
