Section Inspection

Date of inspection 29/06/2020	Time of inspection 7:55 AM	Asset Owner NORTHERN BEACHES COUNCIL	Pipe Asset ID SPI56246	Nr. 1
Project name 2020_06_29 3252 TSS 26 RIVERVIEW RD AVALON	Contract No.	Coding Standard WSA 05-2008 2.2	Name of operator LEN	Job Number 3252

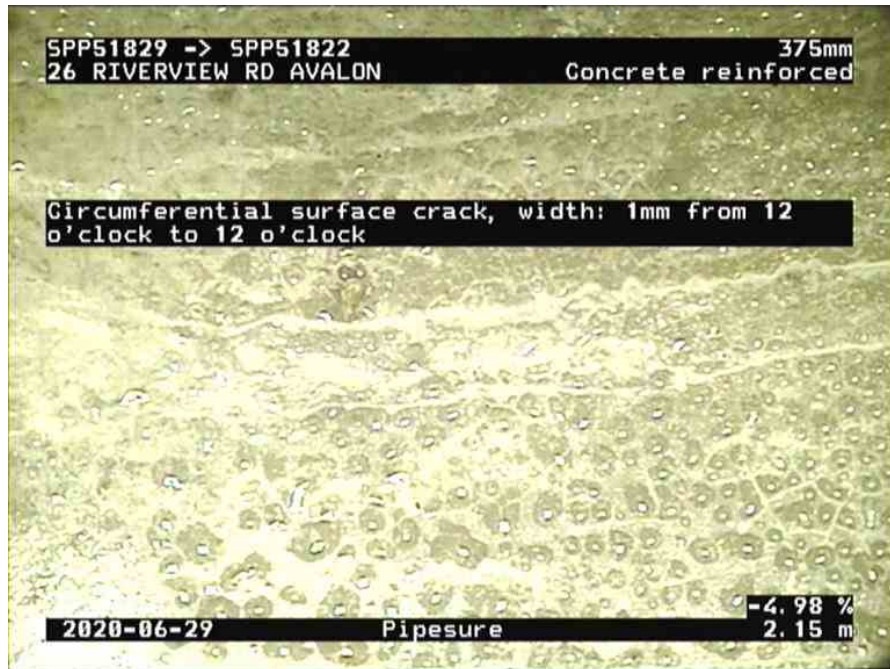
1, 00:02:24, 2.15
Circumferential surface crack, width: 1mm from 12 o'clock to 12 o'clock

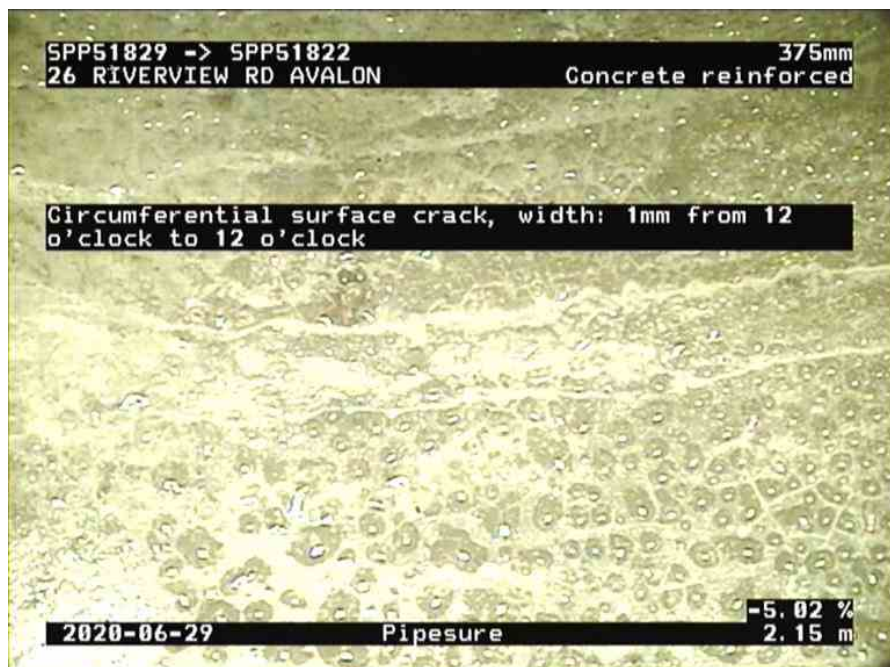
2, 00:02:24, 2.15
Circumferential surface crack, width: 1mm from 12 o'clock to 12 o'clock

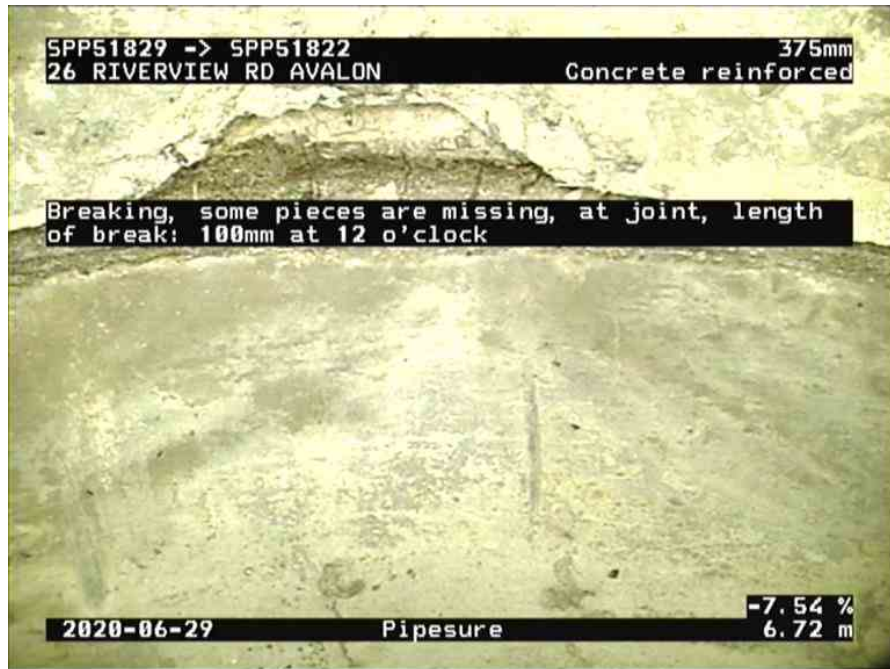
3, 00:05:38, 6.72

Breaking, some pieces are missing, at joint, length of break: 100mm at 12 o'clock

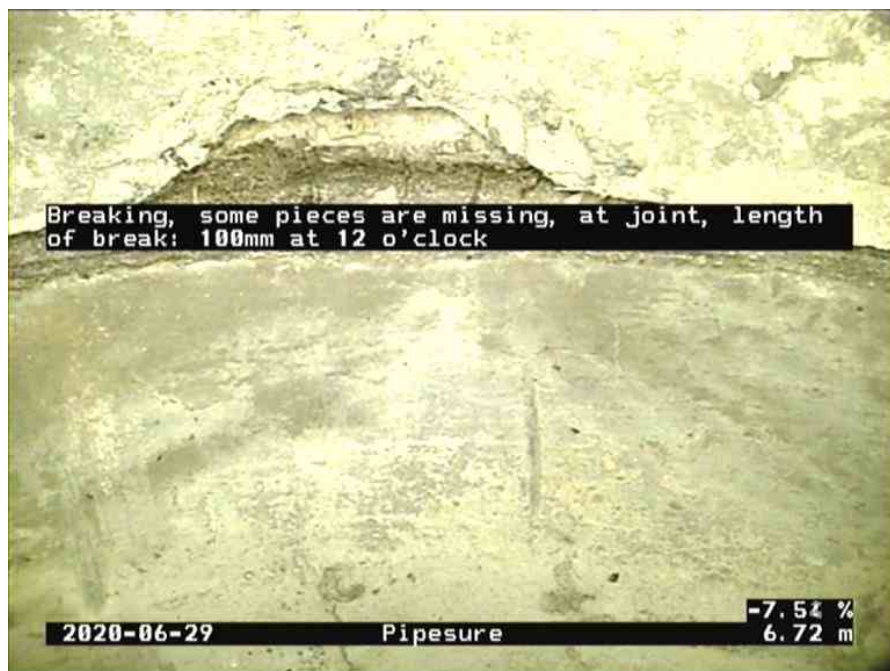
4, 00:05:38, 6.72

Breaking, some pieces are missing, at joint, length of break: 100mm at 12 o'clock

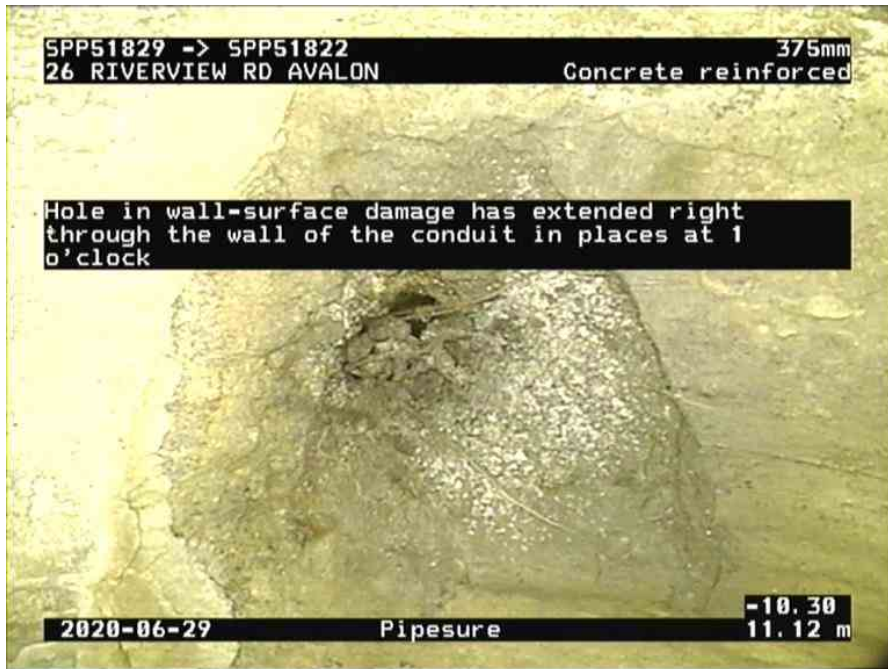
5, 00:06:53, 11.12
Hole in wall-surface damage has extended right through the wall of the conduit in places at 1 o'clock

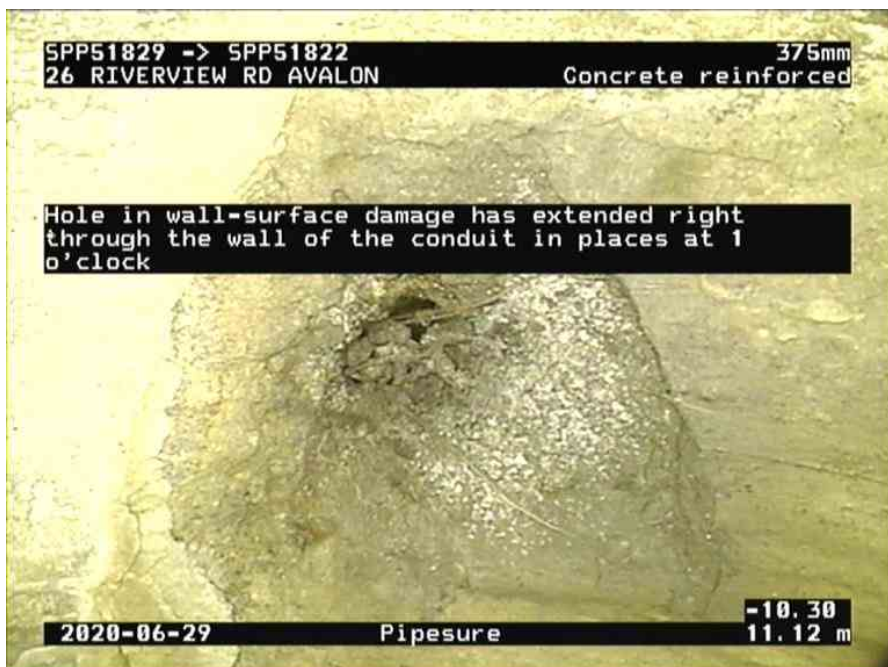
6, 00:06:53, 11.12
Hole in wall-surface damage has extended right through the wall of the conduit in places at 1 o'clock

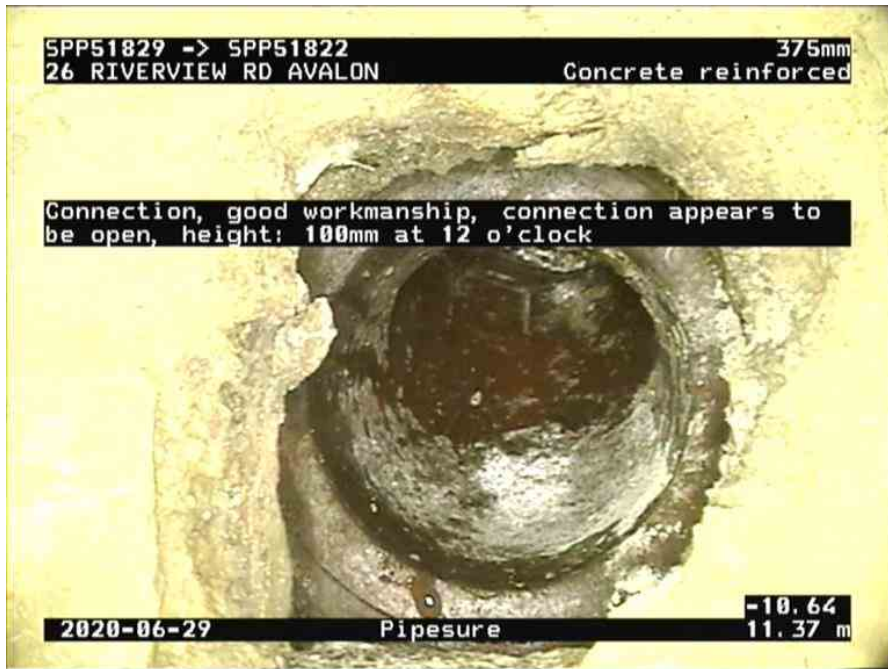
7, 00:07:14, 11.37
Connection, good workmanship, connection appears to be open, height: 100mm at 12 o'clock

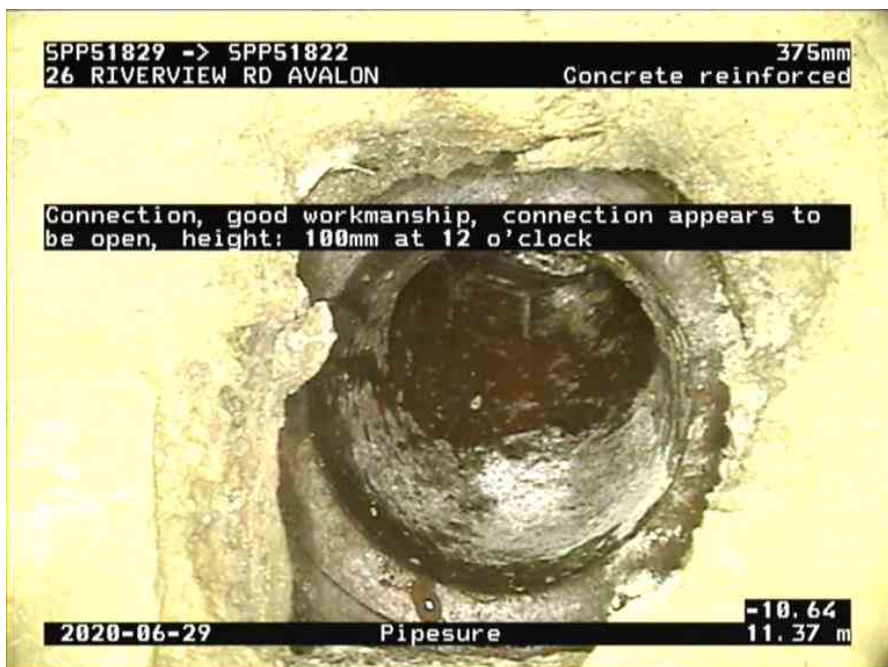
8, 00:07:14, 11.37
Connection, good workmanship, connection appears to be open, height: 100mm at 12 o'clock

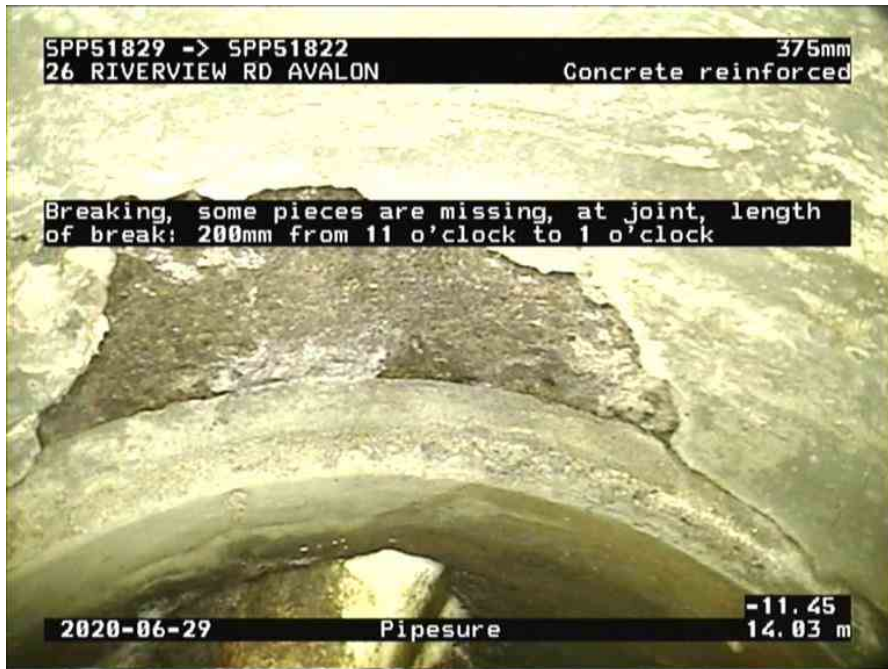
9, 00:08:59, 14.03
Breaking, some pieces are missing, at joint, length of break: 200mm from 11 o'clock to 1 o'clock

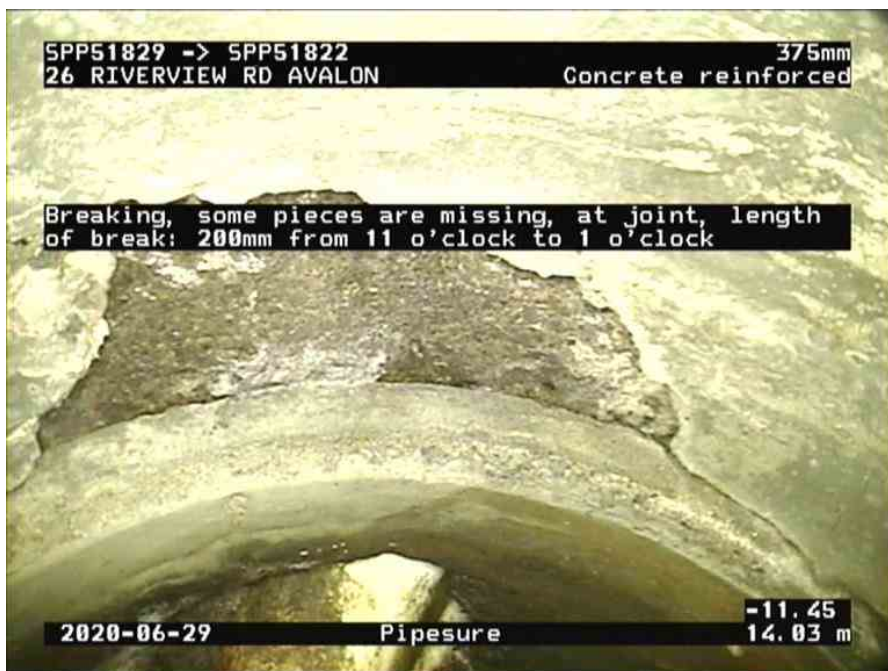
10, 00:08:59, 14.03
Breaking, some pieces are missing, at joint, length of break: 200mm from 11 o'clock to 1 o'clock

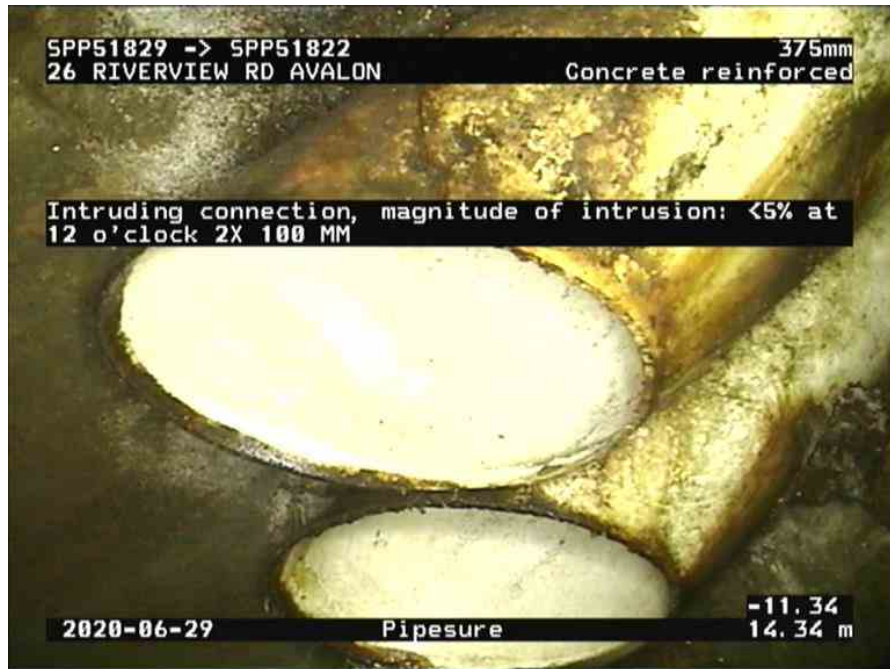
11, 00:09:24, 14.34
Intruding connection, magnitude of intrusion: <5% at 12 o'clock / 2X 100 MM

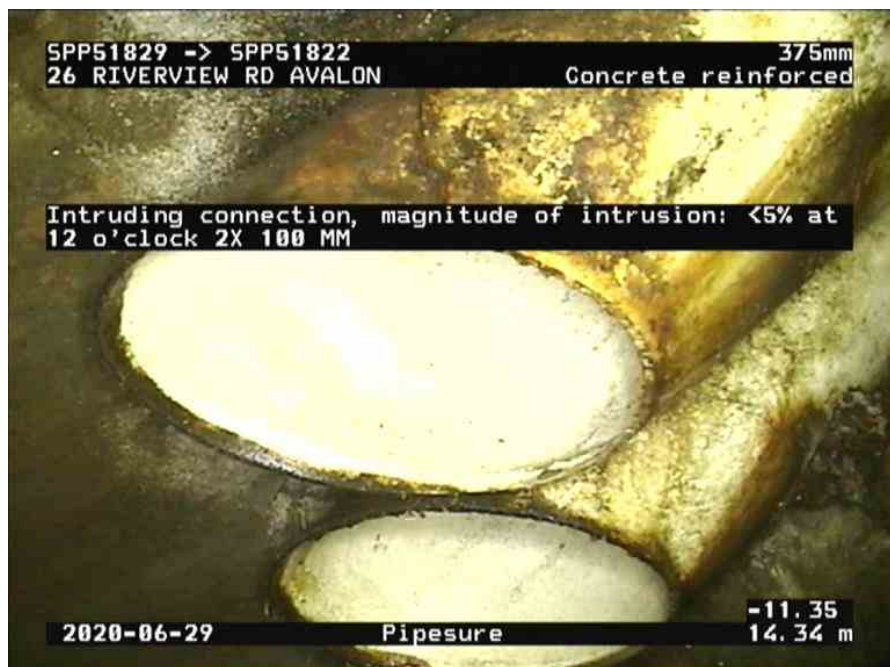
12, 00:09:24, 14.34
Intruding connection, magnitude of intrusion: <5% at 12 o'clock / 2X 100 MM

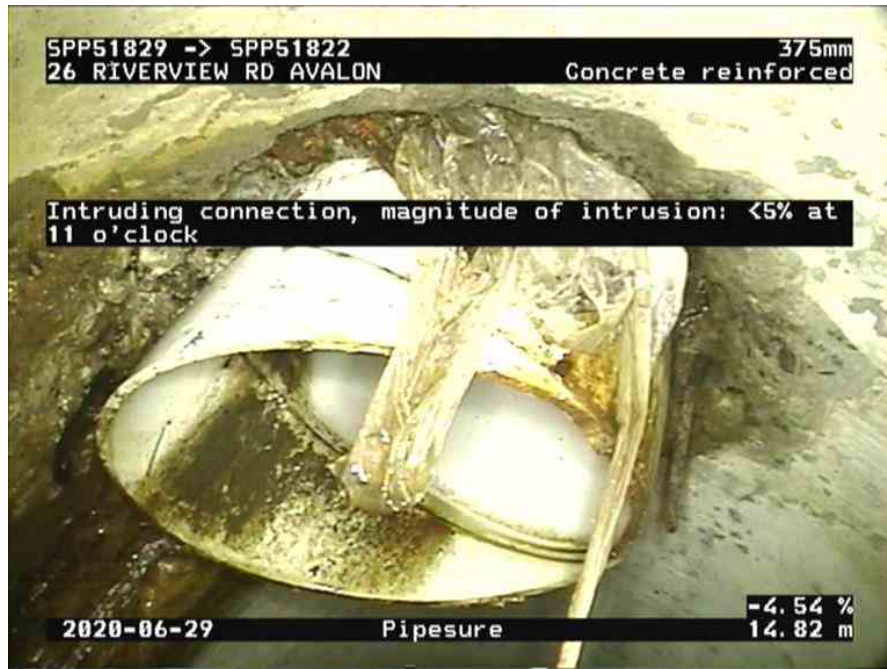
13, 00:10:02, 14.82
Intruding connection, magnitude of intrusion: <5% at 11 o'clock

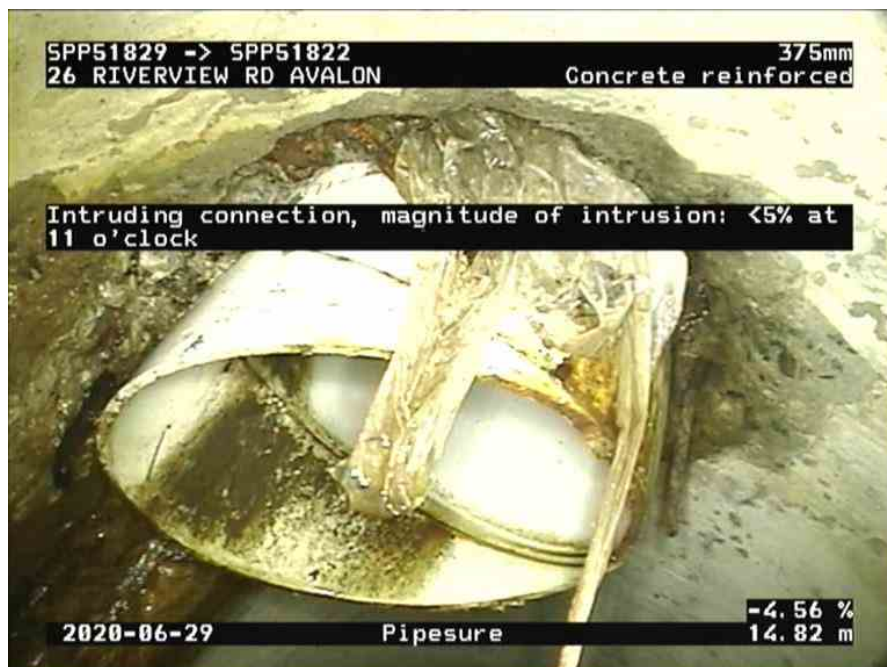
14, 00:10:02, 14.82
Intruding connection, magnitude of intrusion: <5% at 11 o'clock

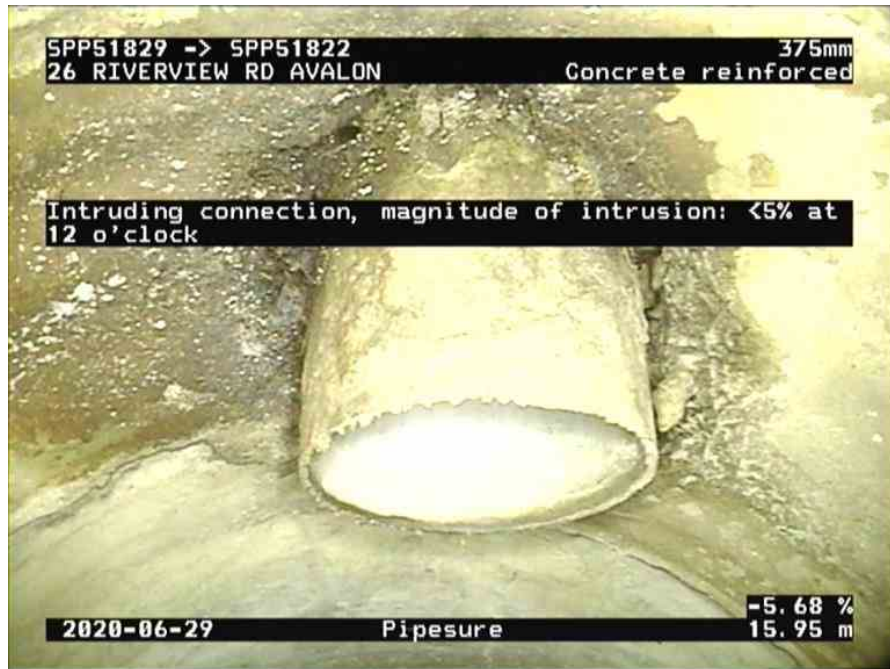
15, 00:10:29, 15.95
Intruding connection, magnitude of intrusion: <5% at 12 o'clock

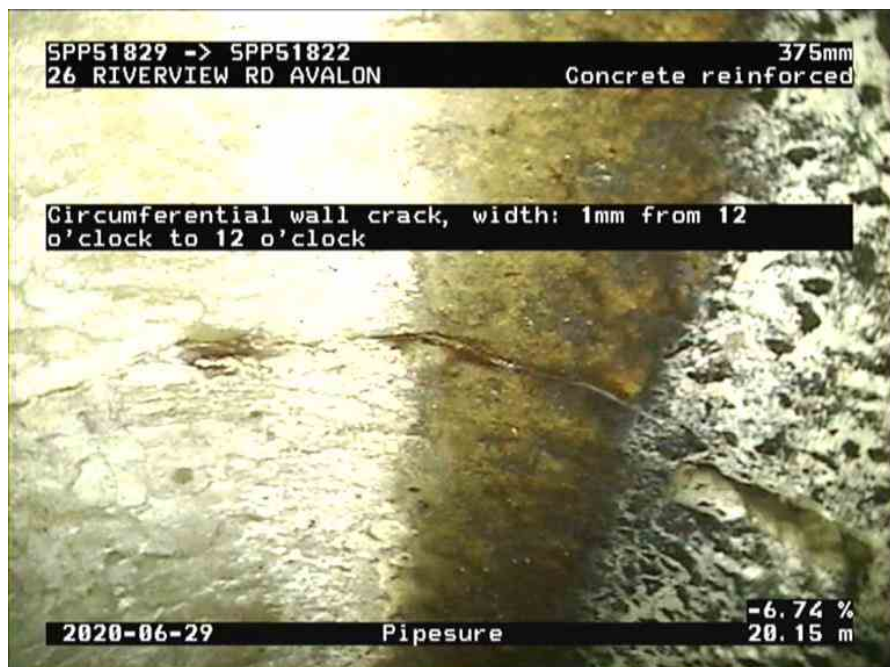
16, 00:12:04, 20.15
Circumferential wall crack, width: 1mm from 12 o'clock to 12 o'clock

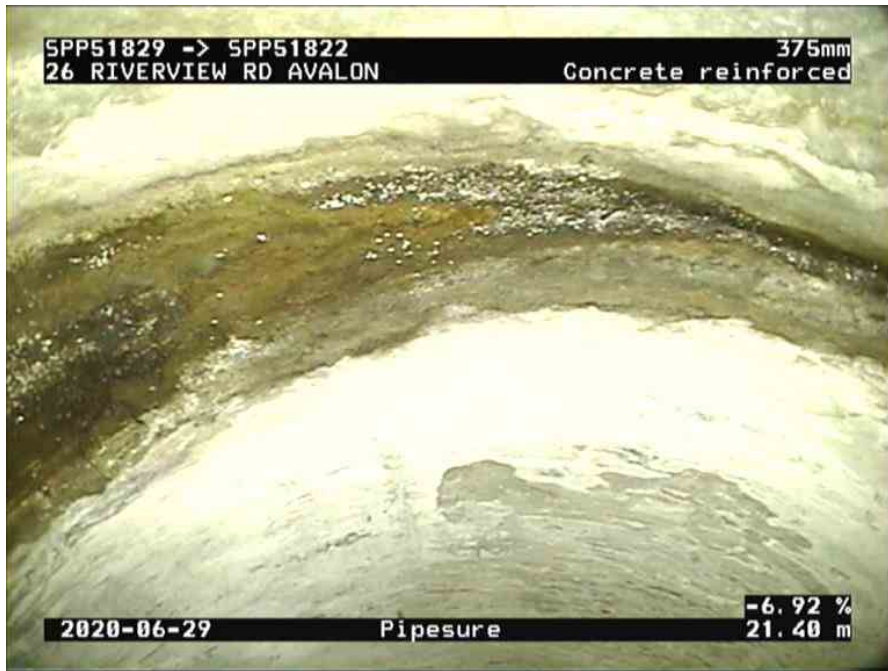
17, 00:12:44, 21.40
Infiltration, Sweating/Seepage--slow ingress of water, no visible drips, at joint from 12 o'clock to 12 o'clock

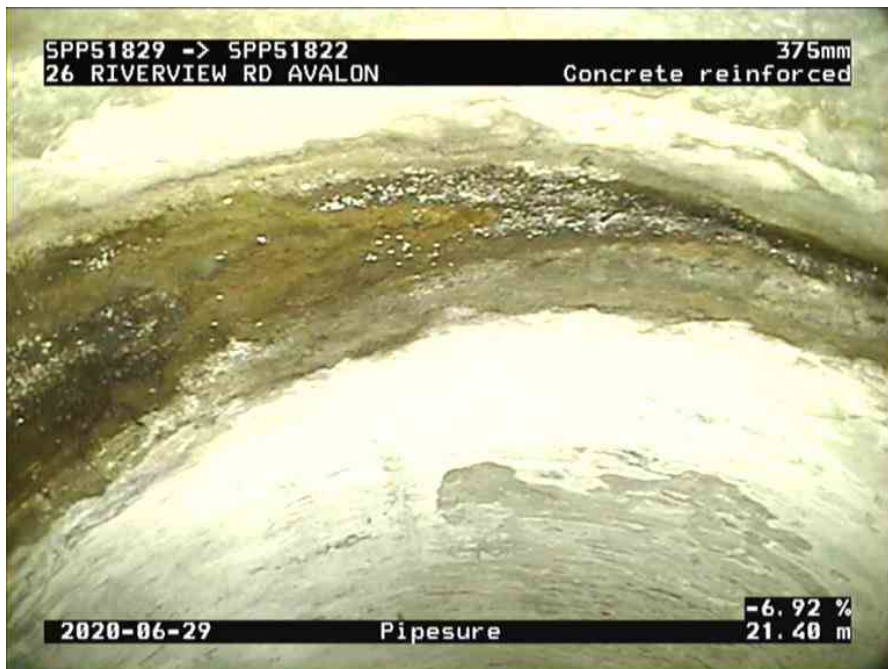
18, 00:12:44, 21.40
Infiltration, Sweating/Seepage--slow ingress of water, no visible drips, at joint from 12 o'clock to 12 o'clock

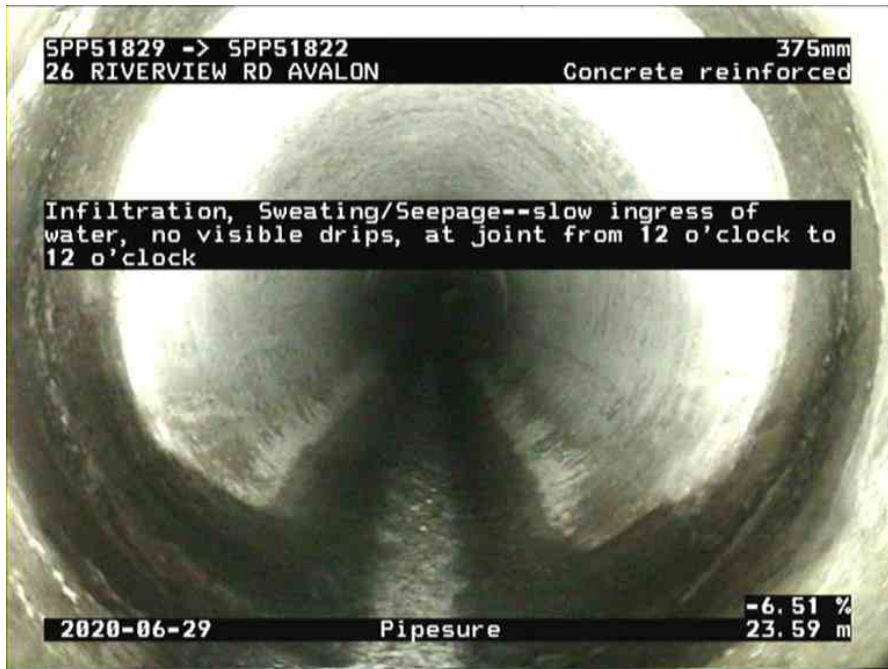
19, 00:13:20, 23.59
Infiltration, Sweating/Seepage--slow ingress of water, no visible drips, at joint from 12 o'clock to 12 o'clock

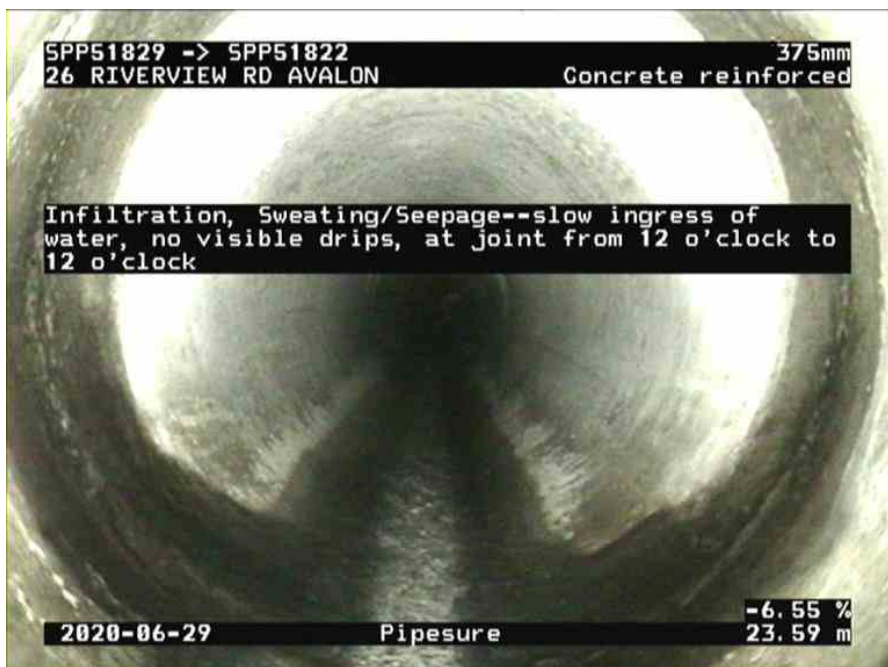
20, 00:13:20, 23.59
Infiltration, Sweating/Seepage--slow ingress of water, no visible drips, at joint from 12 o'clock to 12 o'clock

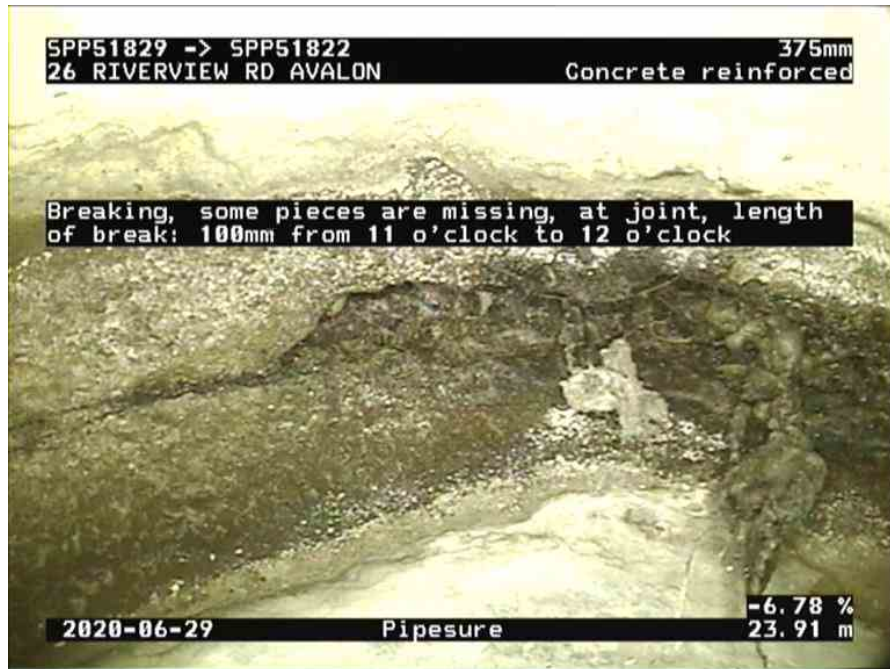
21, 00:13:43, 23.91

Breaking, some pieces are missing, at joint, length of break: 100mm from 11 o'clock to 12 o'clock

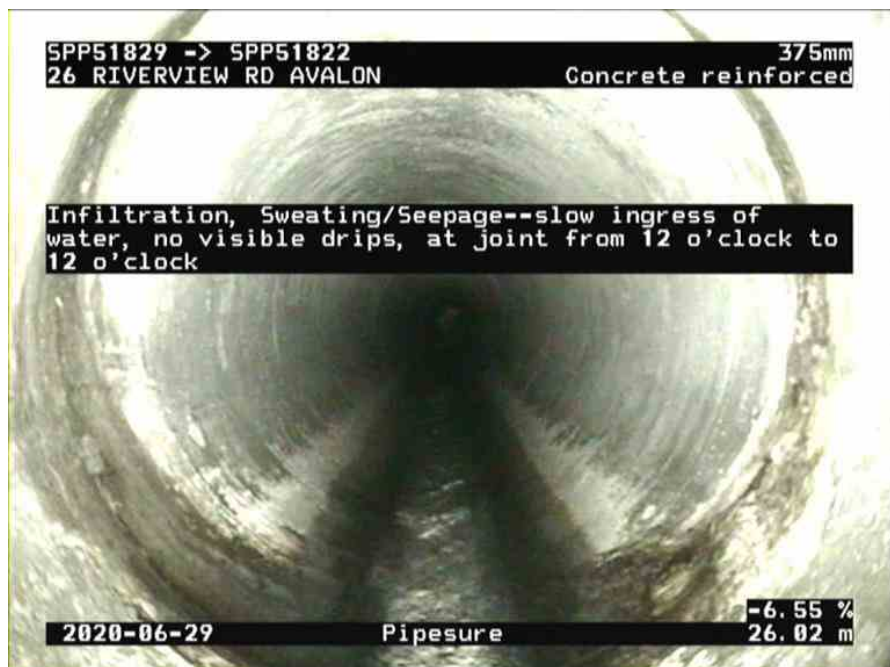
22, 00:14:14, 26.02

Infiltration, Sweating/Seepage--slow ingress of water, no visible drips, at joint from 12 o'clock to 12 o'clock

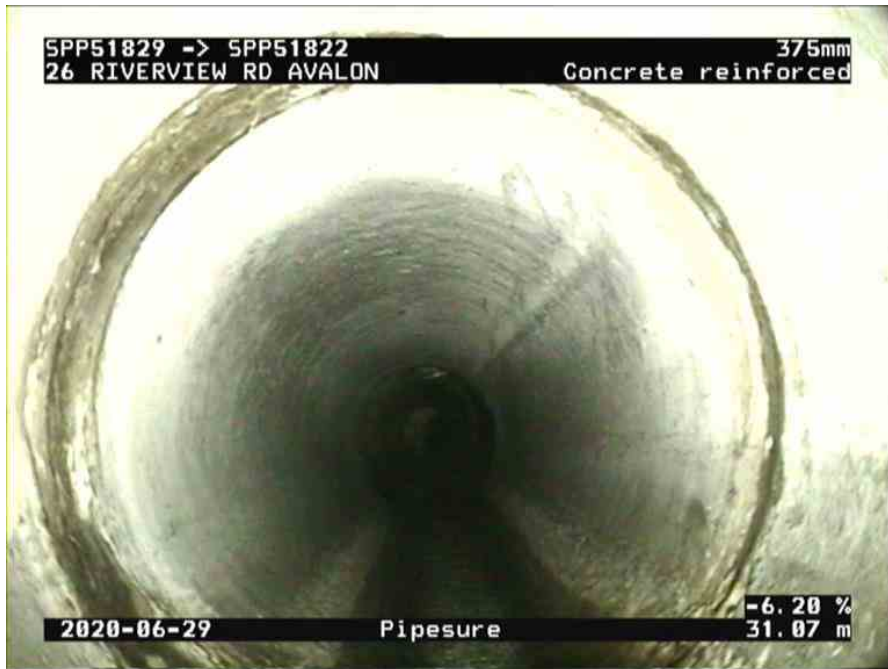
23, 00:15:51, 31.07
Infiltration, Sweating/Seepage--slow ingress of water, no visible drips, at joint from 12 o'clock to 12 o'clock

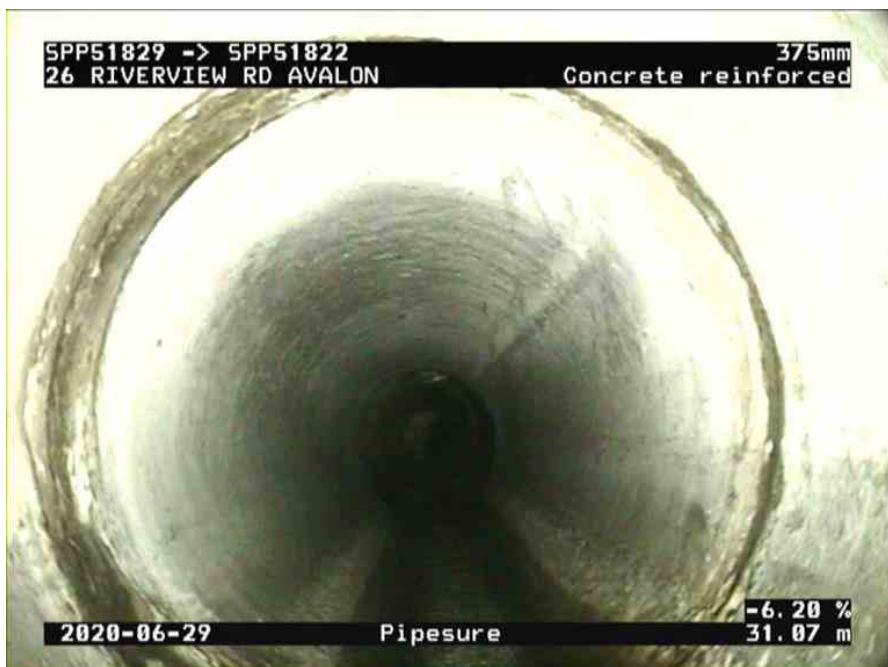
24, 00:15:51, 31.07
Infiltration, Sweating/Seepage--slow ingress of water, no visible drips, at joint from 12 o'clock to 12 o'clock

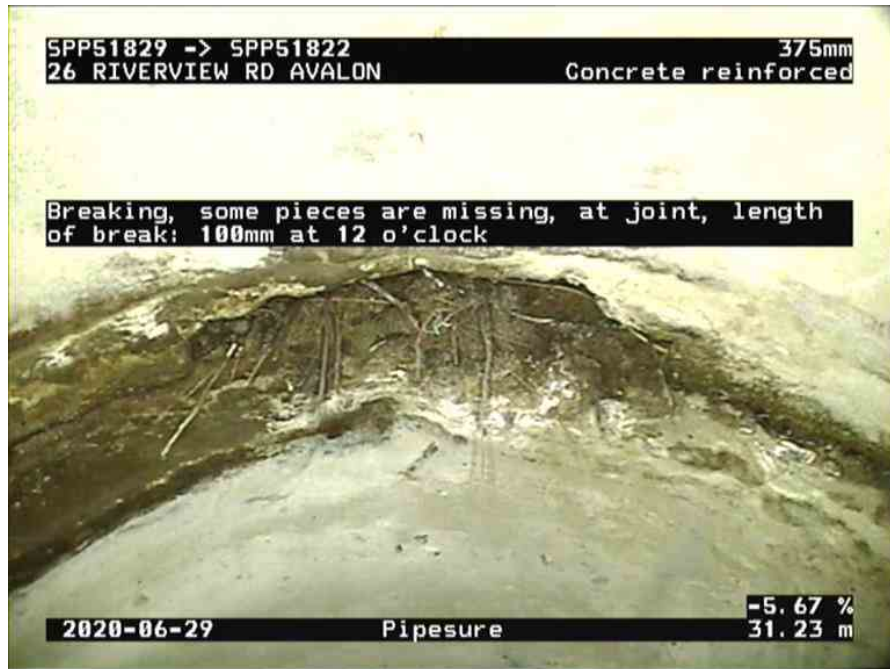
25, 00:16:14, 31.23

Breaking, some pieces are missing, at joint, length of break: 100mm at 12 o'clock

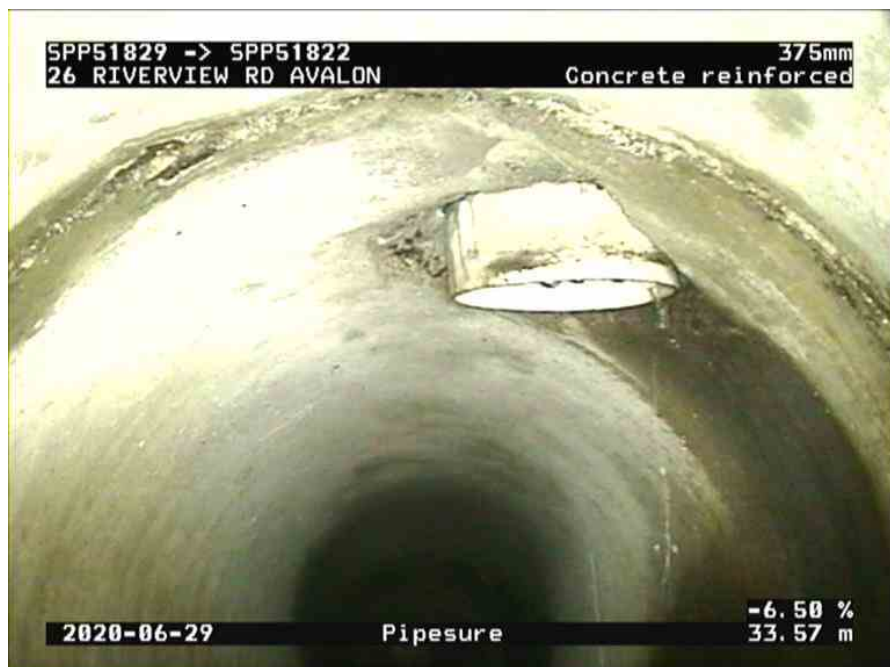
26, 00:16:43, 33.57

Intruding connection, magnitude of intrusion: <5% at 12 o'clock

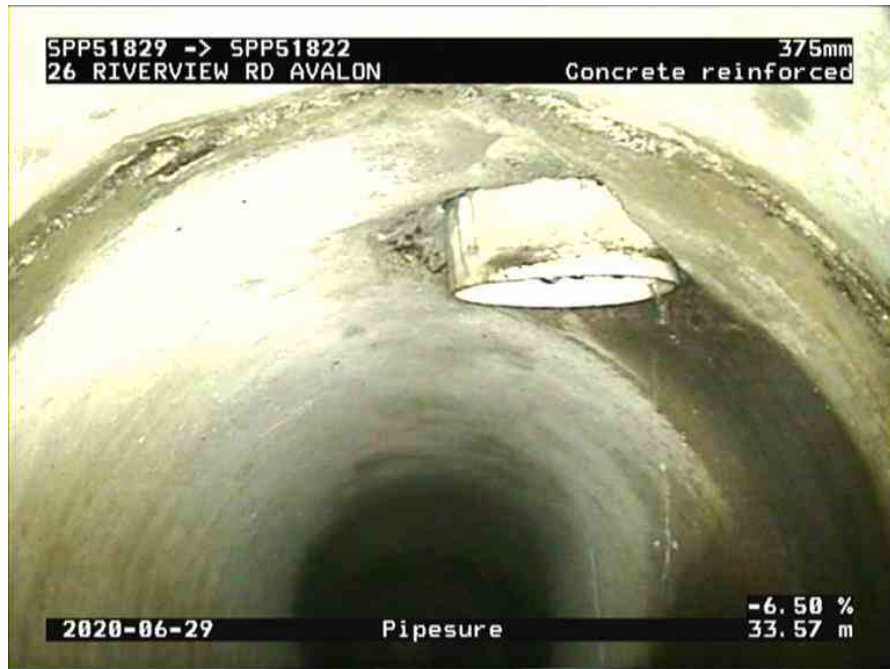
27, 00:16:43, 33.57
Intruding connection, magnitude of intrusion: <5% at 12 o'clock

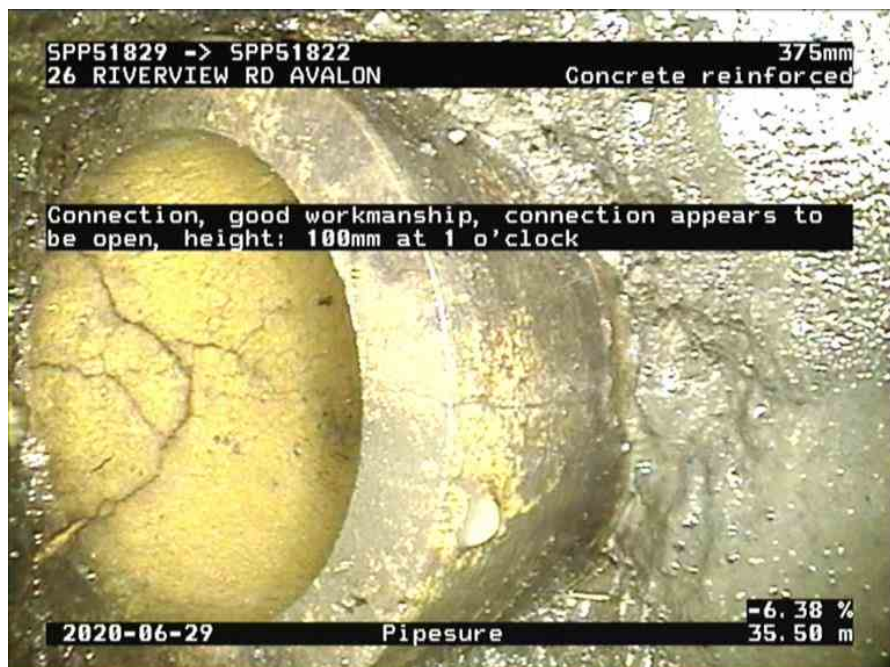
28, 00:17:29, 35.50
Connection, good workmanship, connection appears to be open, height: 100mm at 1 o'clock

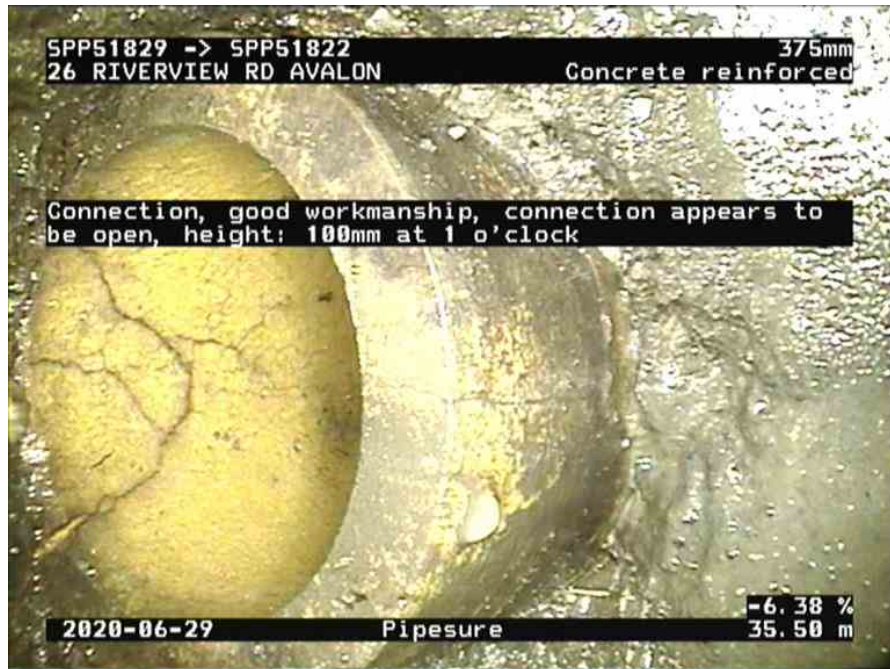
29, 00:17:29, 35.50
Connection, good workmanship, connection appears to be open, height: 100mm at 1 o'clock

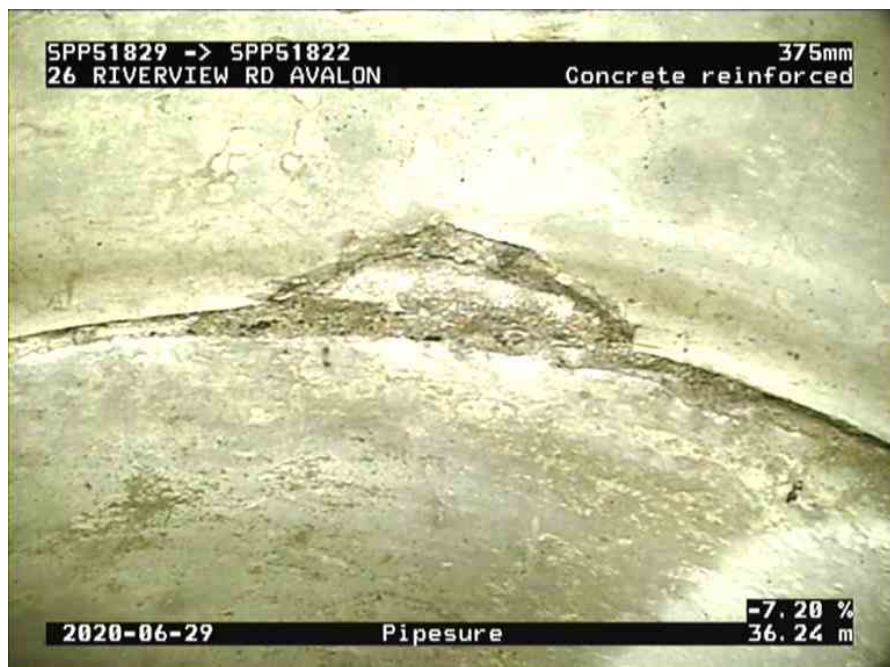
30, 00:18:04, 36.24
Breaking, some pieces are missing, length of break: 100mm at 1 o'clock

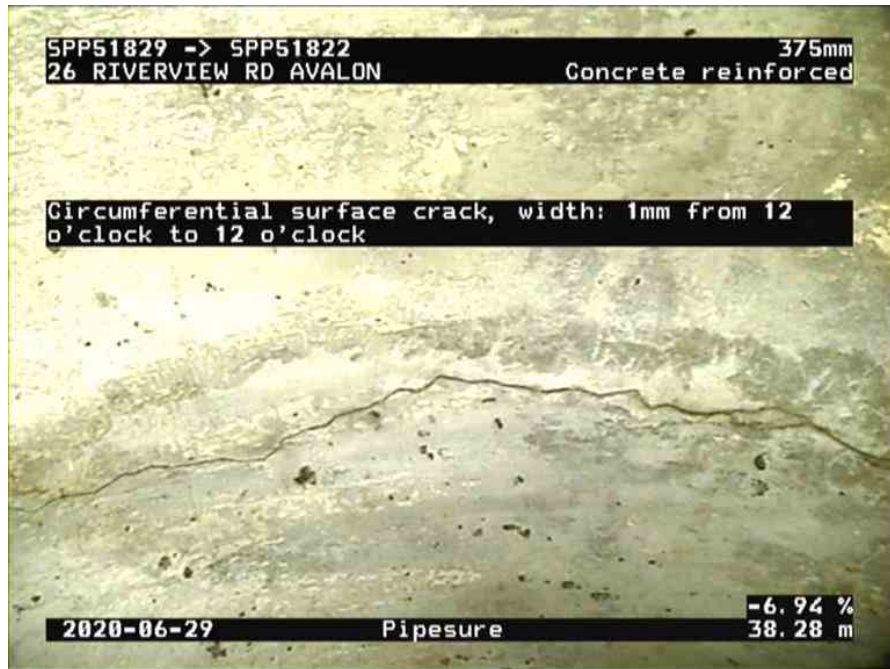
31, 00:18:32, 38.28

Circumferential surface crack, width: 1mm from 12 o'clock to 12 o'clock
