**REPORT TO
MR & MRS S ROONEY**

**ON
GEOTECHNICAL ASSESSMENT
(In Accordance with Pittwater Council Risk
Management Policy)**

**FOR
PROPOSED ALTERATIONS AND ADDITIONS**

**AT
205 RIVERVIEW ROAD, AVALON BEACH, NSW**

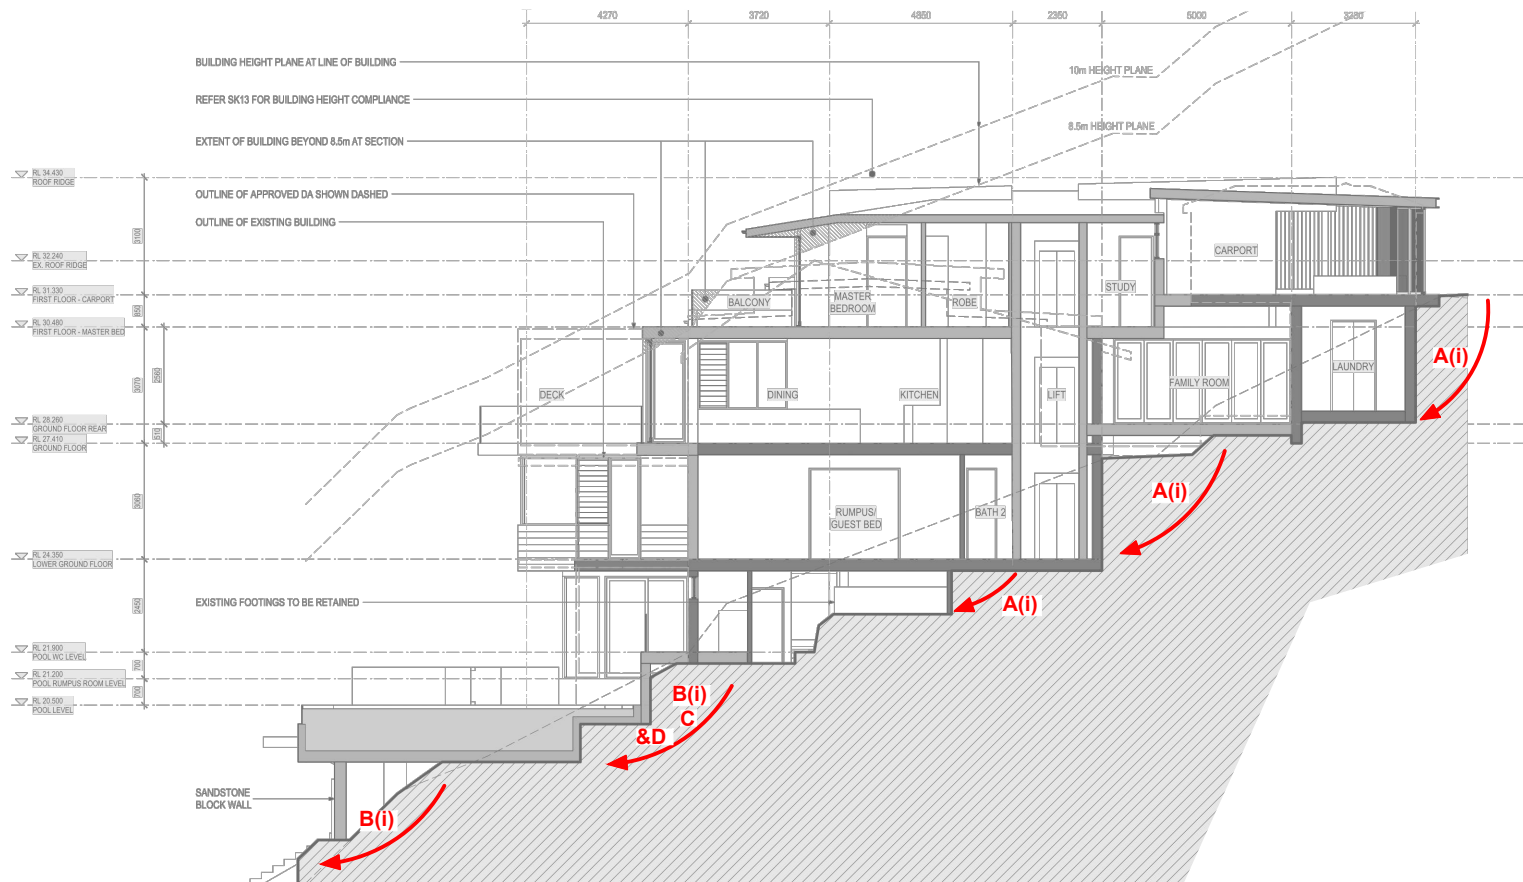
Title: **SECTION A-A SHOWING POTENTIAL LANDSLIDE HAZARDS**

- A Instability of existing retaining walls:
 - (i) Within the house, car port and storage area;
 - (ii) Stacked sandstone, sandstone masonry and concrete panel walls across the site;
 - (iii) Variable condition, timber and stacked sandstone landscape walls over the yard areas; and
 - (iv) Sandstone masonry seawalls.
- B Instability of the natural hillside slopes:
 - (i) Downslope (west) of the existing dwelling;
 - (ii) Upslope (east) of the existing dwelling;
 - (iii) North of the existing dwelling;
 - (iv) South of the existing dwelling; and
 - (v) Collapse of overhang.
- C Instability of temporary excavation batters.
- D Instability of proposed retaining walls and pool walls:

These potential hazards are indicated in schematic form on the attached Figure 3.
