## **Geotechnical Assessment**

**Project:** Alterations & Additions  
72 Herbert Avenue, Newport NSW

**REF: AG 21129**  
17 May 2021

For **Alterations & Additions** at  
**72 Herbert Avenue, Newport NSW**

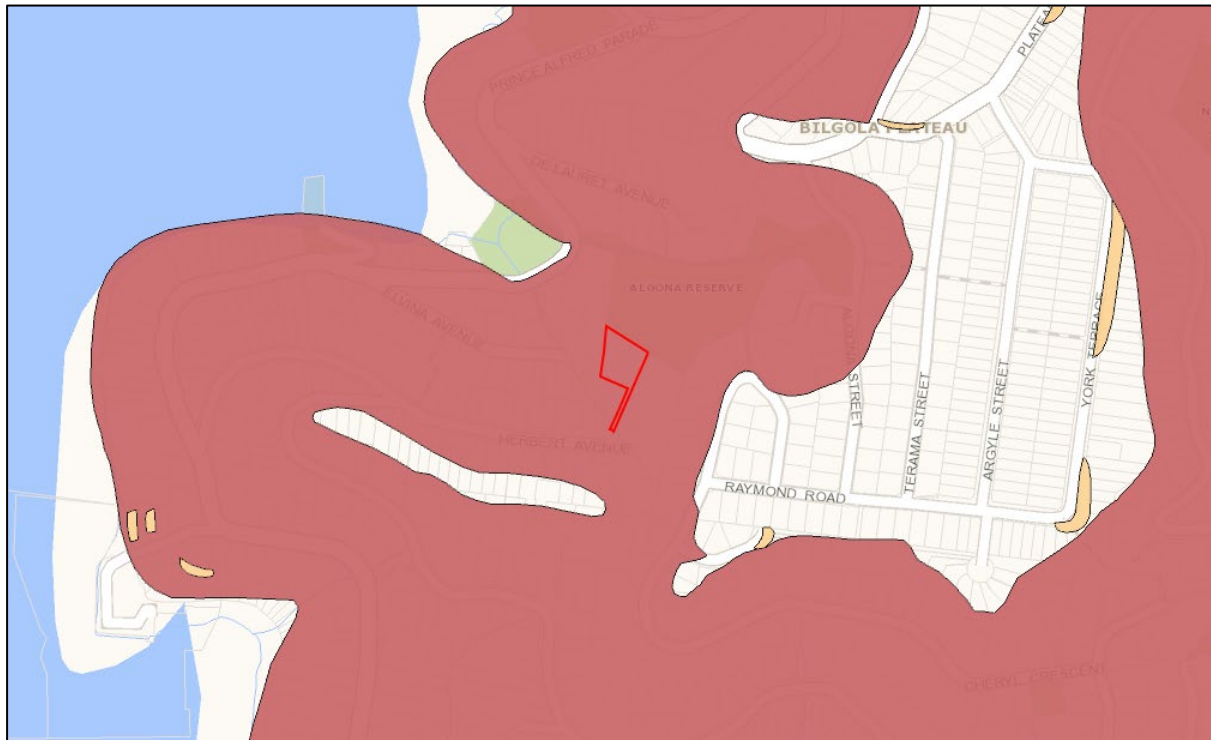
**Image 2.** PLEP Geotechnical Hazard Map  
– 72 Herbert Avenue, Newport NSW

- No evidence of significant soil creep, tension cracks or landslip instability were identified across the site or on adjacent properties, as viewed from the subject site at the time of our inspection.
- Based on reference to the plan entitled “Geotechnical Hazard Mapping” (Ref. P21DCP-BC-MDCP2002, dated 2007) prepared by GHD LONGMAC on behalf of Pittwater Council, the site is located within **Geotechnical Hazard Zone H1 (Image 2)**.
