J2644. 7<sup>th</sup> April, 2020. Page 1.

## **GEOTECHNICAL INVESTIGATION:**

New Garage and Pool at 11 Bungaloe Avenue, Balgowlah Heights

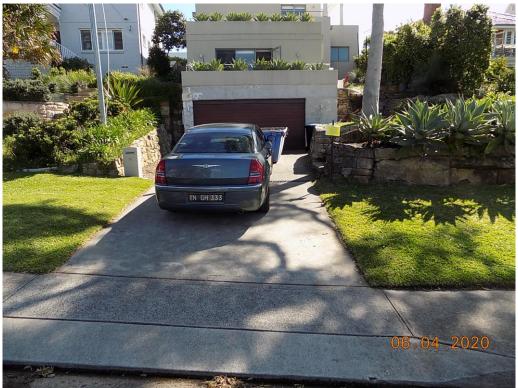
Photo 1

- **2.1** The site was inspected on the 6<sup>th</sup> April, 2020.
- 2.2 This residential property has dual access. It is on the uphill side of Bungaloe Avenue and on the downhill side of Woodland Street. The property has an E aspect. The block is located on the gentle to moderately graded middle reaches of a hillslope. The natural surface rises across the property at an average angle of ~11°. The slope above and below the property continues at similar angles.
- 2.3 At the road frontage to Bungaloe Avenue, a concrete driveway runs to a garage on the downhill side of the property (Photo 1). The cut for the driveway is supported by stable stack rock retaining walls reaching ~1.1m in height (Photo 2). The slope between the road frontage and the house is terraced with a series of stable stack rock

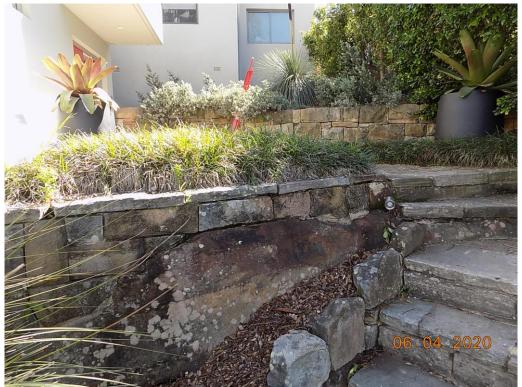
Photo 3

retaining walls (Photo 3). Some of these walls were observed to be supported directly onto outcropping competent Medium Strength Sandstone. The part three-storey rendered masonry house is supported on masonry walls (Photo 4). No significant signs of movement were observed in the supporting walls. An excavation has been made in the slope to create a level platform for the ground floor of the house. The cut is supported by a stable stack rock retaining wall and battered slope that will be removed as part of the proposed works (Photo 5). The slope between the uphill side of the house and the road frontage to Woodland Street is also terraced with a series of low stable stack rock retaining walls that will be removed as part of the proposed works (Photos 6 & 7). Medium Strength Sandstone outcrops through the uphill side of this slope. At the road frontage to Woodland Street, a concrete driveway runs to a brick garage in the SW corner of the property that will be demolished as part of the proposed works (Photo 8).

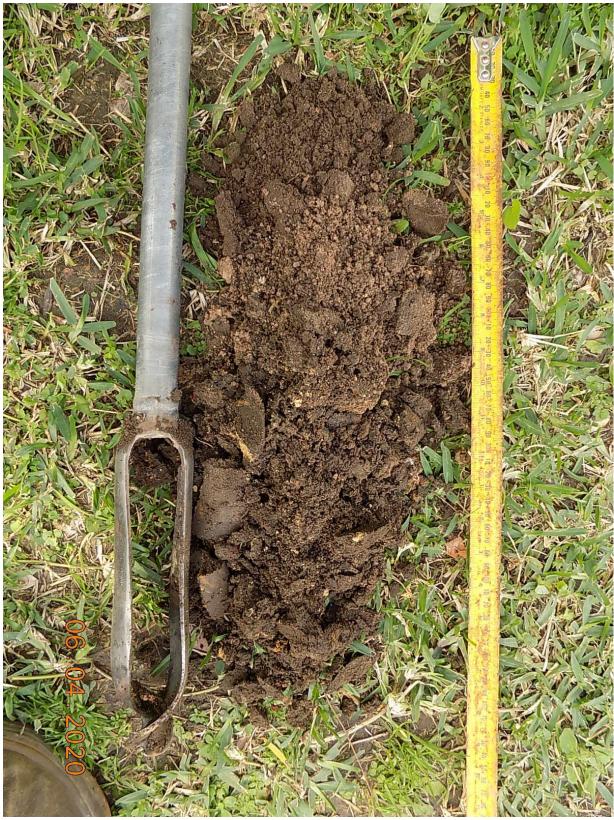
## **AUGER HOLE 1** (~RL57.0) – AH1 (Photo 9)

0.0 to 0.6 FILL, disturbed sandy soil, dark brown and mottled brown and white,

dense, dry, fine to coarse grained with fine trace organic matter.

Refusal @ 0.6m on unknown obstruction in profile. No watertable encountered.

Photo 9: AH1 – Downhole is from top to bottom.
