# Geotechnical Assessment

**Project:** Alterations & Additions  
17 Egan Place, Beacon Hill NSW

**Ref:** AG 24470  
12 November 2024

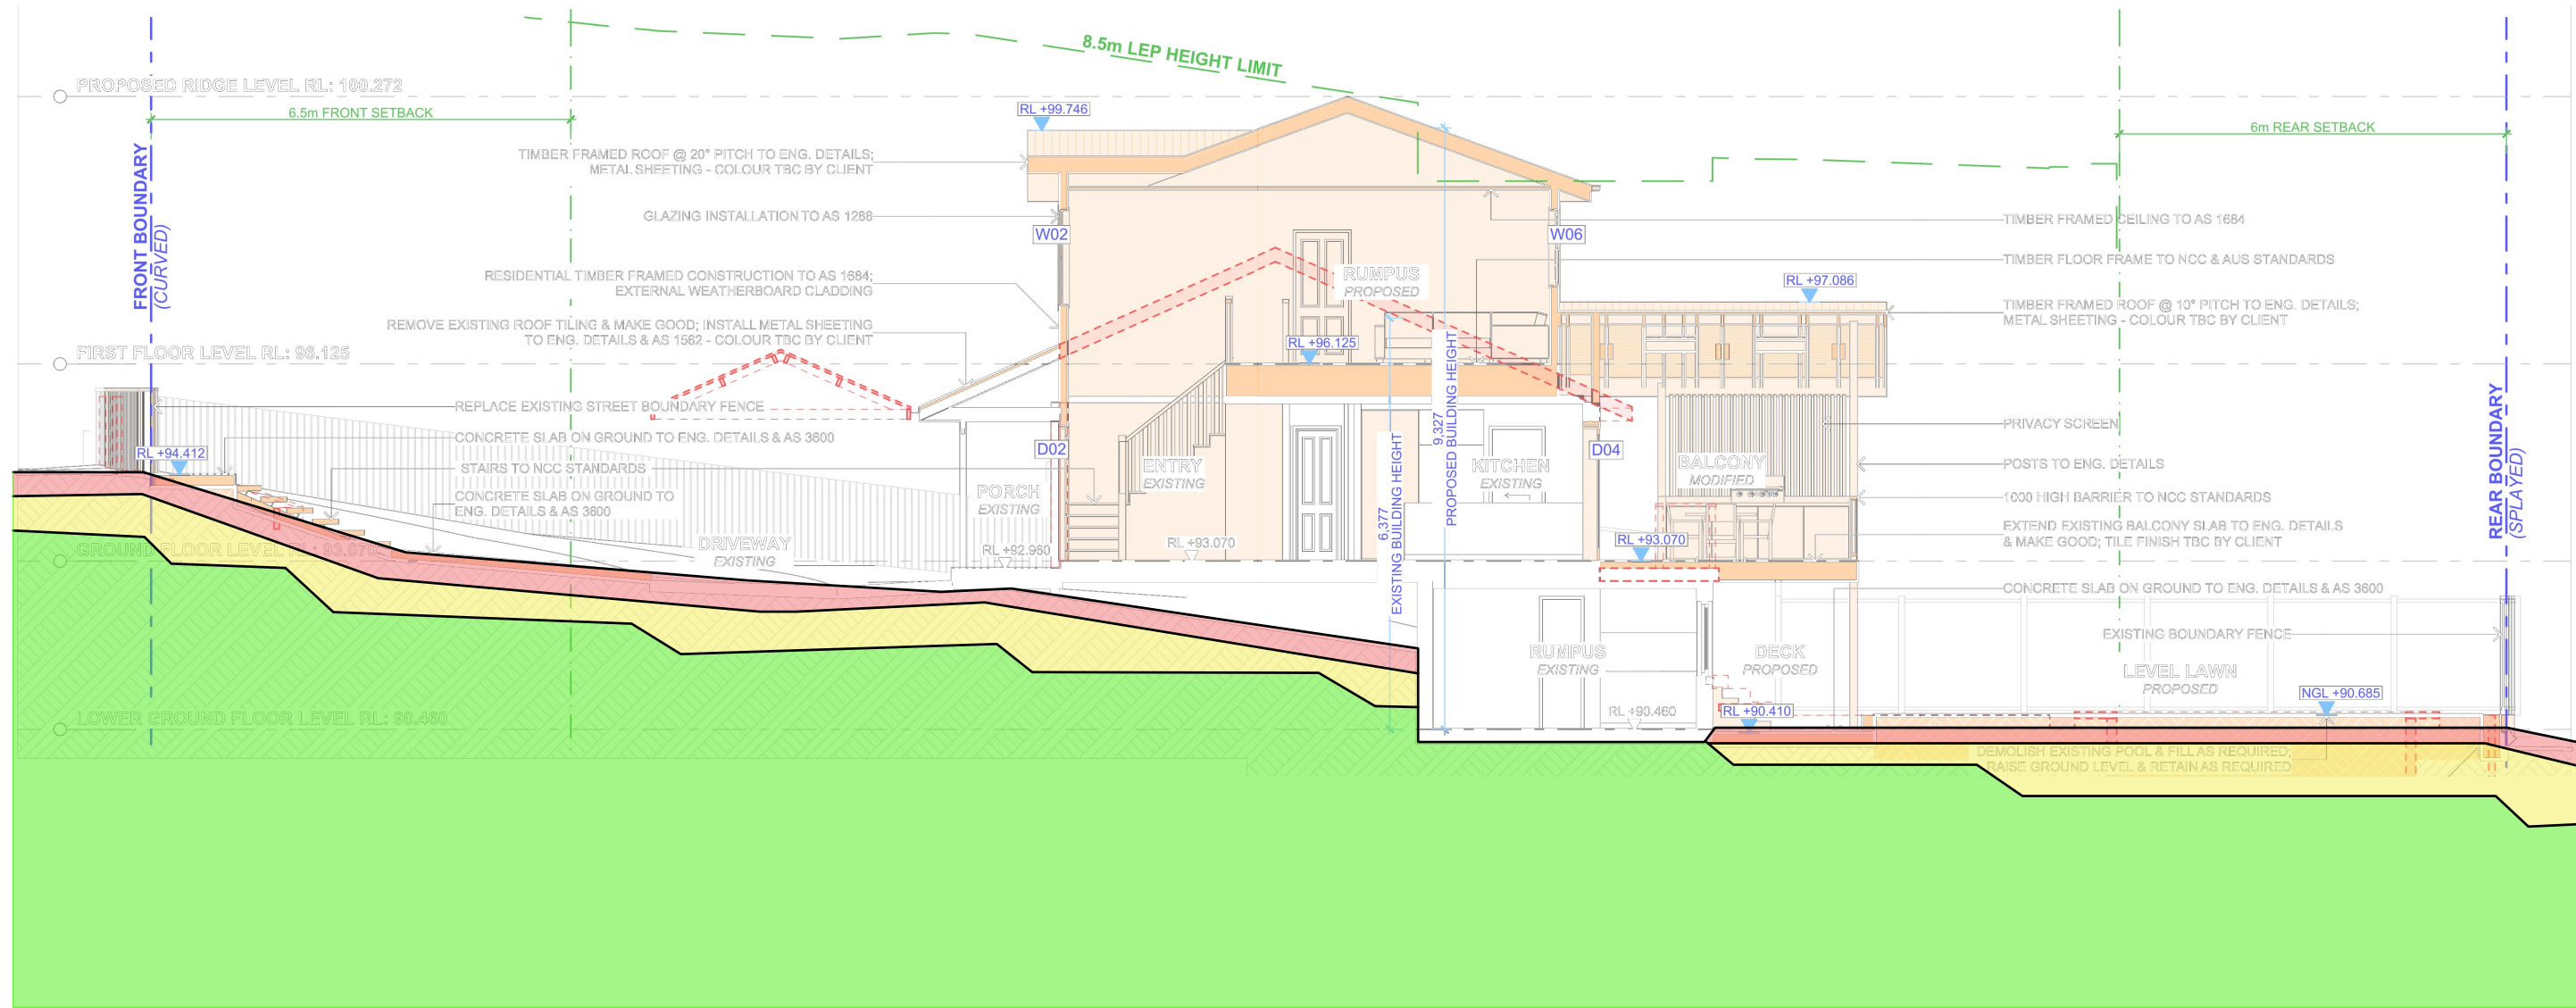
**INFERRED GEOLOGICAL SECTION**  
SCALE NTS

Unit	Material	Comments
1	<b>Topsoil / Fill</b>	Sandy topsoil and fill material. Unit 1 is inferred to be uncontrolled and poorly compacted and may contain portions of hard fill material.
2	<b>Sandy Clay</b>	Low-medium plasticity silty clay. Unit 2 is generally soft consistency.
3	<b>Sandstone</b>	Low strength or greater sandstone bedrock (Class IV+*) expected to be found below the weathered crust (Class V*).

<b>Footings</b>	<p>We recommend that all new footings are taken to and founded directly upon the underlying sandstone bedrock (Unit 3) using piers as required.</p> <p>The allowable bearing pressure for footings taken to competent weathered bedrock of at least low strength is <b>600kPa</b>. Higher allowable bearing capacities may be achievable subject to inspection and certification of excavated footings by AscentGeo.</p> <p>Pier footings should be of sufficient diameter to enable effective base cleaning to be carried out during construction. Small diameter piers that cannot be cleaned should be designed for shaft friction, resulting in a longer rock socket.</p> <p>To mitigate the risk of differential settlement, it is essential that all footings are founded on competent bedrock of similar consistency. This may require excavation through sandstone floaters or the relocation of planned footings.</p> <p><b>It is essential that the foundation materials of all footing excavations be inspected and approved before steel reinforcement and concrete is placed. This inspection should be scheduled while excavation plant and operators are still on site, and before steel reinforcement has been fixed or the concrete booked.</b></p>

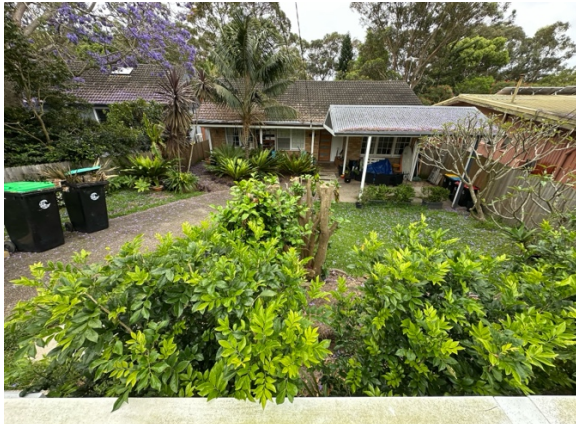
**Photo 1:** Frontage of the dwelling facing north.

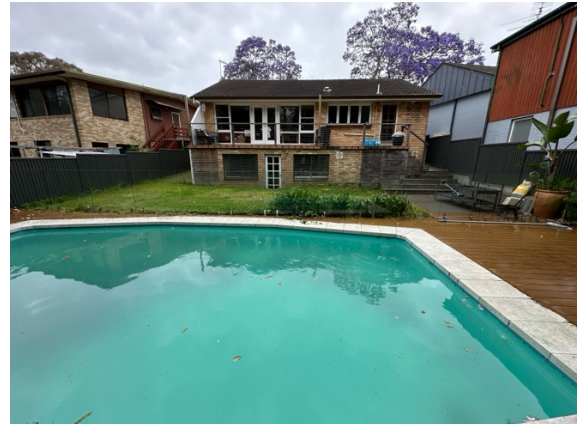
**Photo 2:** Rear of the dwelling facing south.

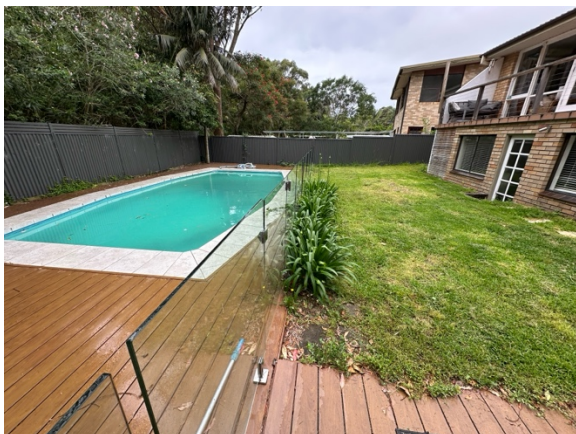
**Photo 3:** Area of proposed balcony, deck, and pool.

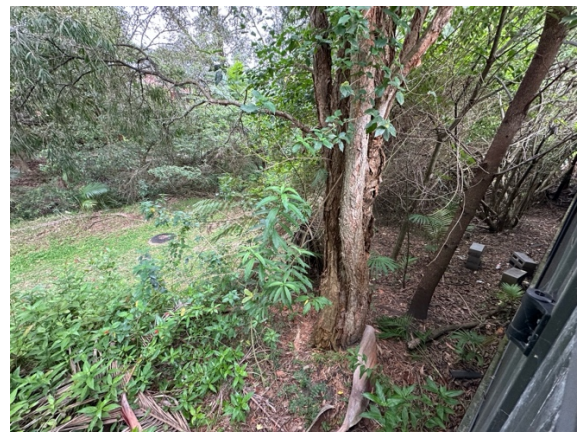
**Photo 4:** South creek at the rear boundary of the site, facing north.

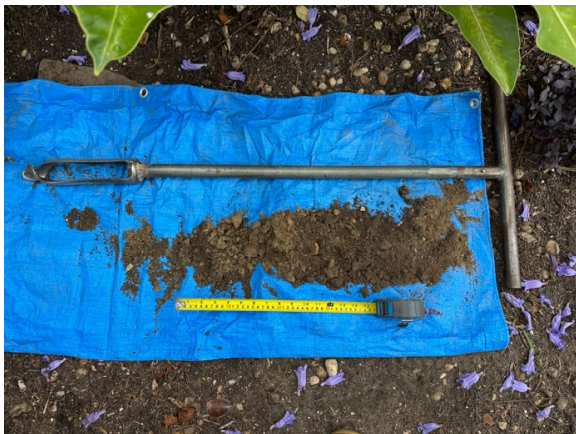
**Photo 5:** Subsurface soil profile seen in BH1.

<b>Silty SAND SM: very loose to loose, grey brown, fine to coarse grained, with fine to coarse sized gravel, natural moist.</b>	VL-L		SM
				<b>BH1 refusal at 0.4m (Auger tip grinding on bedrock.)</b>

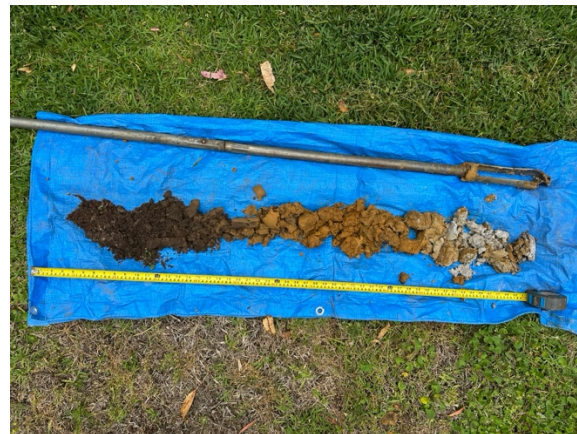
**Photo 6:** Subsurface soil profile seen in BH2.

Depth (m)	Water	Graphic Log	Drilling Method	Material Description	Consistency	Moisture	Classification Code
1				Fill Silty SAND SM: poorly compacted, black, fine to coarse grained, with fine to coarse sized gravel, moist.	PC	M	SM
				Natural Sandy CLAY CL: soft, low plasticity, orange, fine to medium grained sand, inorganic, moist.	S		CL
				Natural Sandy CLAY CL: soft, low plasticity, white grey, fine to coarse grained sand, inorganic, moist.			CL
2				BH2 refusal at 1.3m (Auger tip grinding on bedrock.)
