GEOTECHNICAL INVESTIGATION:

New Courtyard, Landscaping, and New Spa at **9 Salisbury Square, Seaforth**

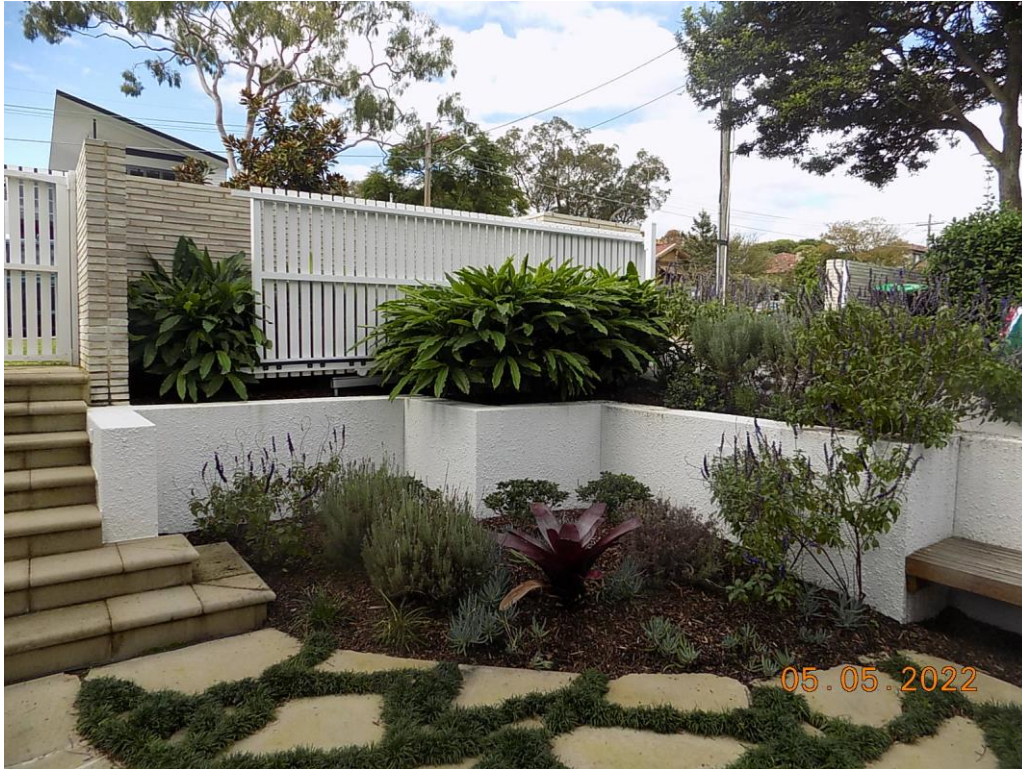
Photo 3

- 2.1** The site was inspected on the 5th May, 2022.
- 2.2** This residential property is on the low side of the street and has a W aspect. It is located on the gentle to moderately graded middle reaches of a hillslope. The slope falls across the property at an average angle of ~6°. The slope above the property continues at similar angles and the slope below the property increases in grade.
- 2.3** At the road frontage, a concrete driveway runs down the slope to a parking garage attached to the uphill side of the house (Photo 1). Between the road frontage and the house is a level paved and garden area (Photo 2). The cut for the level lawn area is supported by a ~0.7m high stable rendered masonry retaining wall that lines the upper boundary (Photos 3). The part three-storey brick house is supported on

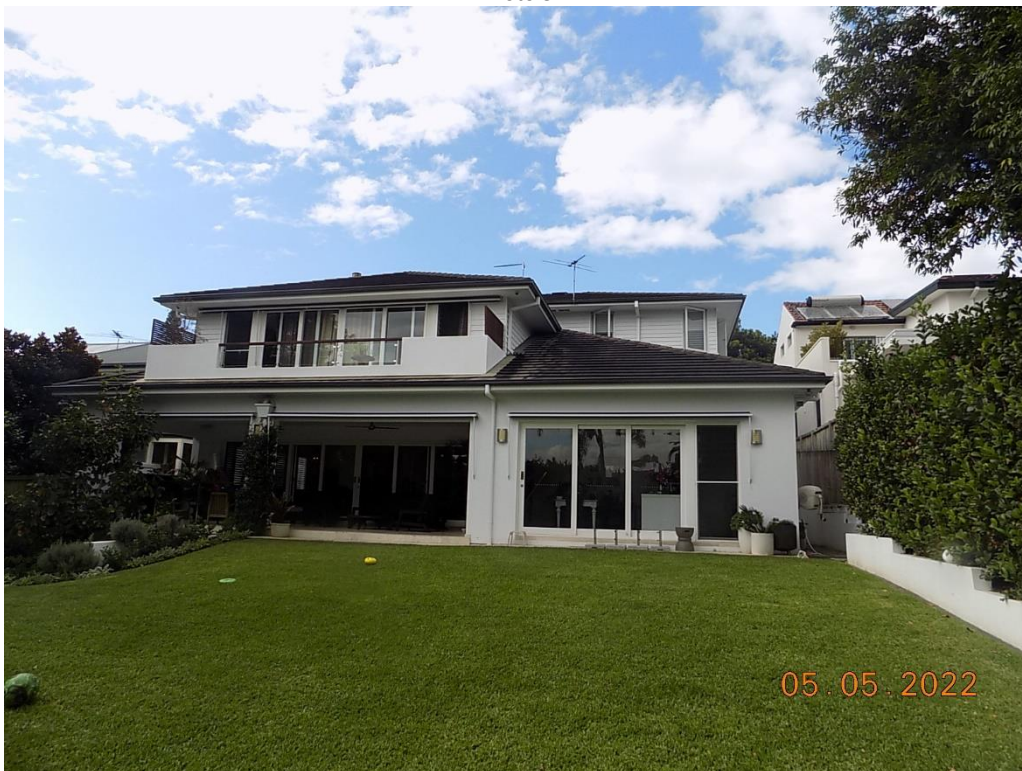
Photo 4

brick walls (Photo 4). The brick walls show no significant signs of movement. Access to the foundation space was not available at the time of this inspection. The cut for the lower level of the house is supported by a stable rendered masonry retaining wall that rises up to ~1.2m high (Photo 5). A gently sloping lawn area extends off the downhill side of the house to a pool at the downhill common boundary (Photo 6). The concrete shell of the pool shows no significant signs of movement as indicated by the water level against the tiles. The fill for the lawn area is supported by a stable ~0.8m high keystone block retaining wall (Photo 7).

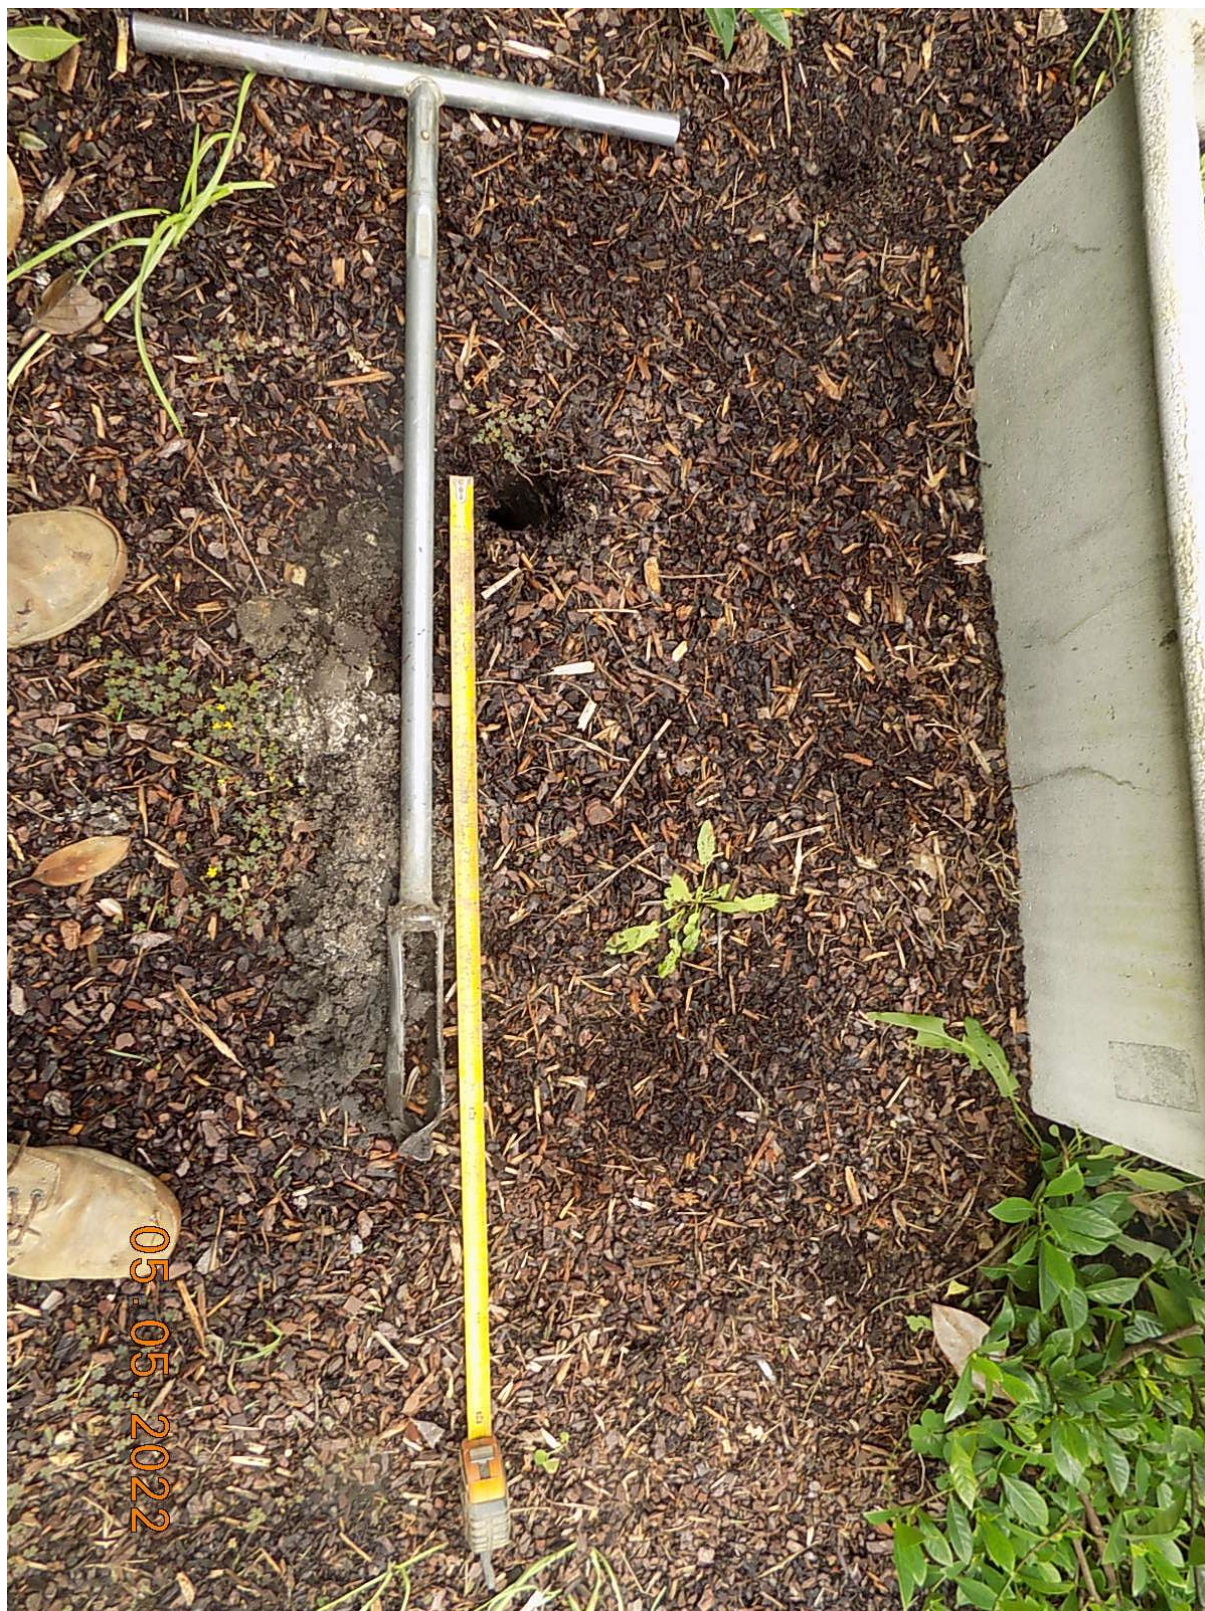
Photo 8 (top to bottom)

AUGER HOLE 1 (~RL49.0) – AH1 (Photo 8)

Depth (m)	Material Encountered
0.0 to 0.1	TOPSOIL , dark brown, medium grained, loose to medium dense, dry.
0.1 to 0.2	FILL , sand derived from Very Low Strength Sandstone, sugary, white, coarse grained, dry.
0.2 to 0.6	FILL , brown, clayey sand, fine, coarse, damp.

Refusal @ 0.6m on rock. Auger grinding. No water table encountered.

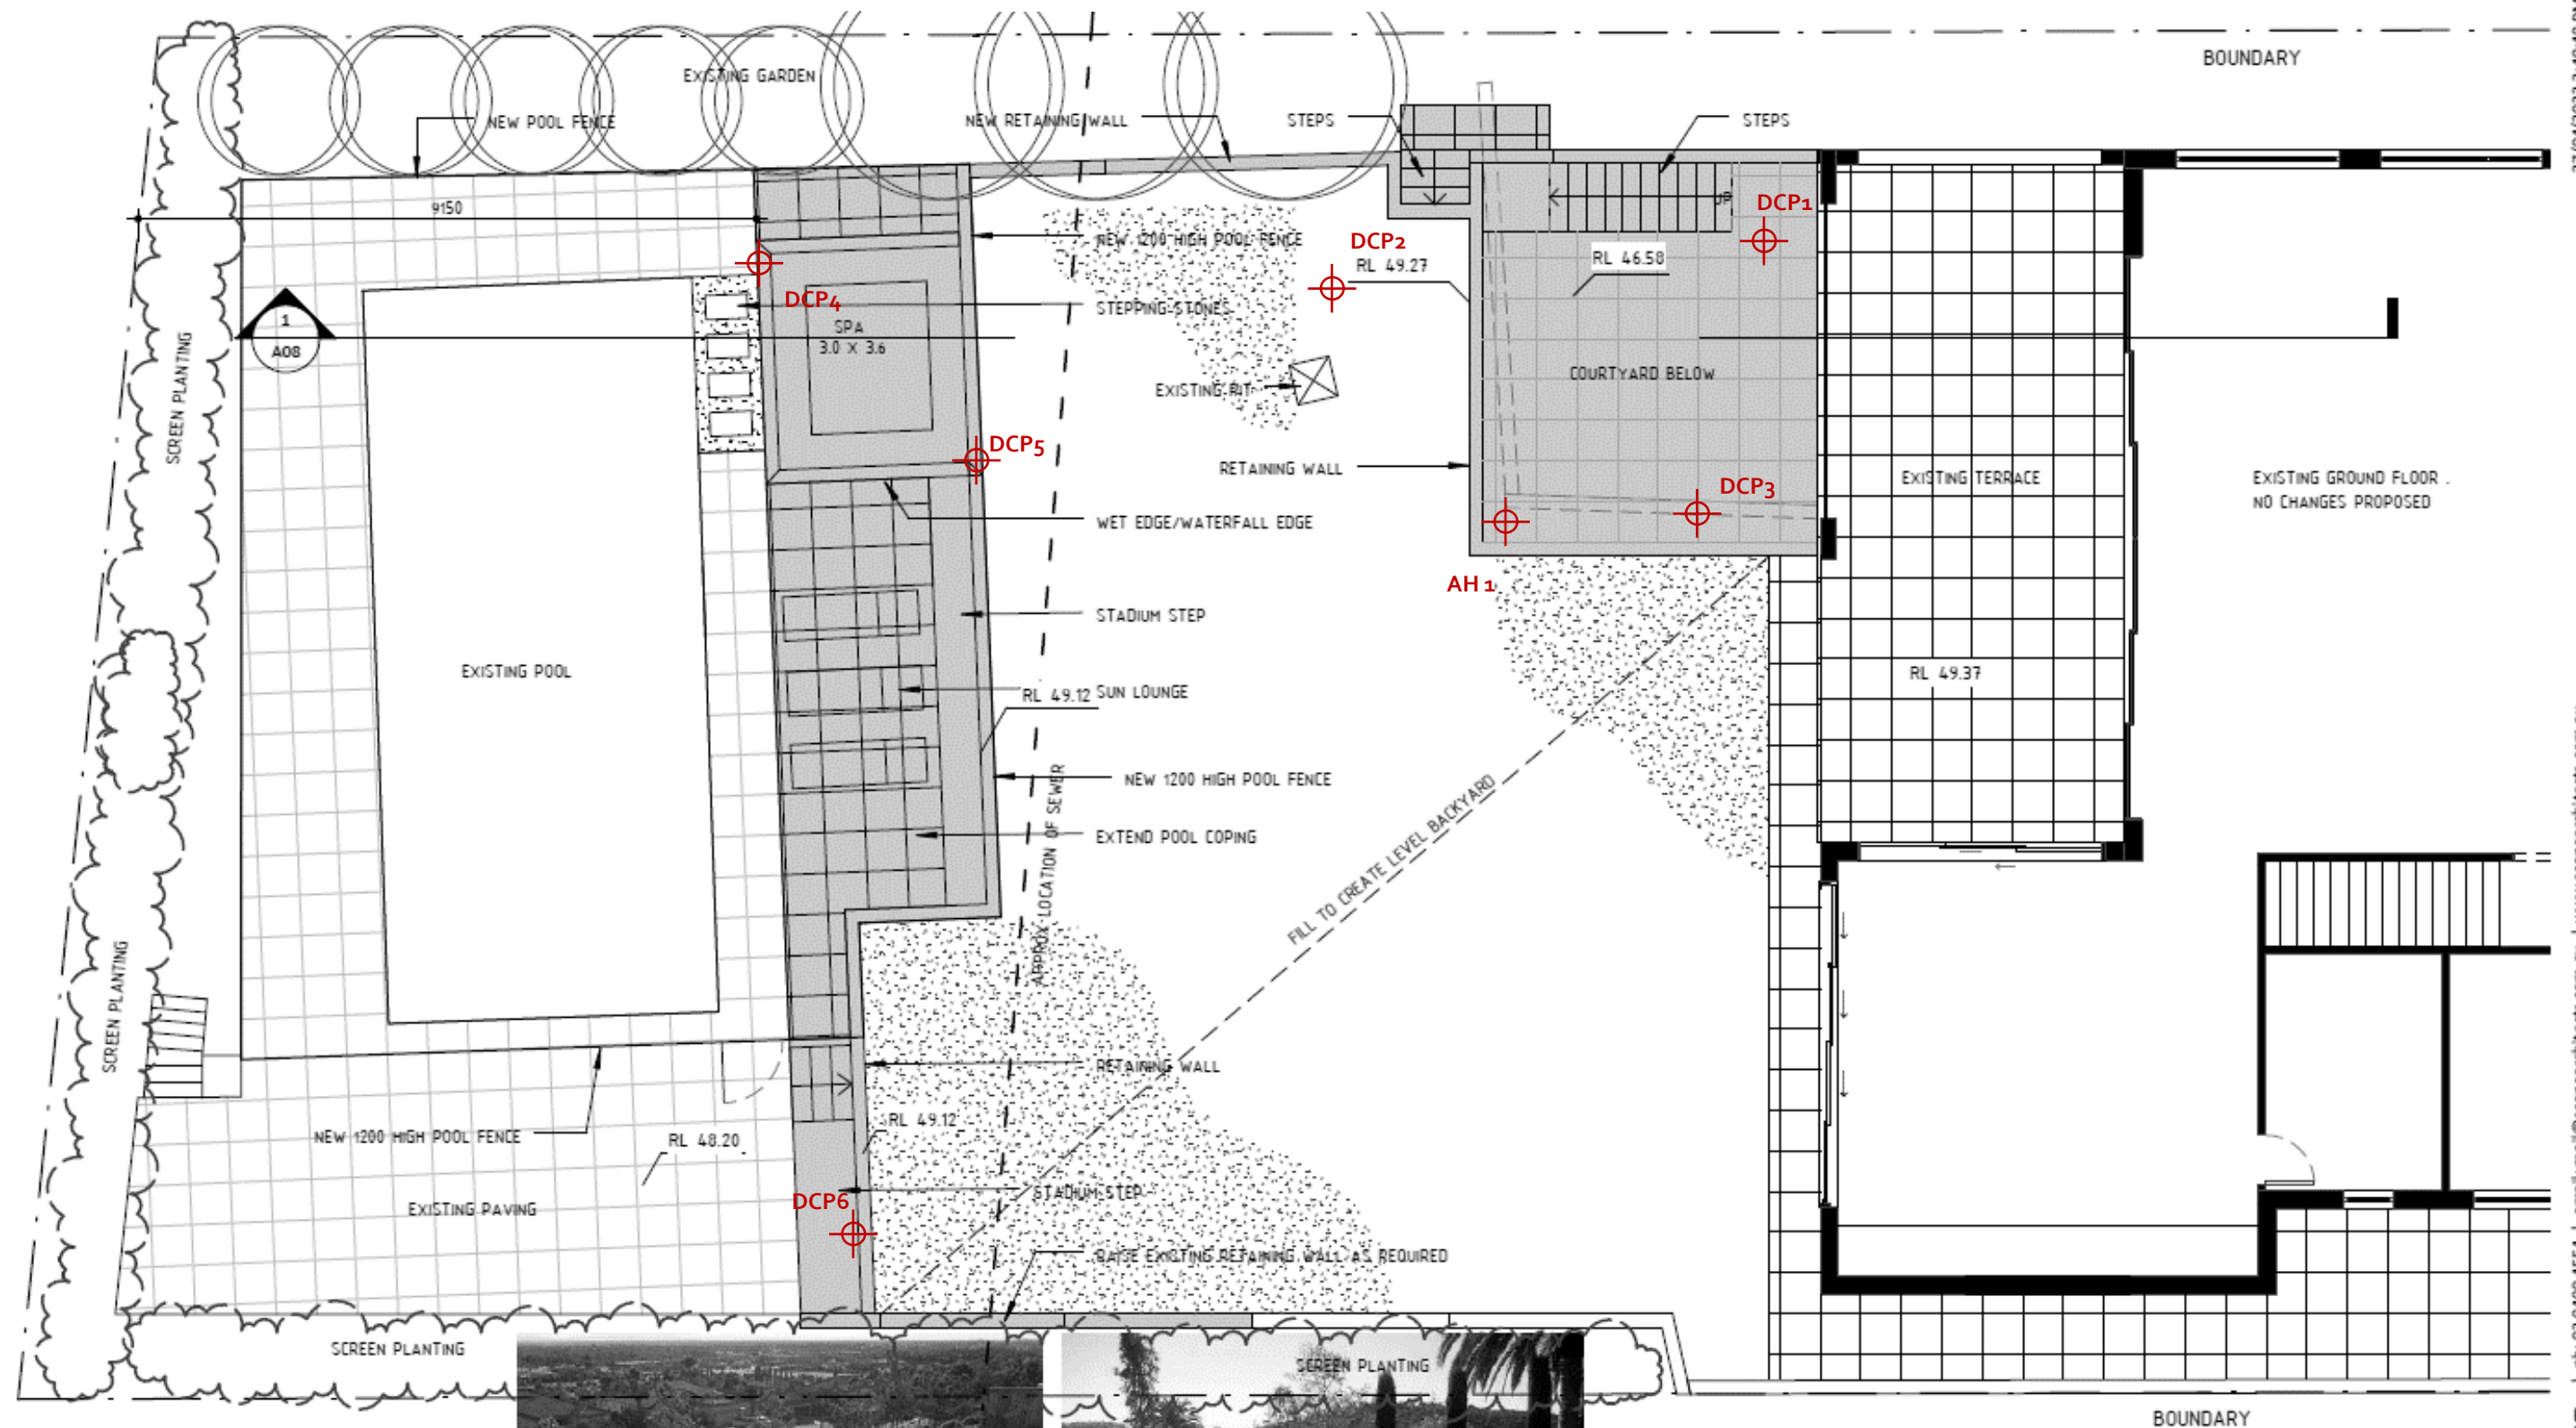
SITE PLAN – showing test locations

One hand Auger Hole (AH) was put down to identify the soil materials. Six Dynamic Cone Penetrometer (DCP) tests were put down to determine the relative density of the overlying soil and the depth to bedrock. The locations of the tests are shown on the site plan attached. It should be noted that a level of caution should be applied when interpreting DCP test results. The test will not pass through hard buried objects so in some instances it can be difficult to determine whether refusal has occurred on an obstruction in the profile or on the natural rock surface. This is not expected to be an issue for the testing on this site. However, excavation and foundation budgets should always allow for the possibility that the interpreted ground conditions in this report vary from those encountered during excavations. See the appended "Important information about your report" for a more comprehensive explanation. The results are as follows:

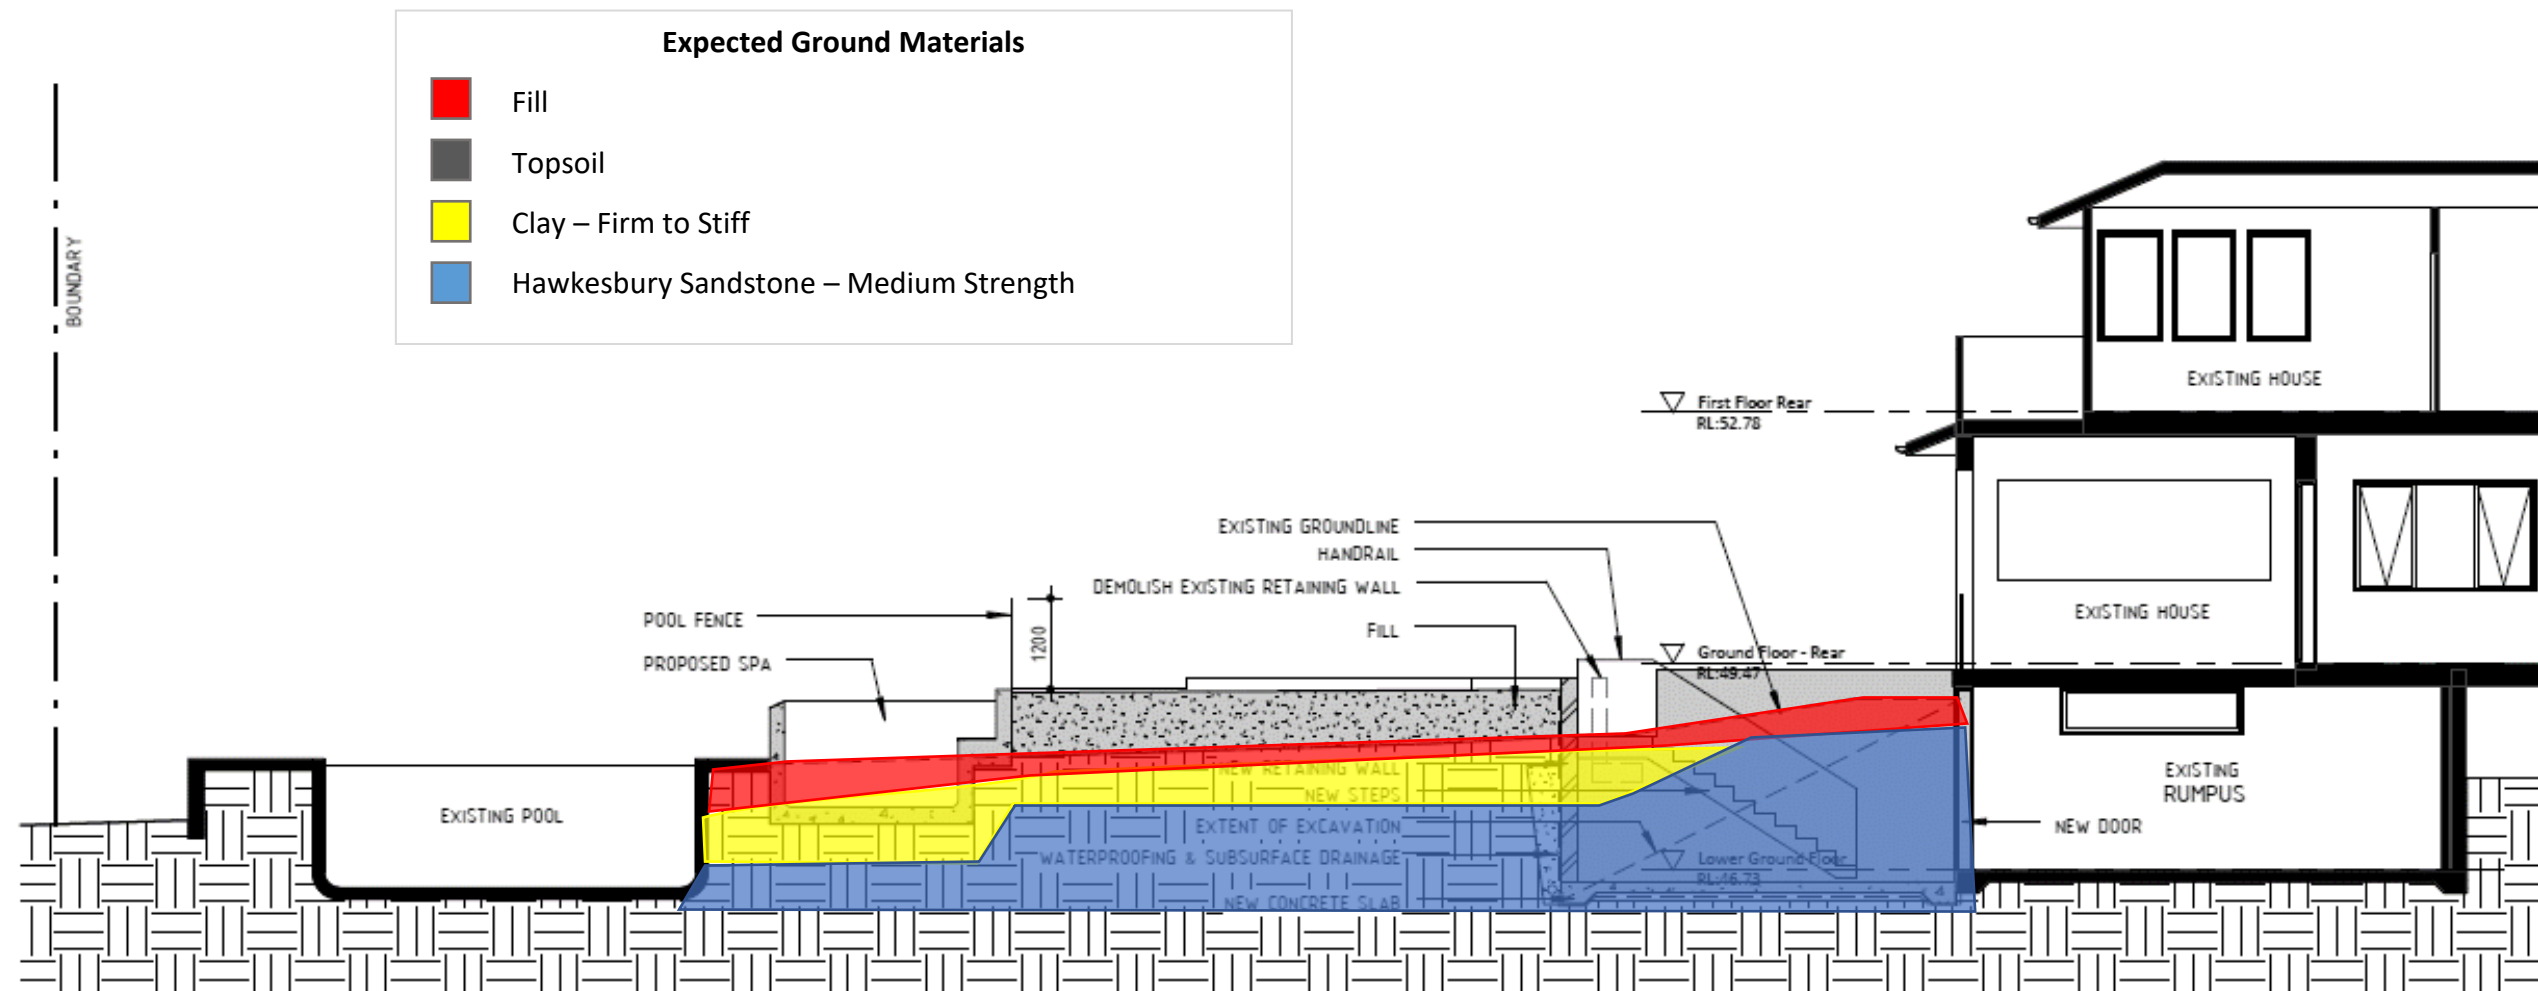
TYPE SECTION – Diagrammatical Interpretation of expected Ground Materials

The surface features of the block are controlled by the underlying sandstone bedrock that steps down the property forming sub-horizontal benches between the steps. Where the grade is steeper, the steps are larger and the benches, narrower. Where the slope eases, the opposite is true. Filling has been placed around the site for garden beds and levelling of the existing lawn area. The rock is overlain by a thin topsoil over clays that fill the bench step formation. In the test locations, the depth to rock ranged between 0.4 to 1.6m below the current surface, being slightly deeper due to the presence of fill and the stepped nature of the underlying bedrock. The sandstone underlying the property is estimated to be medium strength or better as the DCP bounced at the end of every test. Similar strength rock is expected to underlie the entire site. See Type Section attached for a diagrammatical representation of the expected ground materials.
