Date: 4th February 2022

Project No.: 2022-004

Levi & Cathy Littlejohn,
109 Rose Avenue,
Wheeler Heights, NSW 2097

Preliminary Landslip Assessment for 109 Rose Avenue, Wheeler Heights, NSW.

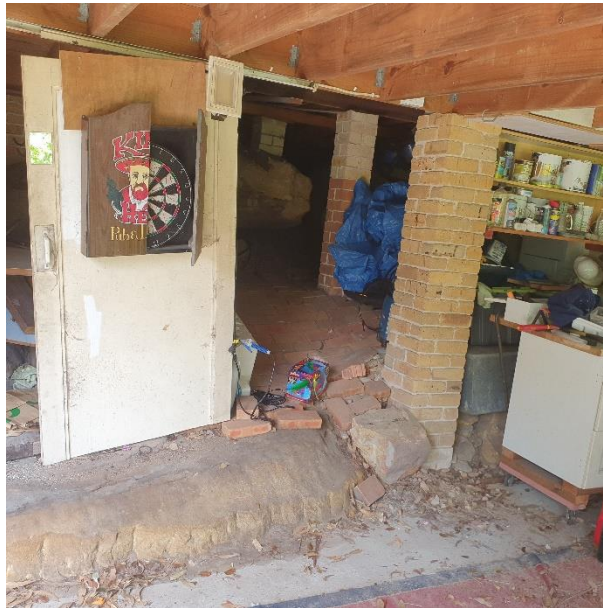
The site is accessed via a concrete driveway along the north boundary that rises and extends east and is supported by a mortared sandstone rock wall along the northern side of the driveway. The southern front of the site is also occupied by a grass lawn (at similar level to the north-western side of the site) and along the eastern side is an interpreted sandstone bedrock ledge that is approximately 2.0m higher than the grass lawn and extends east and is also exposed below the site-dwelling (Photograph-1). The front of the site appears in good condition, signs of ground movement, unstable boulders or underlying geotechnical issues were not observed within the front of the site.

Photograph-1: Potential bedrock observed below the western side of the GFL. View looking east.

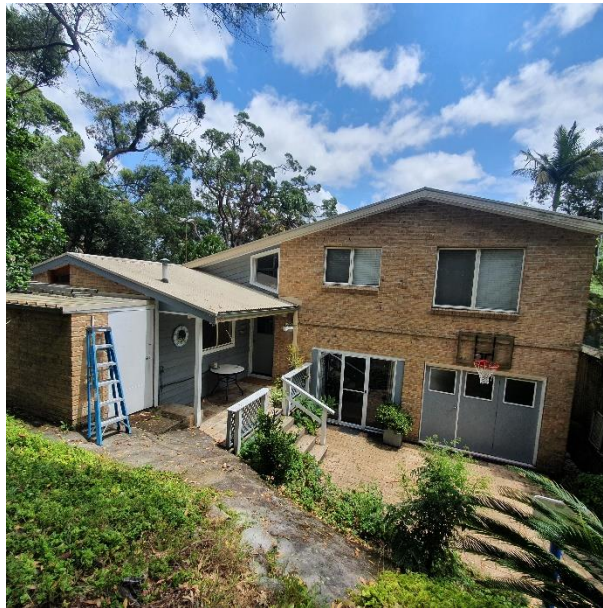
The centre of the site is broadly occupied by a one (southern half) and two (northern half) storey brick and timber dwelling that contains a timber deck and paved patio to the west and east of the site-dwelling, respectively. The dwelling extends north and south to approximately 1.50m from the northern and southern boundaries. Observation below the Ground Floor Level (GFL) identified that at least the western side of the GFL is supported by brick piers and walls which are then supported by the interpreted sandstone bedrock. Bedrock was also exposed at numerous locations within the site; therefore, it is likely that the site-dwelling is founded down to bedrock. Cracking, signs of ongoing settlement or underlying geotechnical issues were not observed within the site-dwelling and it appeared in good condition.

Photograph-2: Rear view of the site-dwelling. View looking down west from the rear of the site.

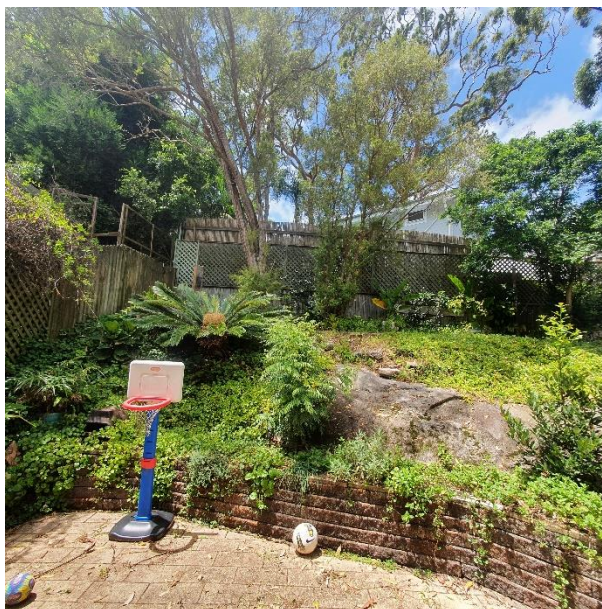
The eastern rear of the site is marked by a north-south striking bedrock ledge that is approximately 2.0m higher than the rear patio level and rises in level towards the east and is overlaid by grass lawn and several trees along the eastern boundary (Photograph-3). The eastern portion of the site did not contain any unstable boulder, signs of slope instability or underlying geotechnical issues and appeared in good condition.

Photograph-3: Rear of the site. View looking up east from the rear patio.
