ARBORICULTURAL DEVELOPMENT IMPACT ASSESSMENT REPORT

Dee Why RSL Car Wash NSW

11th of June 2020

Prepared for Dee Why RSL

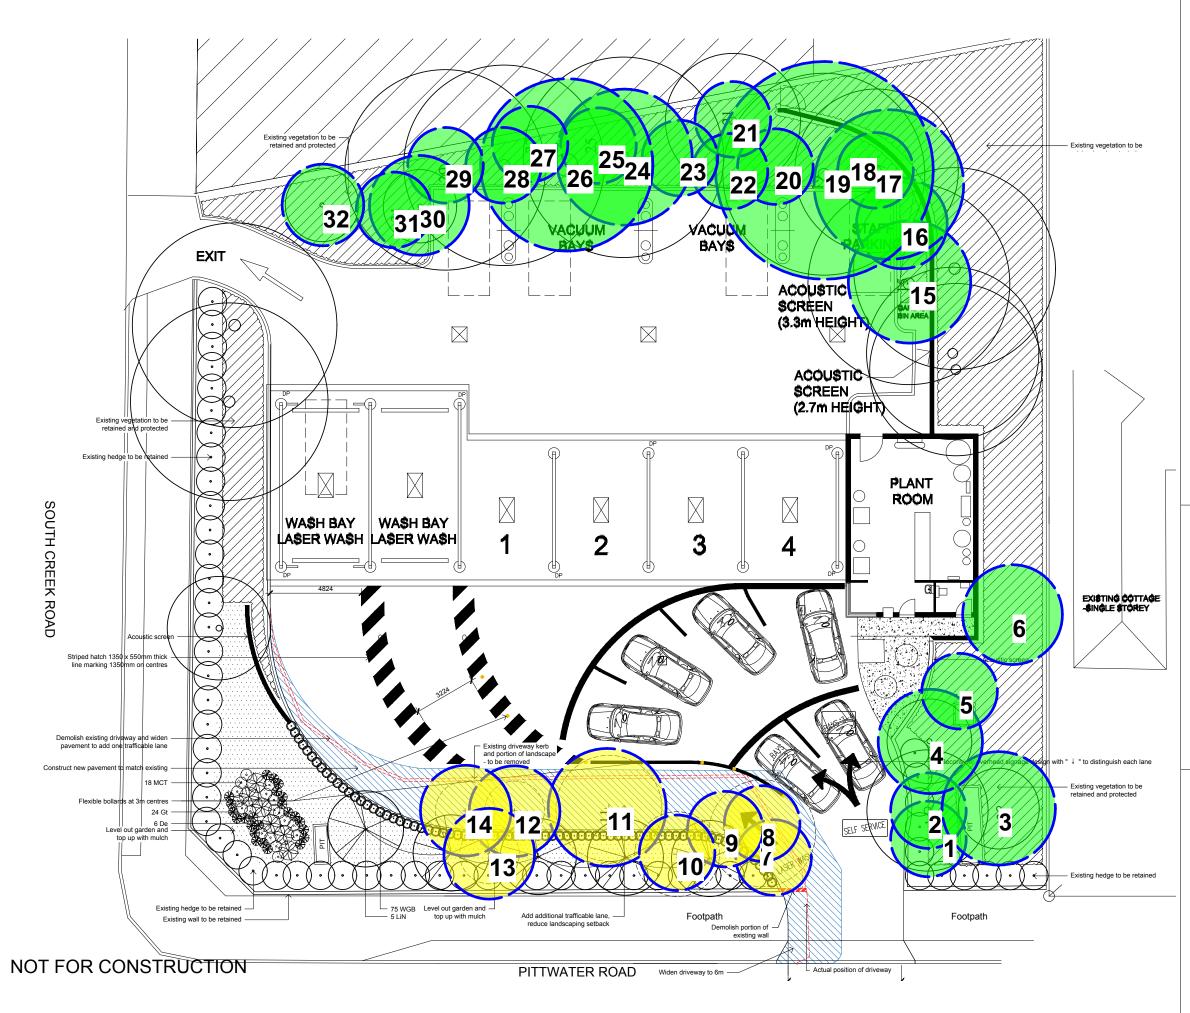
Appendix D Tree Location Plans

Trees 7, 8, 9, 10, 11, 12, 13 and 14 are encroached by the proposed construction and required earthworks by a major encroachment as defined by *AS4970-2009 Protection of Trees on Development Sites*. These trees will not be viable to be retained and are recommended for removal.
