Geotechnical Assessment

Project: Alterations & Additions
84 Lagoon Street, Narrabeen NSW

Prepared for:
Beams Building Pty Ltd

Ref: AG 24380
19 September 2024

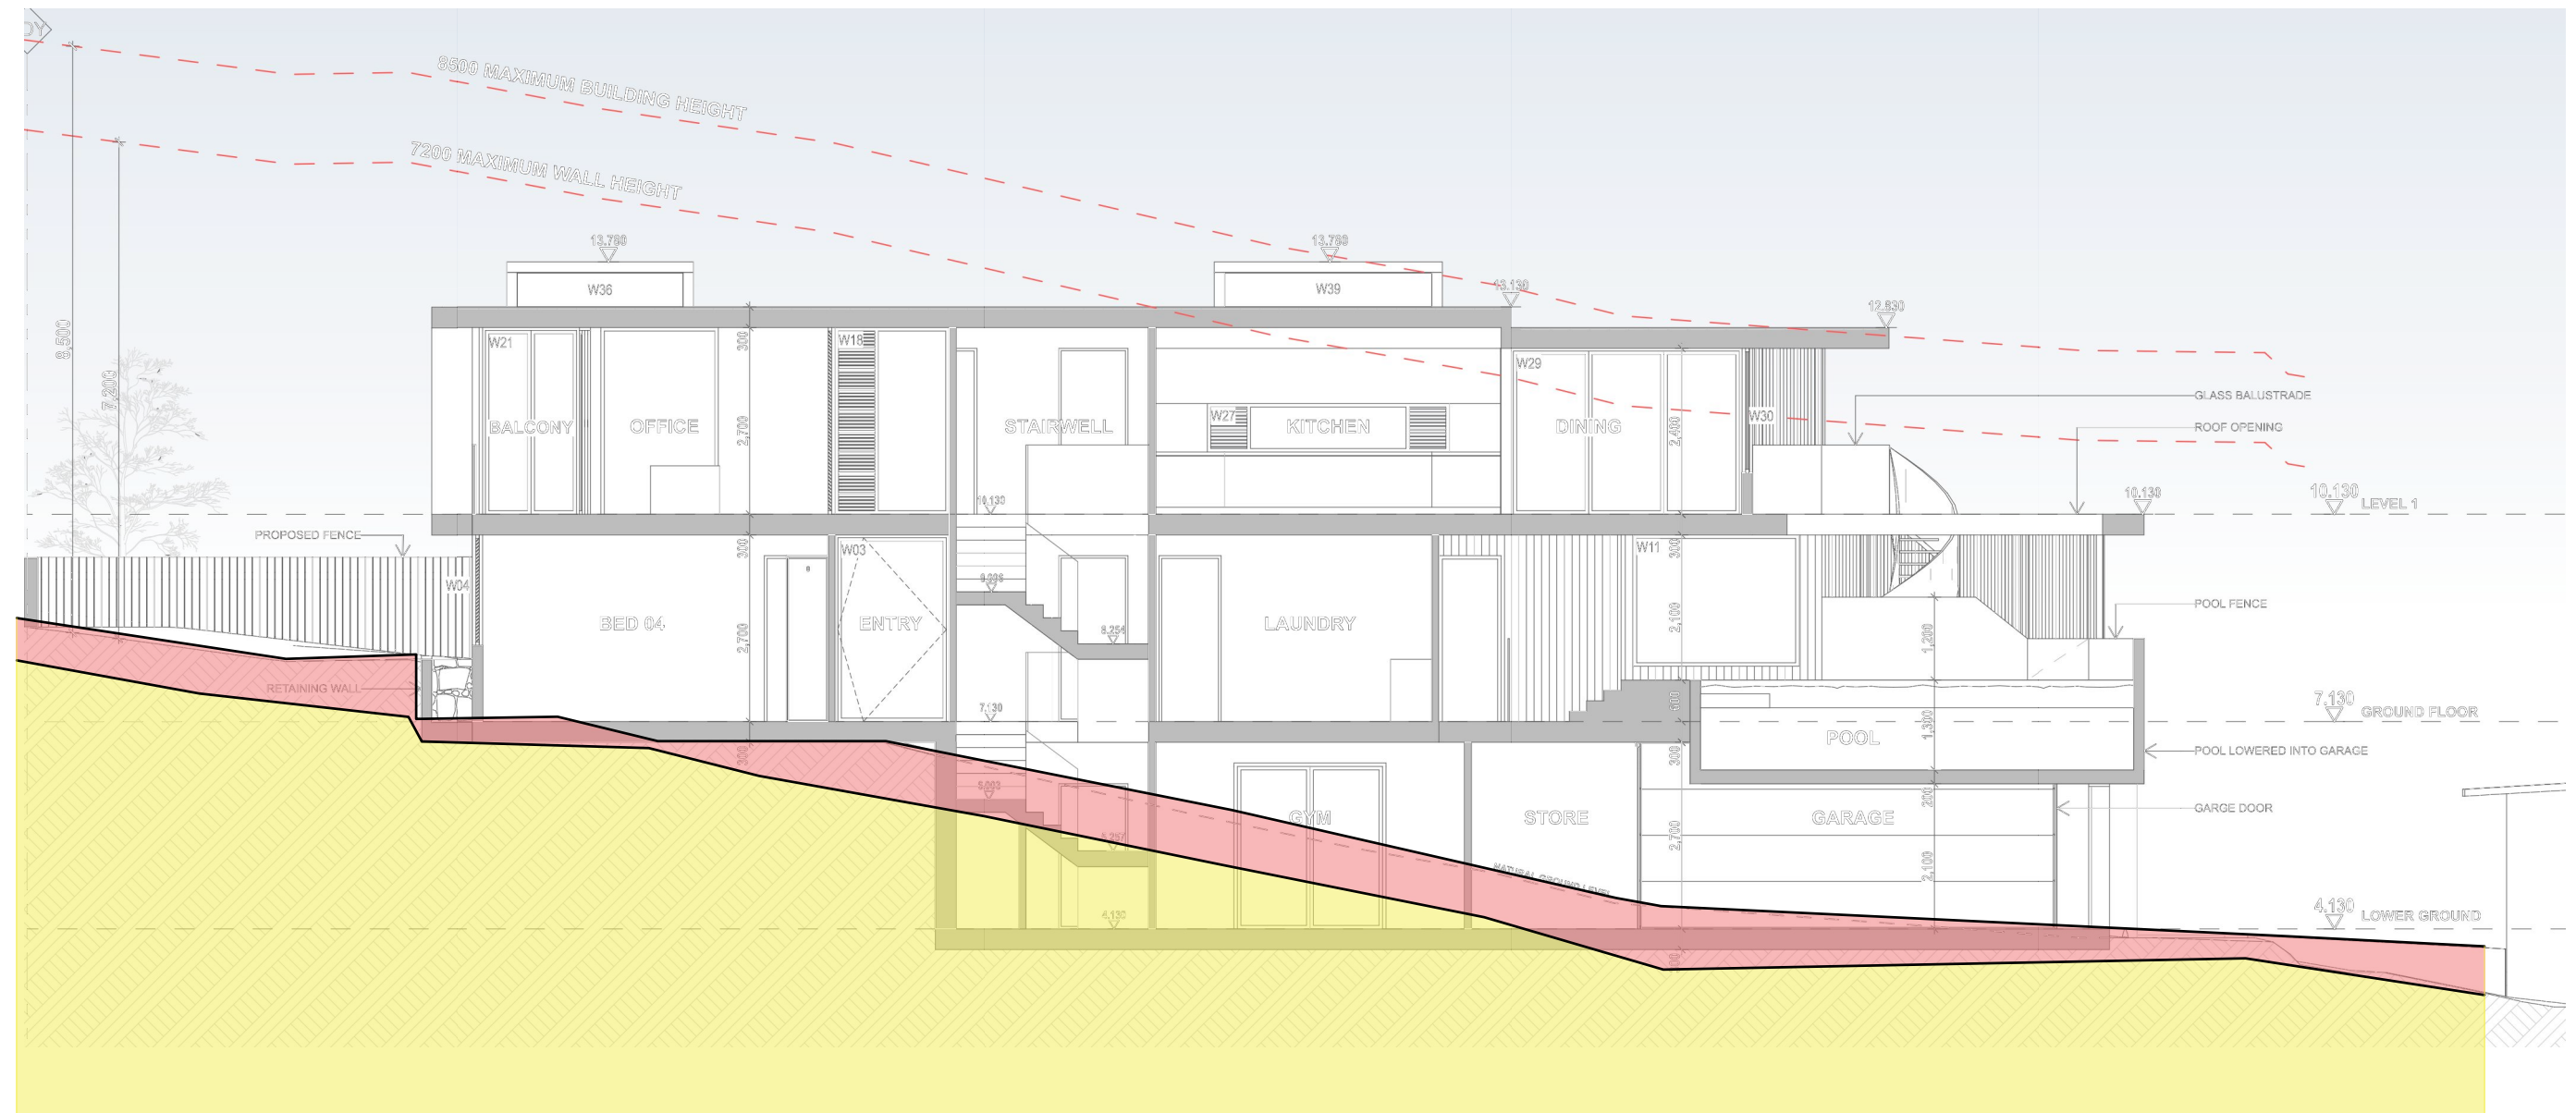
INFERRED GEOLOGICAL SECTION
SCALE NTS

Unit	Material	Comments
1	Topsoil / Fill	Sandy disturbed topsoil and uncontrolled, poorly-compacted fill material.
2	Silty Sand	Fine to medium grained, Silty Sand. Loose to medium dense in consistency, increasing density with depth.
3	Sandstone	Low strength or greater sandstone bedrock (Class IV+*) expected to be found below the weathered crust (Class V-IV*) at unknown depths.

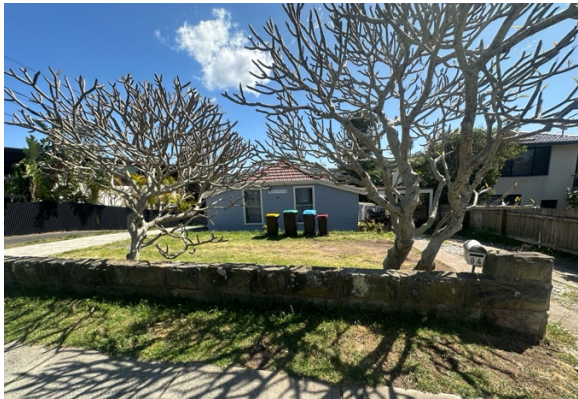
Photo 1: Site frontage, looking west.

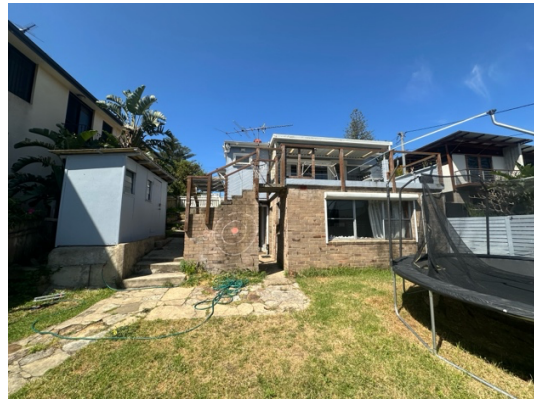
Photo 2: Rear of site, looking east.

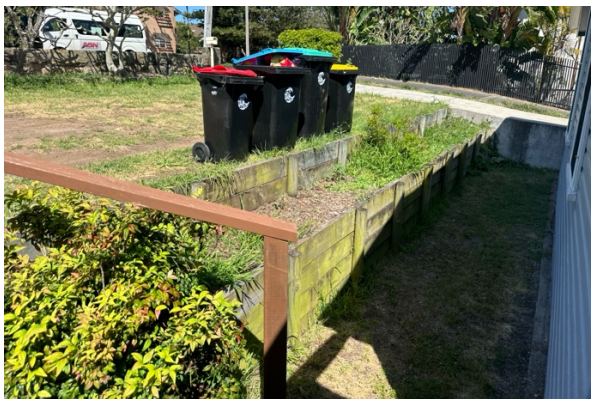
Photo 3: Front yard of site, looking south-east.

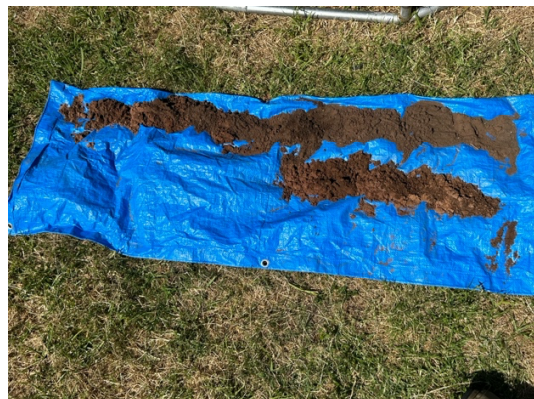
Photo 4: Subsurface soil profile of BH01.

Natural Silty SAND SM: loose to medium dense, brown / red / light brown, fine to coarse grained, trace fine sized gravel, moist.	SM	L-MD				
2					BH01 Terminated at 1.8m (Practical limit of equipment)
