GEOTECHNICAL INVESTIGATION:

New Pool and Cabana at **99 Riverview Road, Avalon Beach**

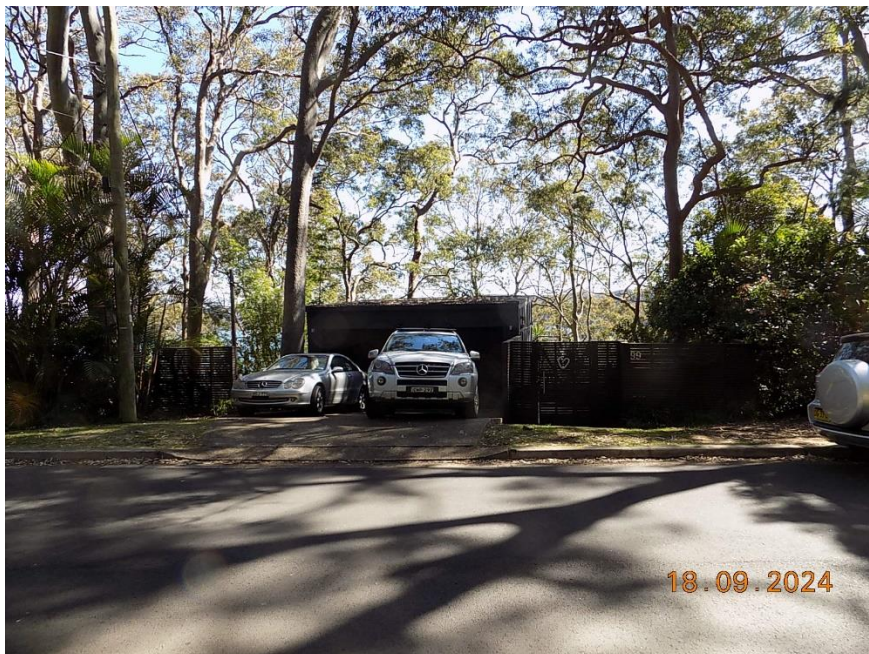
Photo 1

- 2.3** At the road frontage (Photo 1), a concrete driveway runs to a stable timber clad garage on the uphill side of the property. The concrete piers for the garage stand vertical. The steep slope between the garage and the house which is the location of the proposed works, is terraced by low timber and dry stack stone retaining walls. These retaining walls are largely considered stable. One wall below the garage was measured to be tilting downslope up to ~11° (Photo 2) due to the loads exerted by the plants above it, which were also tilting. See '**Section 17**' for advice. A band of Medium

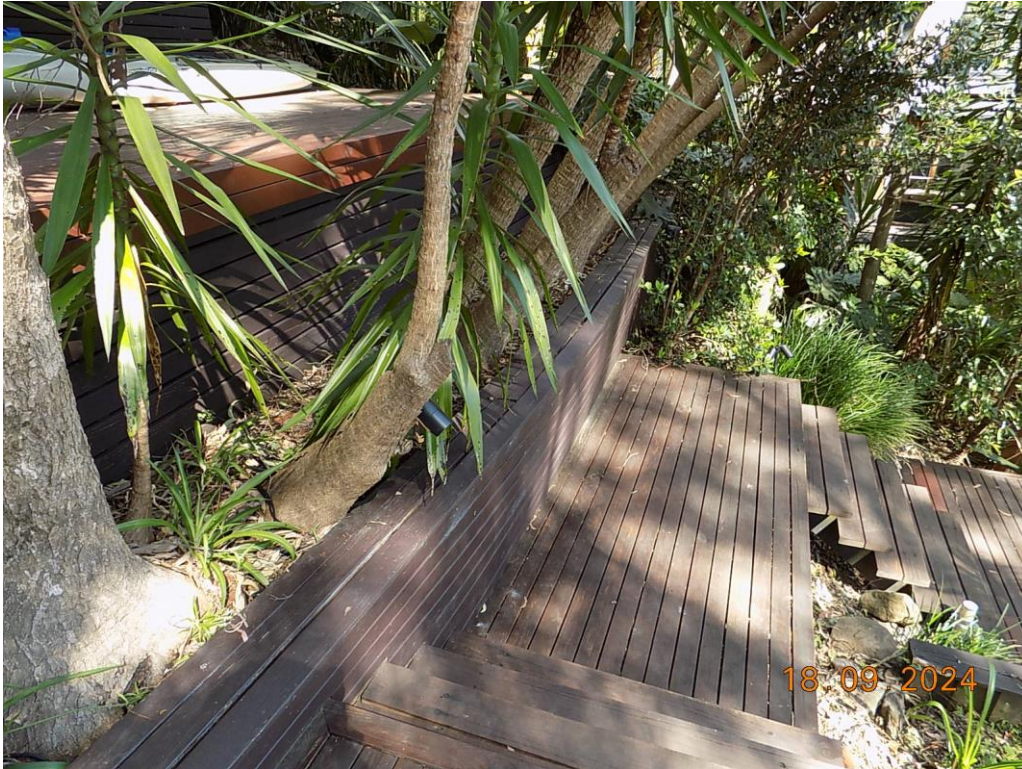
Photo 2

HAZARDS	Hazard Three	Hazard Four
TYPE	The excavations collapsing onto the work site before retaining structures are in place.	Further movement of the timber retaining wall below the garage (Photo 2) that will eventually result in failure.
LIKELIHOOD	'Possible' (10^{-3})	'Likely' (10^{-2})
CONSEQUENCES TO PROPERTY	'Medium' (10%)	'Minor' (10%)
RISK TO PROPERTY	'Moderate' (5×10^{-4})	'Moderate' (5×10^{-4})
RISK TO LIFE	8.3×10^{-6} /annum	1.3×10^{-5} /annum
COMMENTS	This level of risk to property is 'UNACCEPTABLE'. To move risk to 'ACCEPTABLE' levels, the recommendations in Section 13 and 14 are to be followed.	This level of risk to life and property is 'UNACCEPTABLE'. To move risk to 'ACCEPTABLE' levels, the recommendations in Section 17 are to be followed.

The timber retaining wall below the garage (Photo 2) was measured to be tilting ~11° downslope and in the process of failure due to the loads exerted by the plants above. Should the wall fail, it could impact on the steep slope below as well as the decking and garage nearby. This wall is to be remediated as part of the proposed works so that it meets current engineering standards.

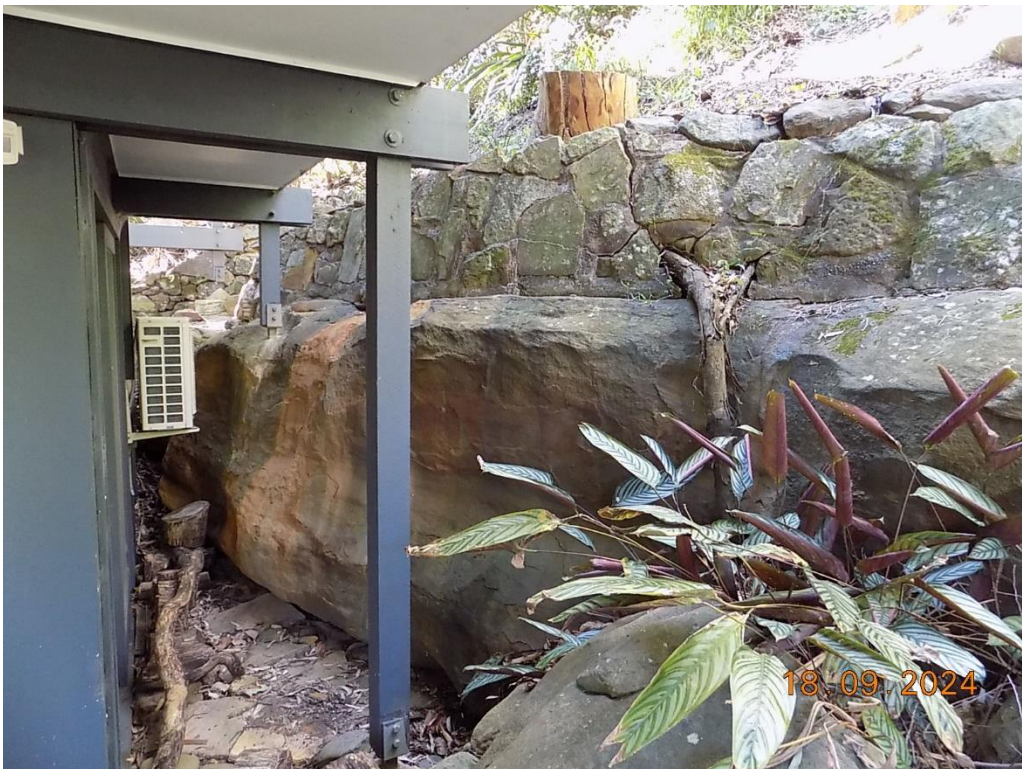
Photo 3

Strength Sandstone outcrops immediately above the subject house (Photo 3). The observable portions of the rock face were seen to be free from significant geological defects that could affect its stability. Fill for landscaping in this location is supported by a stable low mortared sandstone retaining wall which is partially supported on the outcropping rock (Photo 3). The part three-story fibre board and timber clad house is supported on concrete piers and timber posts. One of the concrete piers exhibits slight tilting. This appears to have been how it was initially constructed. As such, all foundations are considered stable. A cut for the lower ground floor of the house is supported by a stable mortared sandstone retaining wall reaching up to ~1.1m high (Photo 4). An inclined lift extends from the N of the house to the road frontage. Where the lift has been excavated into the slope, the cut is supported by a stable dry stack retaining wall (Photo 5) which is partially supported on outcropping sandstone. Stable low timber retaining walls support fill for landscaping between the downhill side of the house and the lower common boundary (Photo 6).

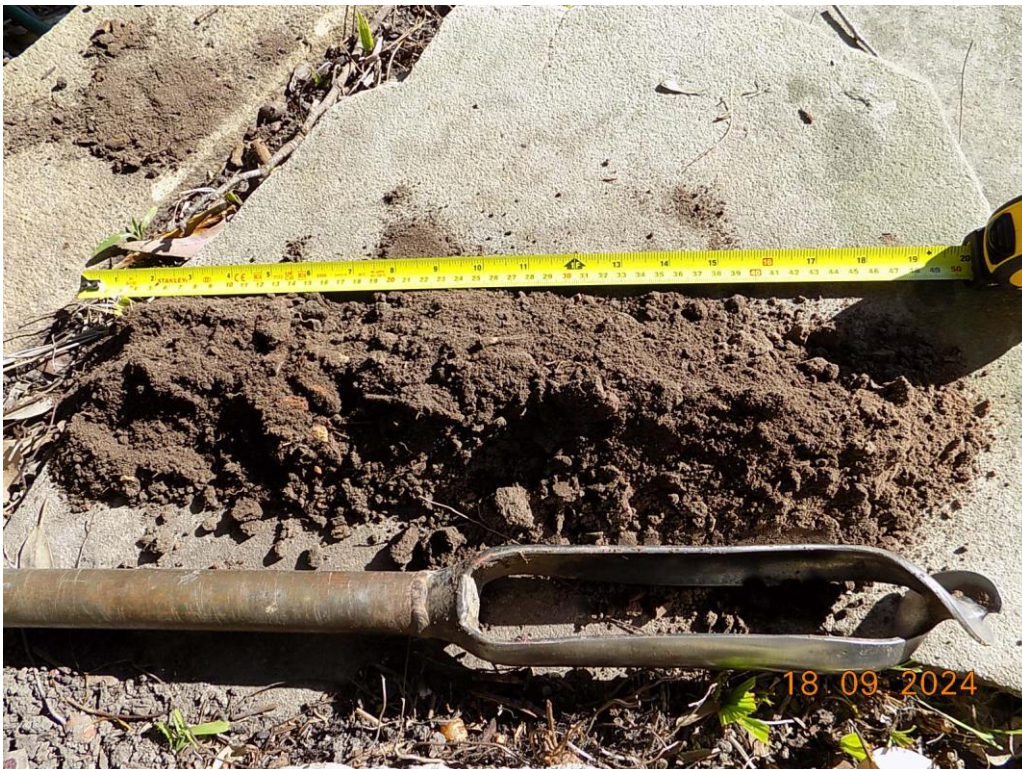
Photo 7

AUGER HOLE 1 (~RL34.1) – AH1 (Photo 7)

Depth (m)	Material Encountered
0.0 to 0.5	TOPSOIL , brown, Dense, dry, fine to coarse grained, fine organic content and rock fragments included.

Refusal @ 0.5m. Auger not progressing through dense topsoil. No water table encountered.

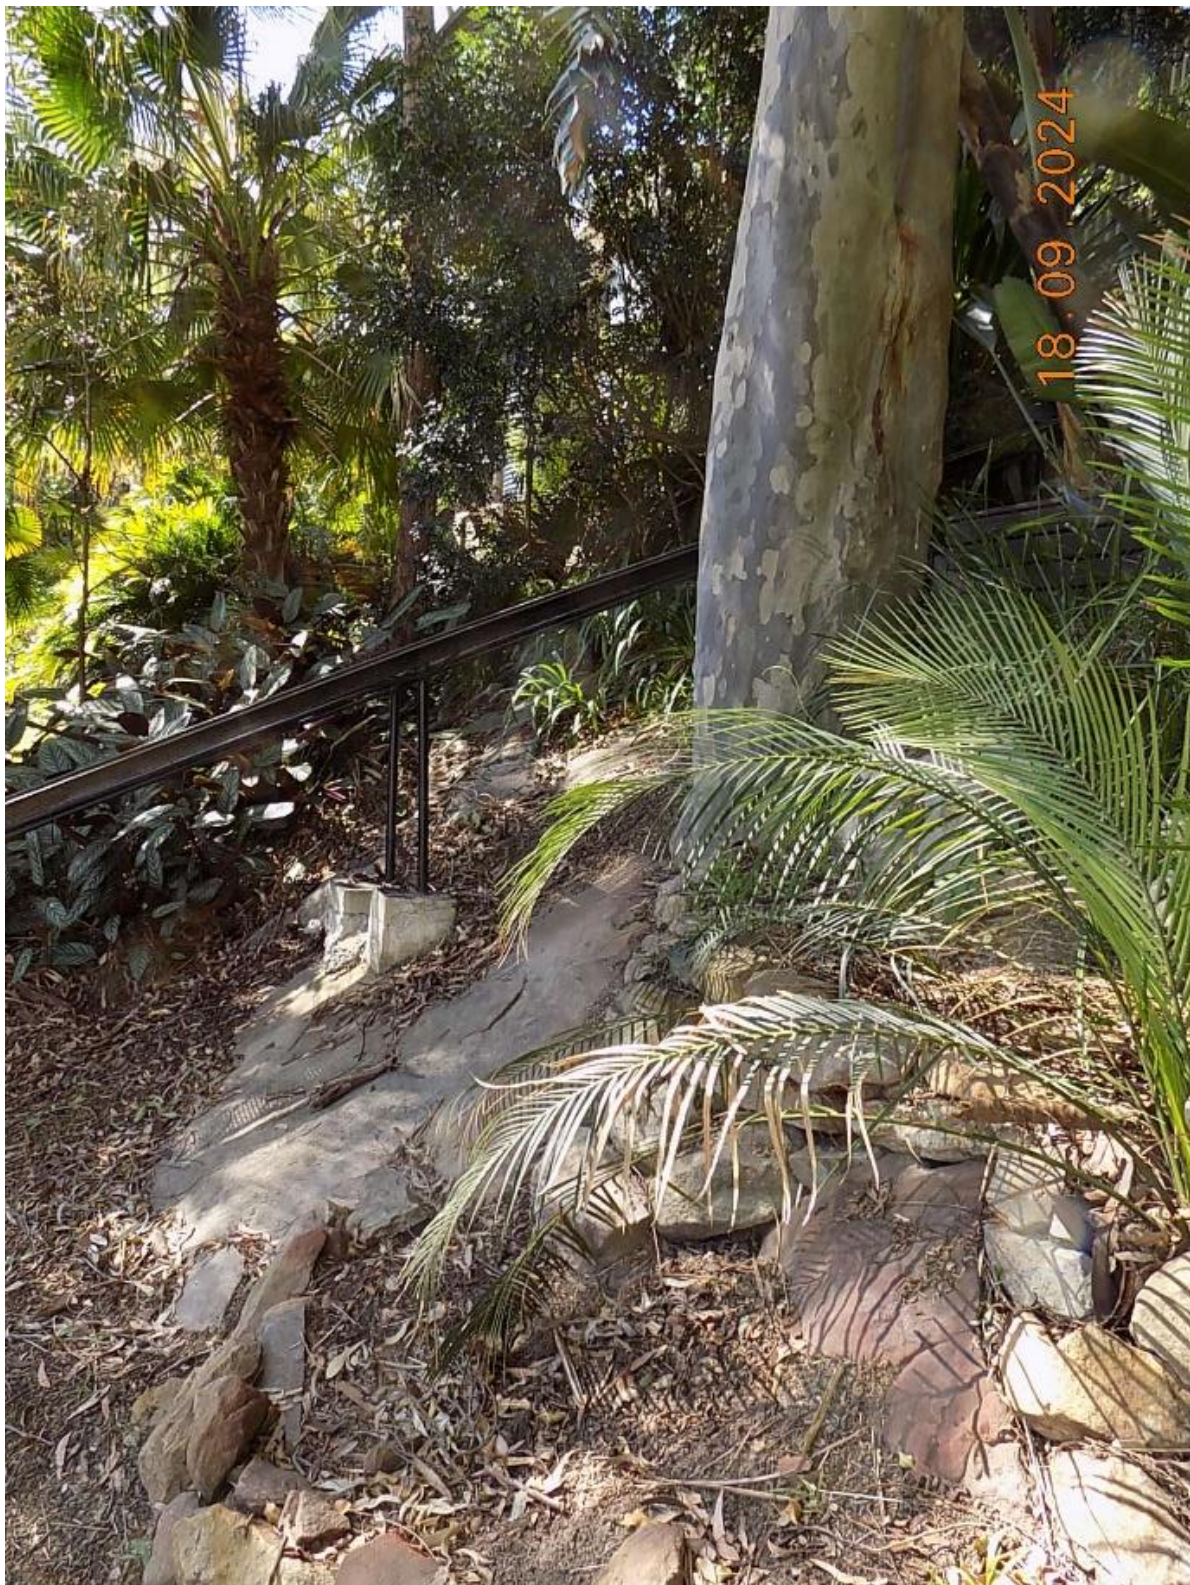
Photo 8

A Medium Strength Sandstone boulder appears to outcrop at the location of the cabana excavation (Photo 8). Excavations through Medium Strength Sandstone will require rock sawing and breaking.

The cut for the cabana will encounter a Medium Strength Sandstone boulder which has the potential to generate vibrations that may impact on surrounding structures.

The excavations for the proposed pool and cabana will reach a maximum depth of ~1.3m. Allowing 0.5m for back wall drainage, the excavations will be set back ~0.6m from a large eucalyptus tree on the uphill side of the proposed cut for the cabana (Photo 8).

The excavation margin is to be cut with a rock saw prior to any rock breaking with a pneumatic hammer up to 200kg. Provided this advice is carried out, vibrations from the excavation will not exceed tolerable limits for building or infrastructure damage.

The geotechnical consultant is to inspect the excavation for the cabana while the cut through the sandstone boulder is being made. This is to confirm the boulders thickness and stability during the works.

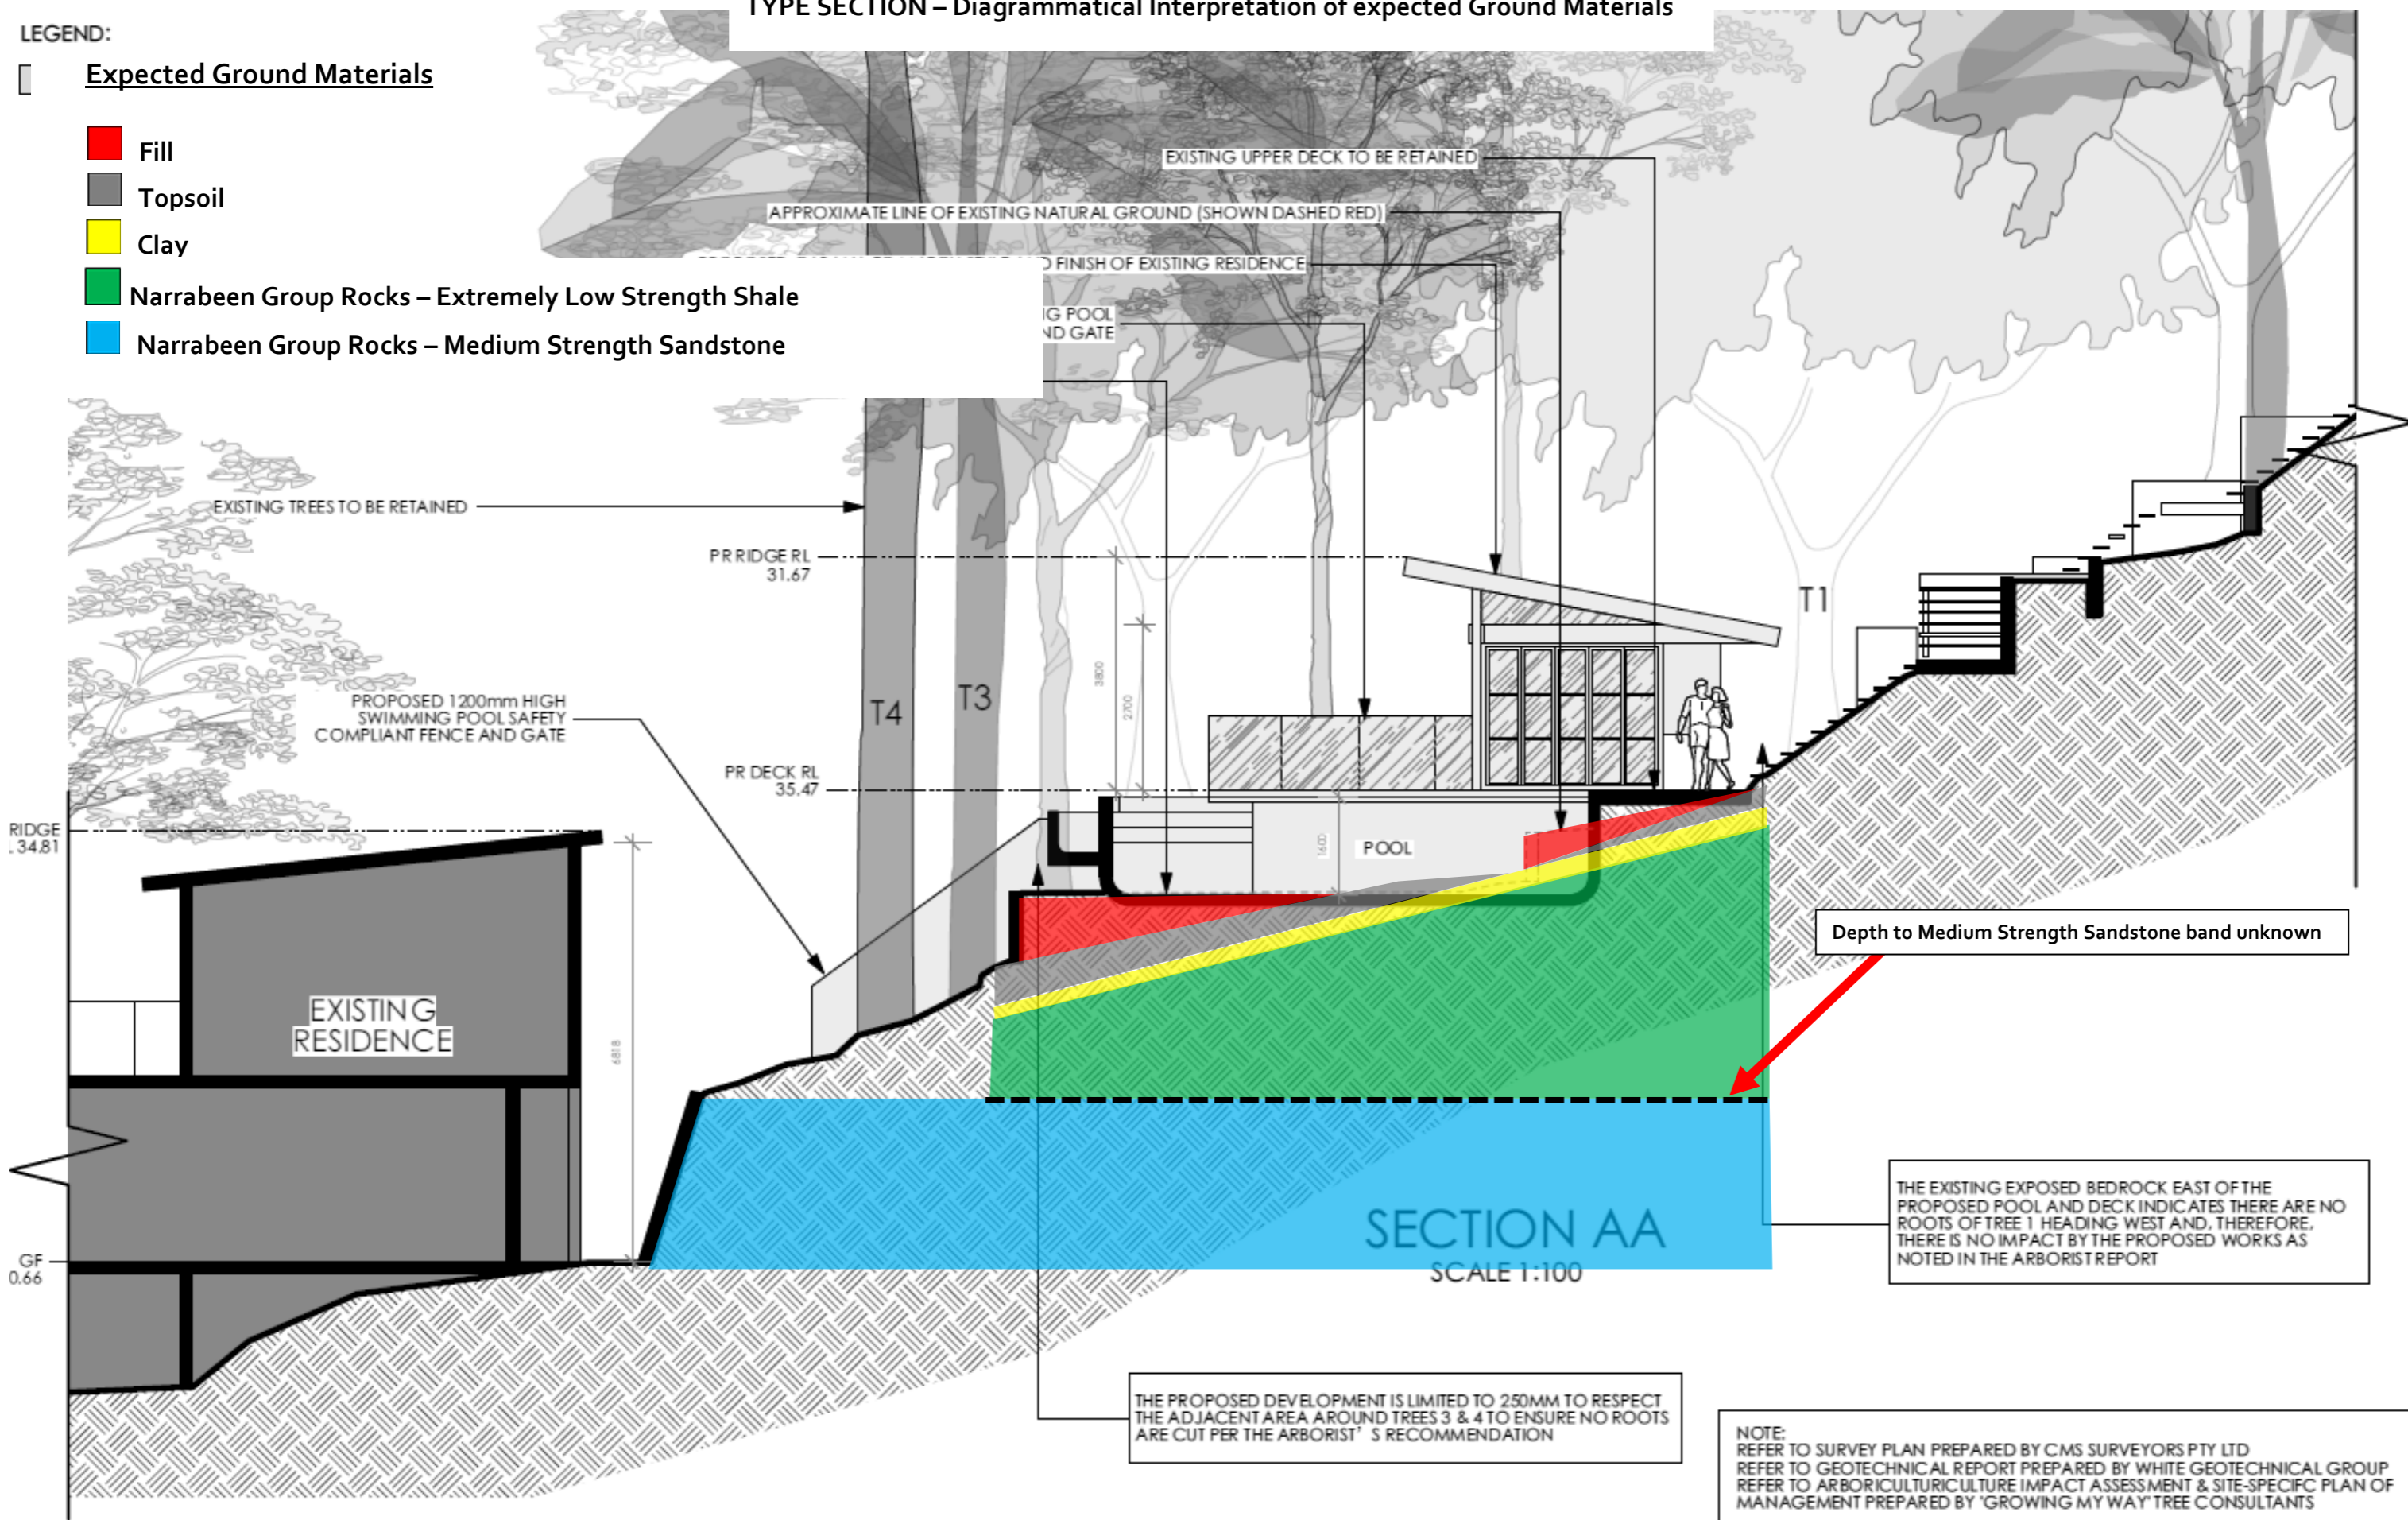
Expected Ground Materials

The natural slope materials are colluvial at the near surface and residual at depth. In the test locations, the ground materials consist of a topsoil over clays. Filling has been placed across the property for landscaping. The clays merge into the weathered zone of the underlying shale at depths of between 0.6m to 1.5m below the current surface being deeper due to the presence of filling and a variable weathering profile. The weathered zone is interpreted as Extremely Low Strength Shale. It is to be noted that this material can appear as a mottled stiff clay when it is cut up by excavation equipment. A band of sandstone immediately above the house can be seen outcropping through the otherwise shale-dominated profile. From our previous experience in the Narrabeen Group, it is likely any sandstone bands will be limited in thickness and extent. See Type Section attached for a diagrammatical representation of the expected ground materials.
