GEOTECHNICAL INVESTIGATION:

New Pool at 129 Upper Clontarf Street, Seaforth

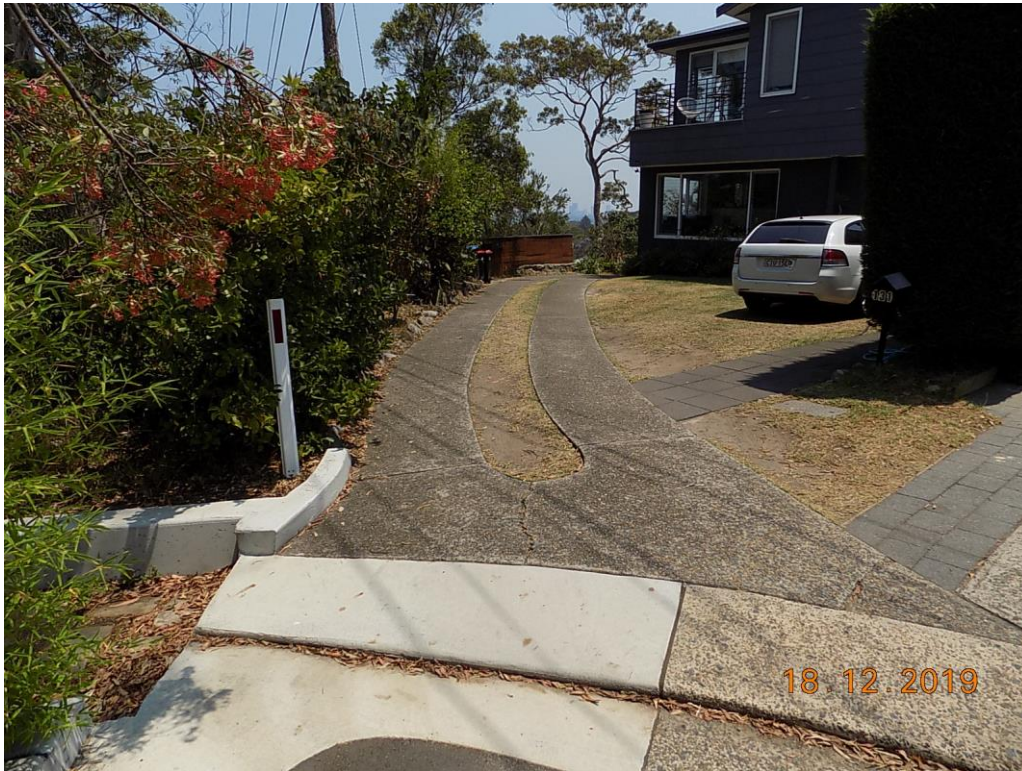
Photo 1

- 2.3** At the road frontage, a concrete driveway runs across the upper sandstone bench to a garage attached to the E side of the house (Photos 1 & 2). A sandstone cliff face falls from the downhill side of the driveway to a level lawn area at the lower common boundary (Photos 3 & 4). The cliff reaches a maximum height of ~6.0m. The majority of the cliff displays no significant geological defects. The W end of the cliff is undercut in two locations. The E location is undercut ~2.0m and has a relatively thin cantilever arm in relation to its overhang length (Photo 5). The undercut has been remediated in the past with three steel posts and a rough, stack rock blade wall. Only one of the steel posts still makes contact with the underside of the undercut joint block. This undercut is immediately adjacent to the proposed pool. See **Section 13** for recommendations regarding this undercut. The W location is undercut ~1.5m, has a
