Preliminary Geotechnical Assessment

Project: Alterations & Additions
22 Tobruk Avenue, Allambie Heights NSW

Ref: AG 24559
12 December 2024

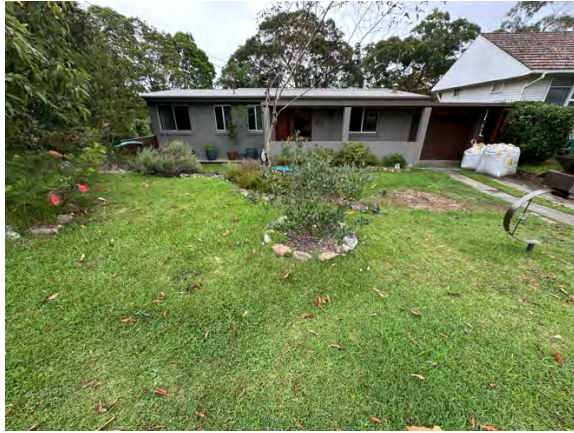
Photo 1: Frontage of the dwelling facing north-west.

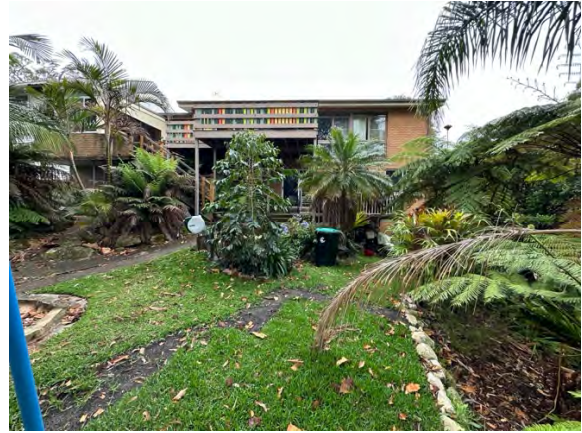
Photo 2: Rear of the dwelling facing south-east.

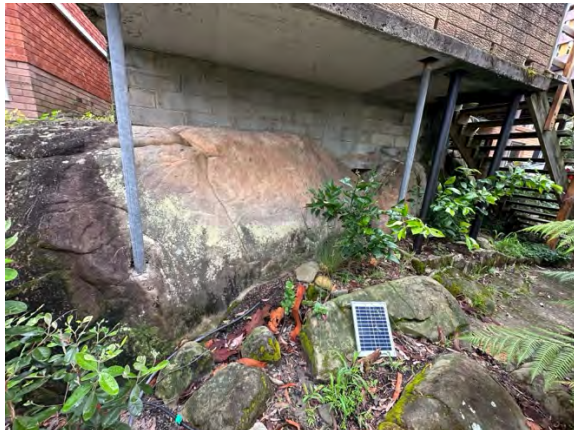
Photo 3: Outcropping sandstone bedrock under the existing dwelling.

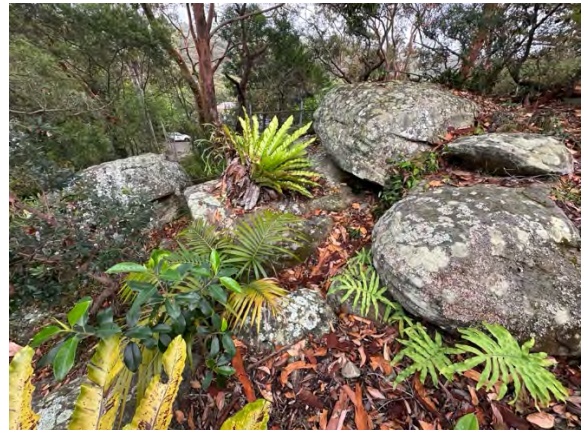
Photo 4: Highly weathered sandstone bedrock and detached floaters at the rear of the site.
