Preliminary Geotechnical Assessment

For Alterations & Additions at
63B Norfolk Avenue, Collaroy NSW

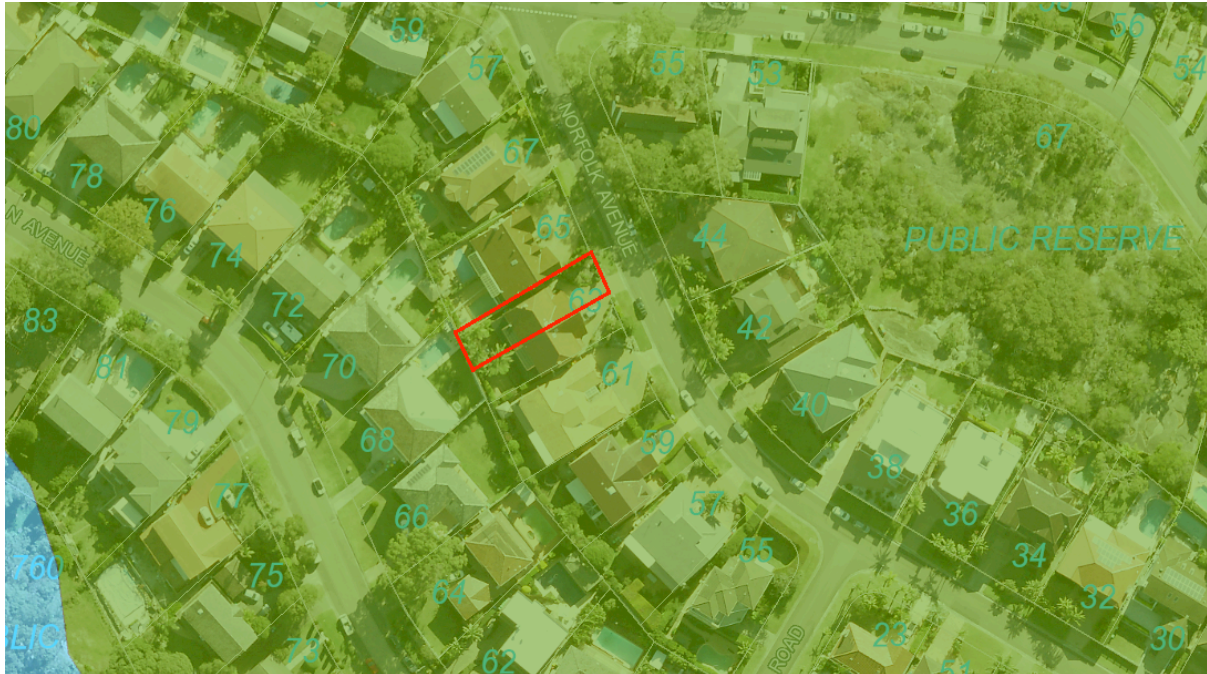
WARRINGAH LANDSLIP RISK MAP

The site is mapped as **Area D** on the Landslip Risk Map WLEP 2011 (**Image 1**, below).
