Report Title: Geotechnical Report 25 York Terrace, Bilgola Plateau
Report Date: 23/1/23

GEOTECHNICAL INVESTIGATION:

New House and Pool at 25 York Terrace, Bilgola Plateau

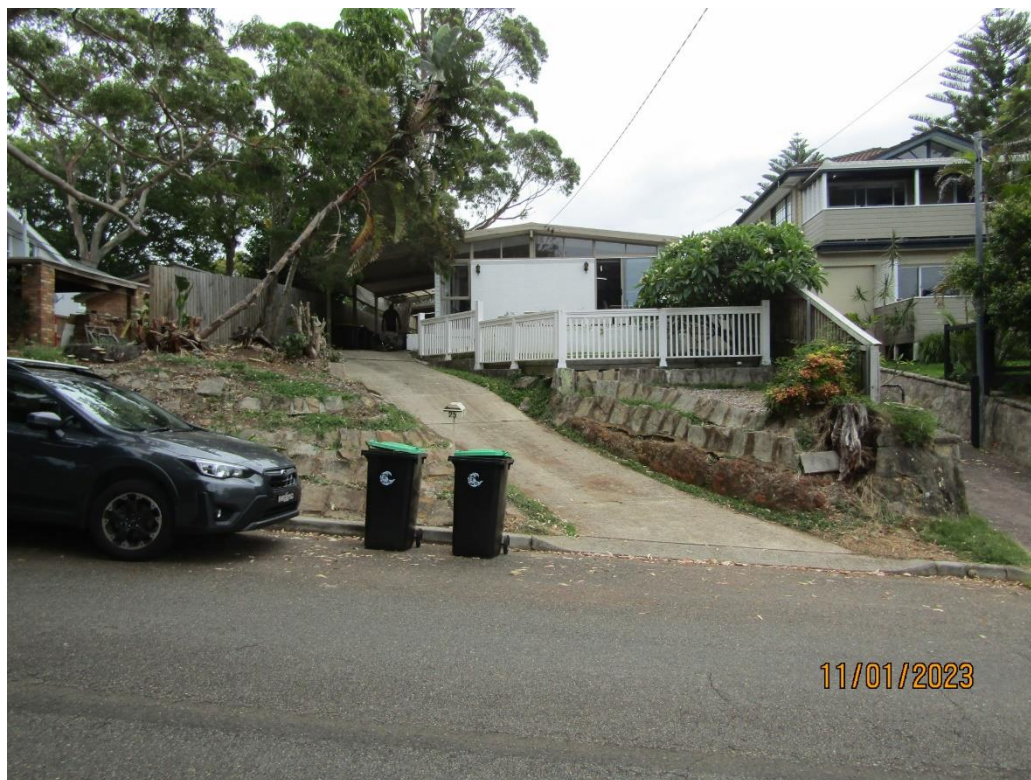
Photo 1

- 2.1** The site was inspected on the 11th January, 2023.
- 2.2** This residential property is on the high side of the road and encompasses the crest and flanks of a N-S trending ridge. The slopes below the property gradually increase in grade.
- 2.3** At the road frontage, a concrete driveway runs up and across the slope to a carport attached to the S side of the house and to a free-standing garage on the W side of the property (Photos 1 & 2). The slope between the road frontage and the house is terraced with a series of low stable retaining walls. A gently sloping lawn extends off the W side of the house to the W common boundary (Photo 3). The house,

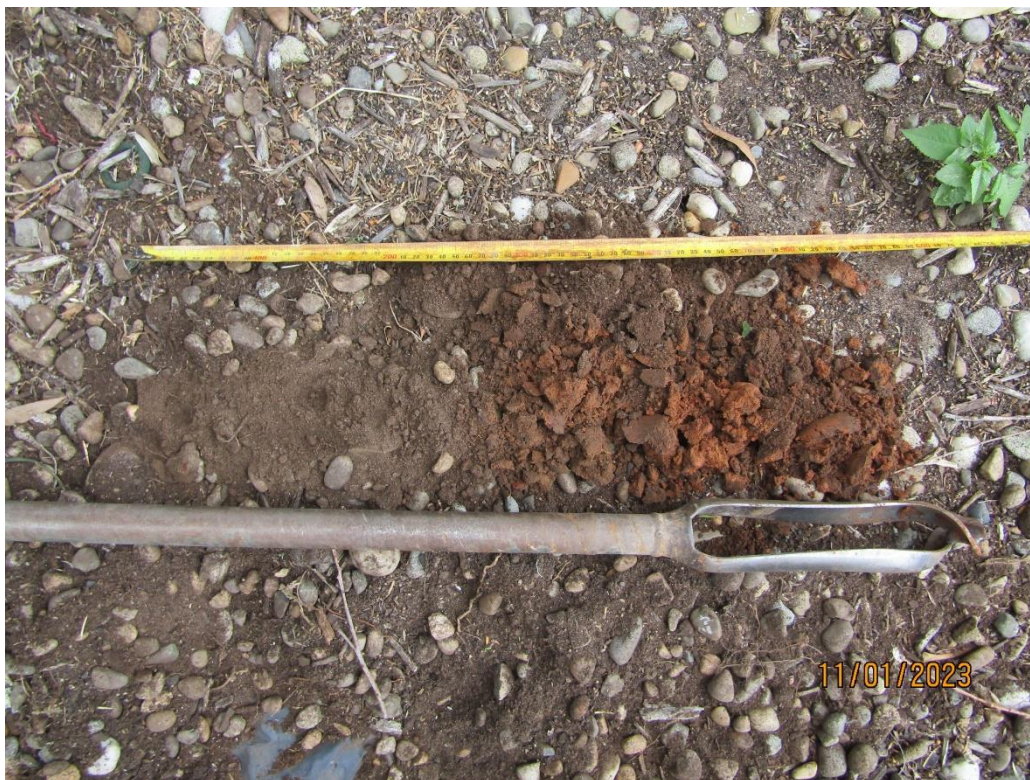
AUGER HOLE 1 (~RL144.0) – AH1 (Photo 4)

Depth (m)	Material Encountered
0.0 to 0.3	FILL , disturbed gravelly soil, dark brown, medium dense, dry, fine to coarse grained, with fine trace organic matter.
0.3 to 0.6	SANDY CLAY , dark orange, stiff, dry, fine to medium grained with fine trace organic matter.

Refusal @ 0.6m. Auger grinding on buried rock surface. No water table encountered.

Photo 4: AH1 – Downhole is from left to right

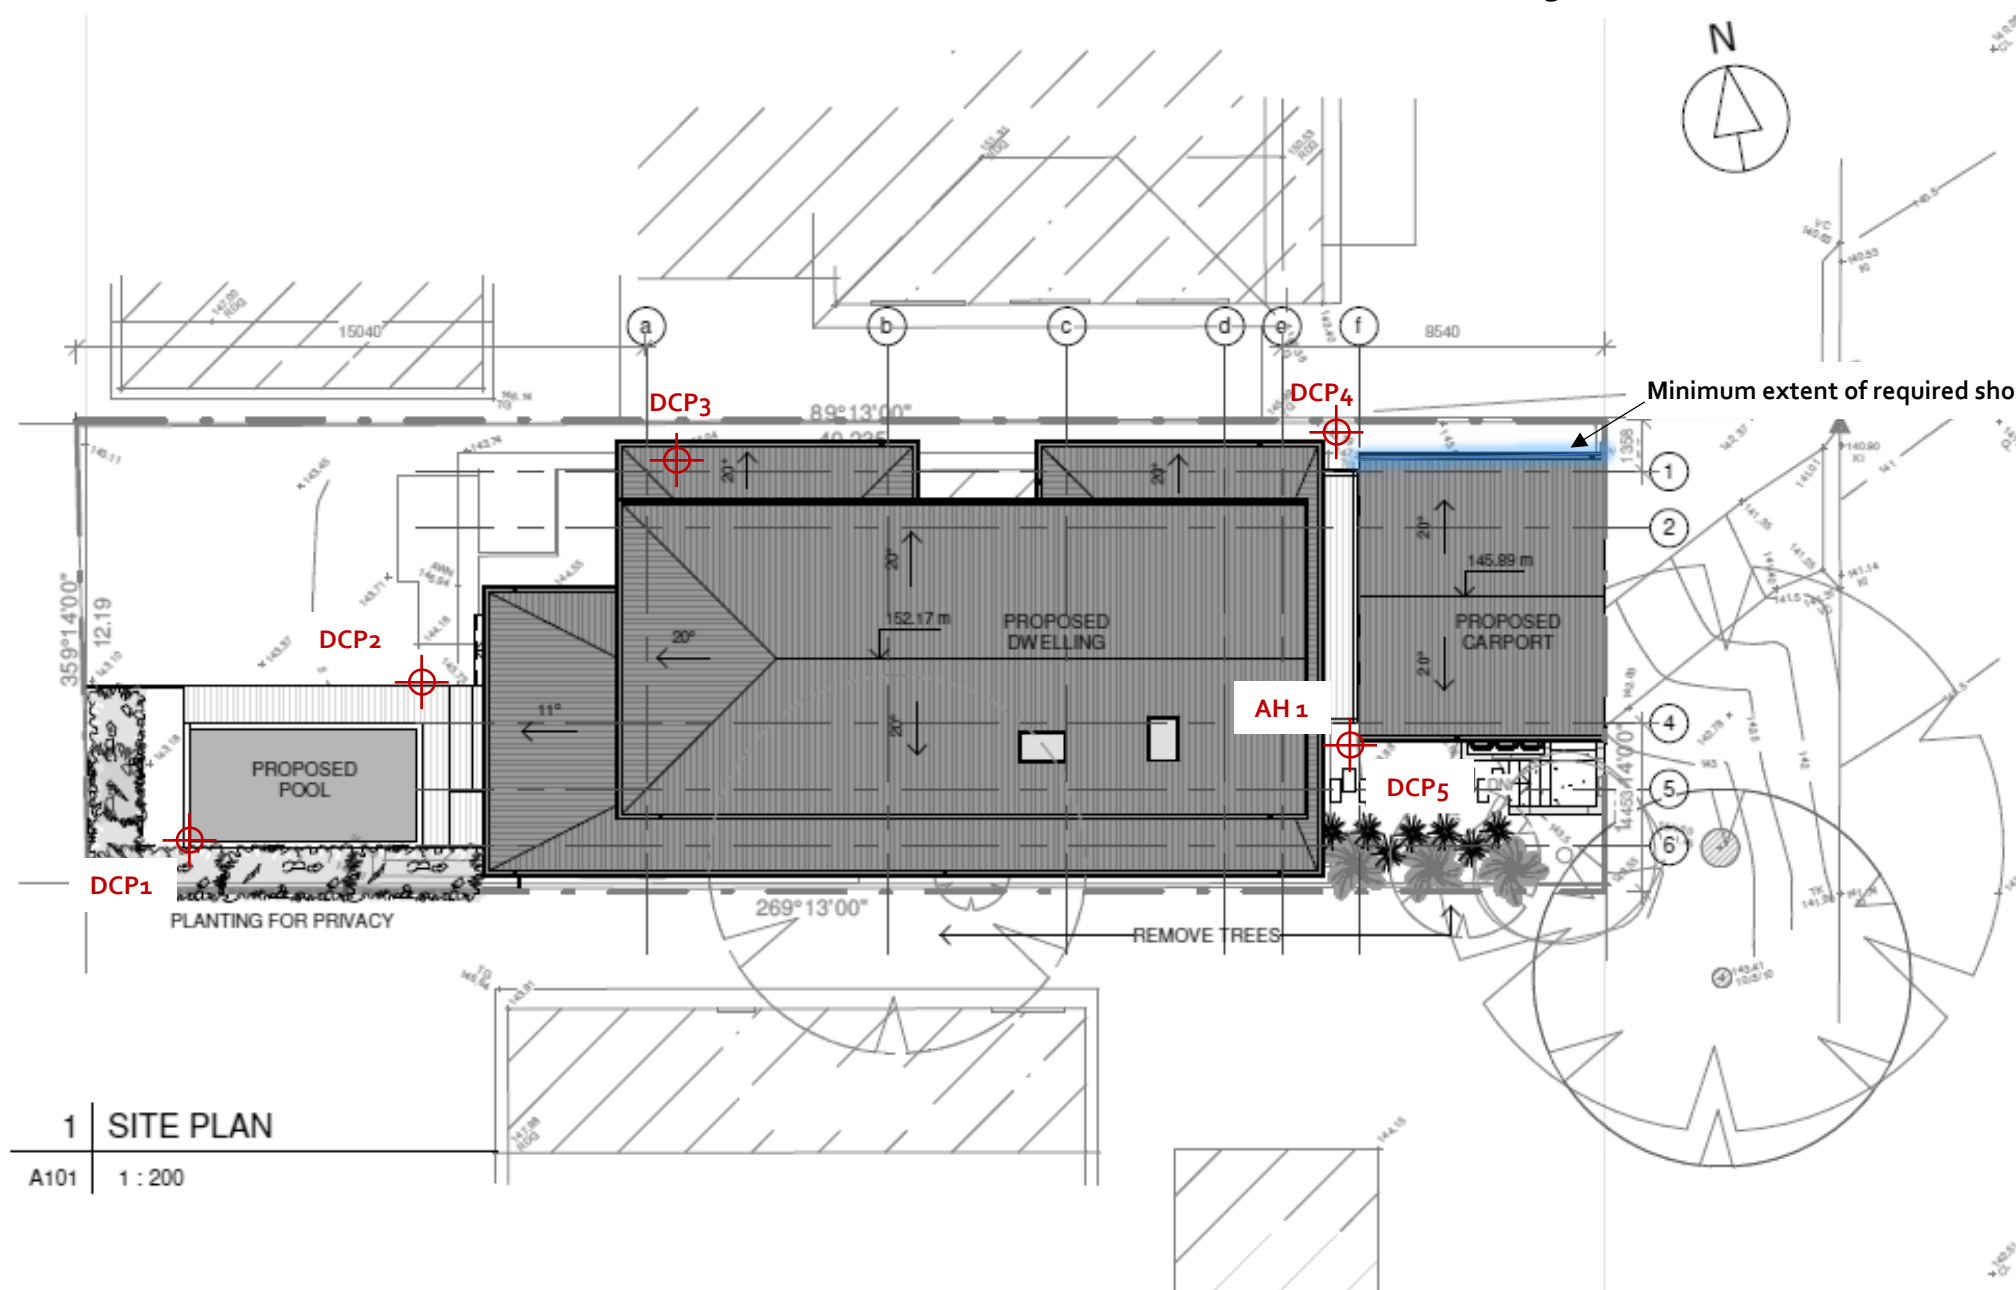
SITE PLAN – showing test locations

One hand Auger Hole (AH) was put down to identify the soil materials. Five Dynamic Cone Penetrometer (DCP) tests were put down to determine the relative density of the overlying soil and the depth to bedrock. The locations of the tests are shown on the site plan attached. It should be noted that a level of caution should be applied when interpreting DCP test results. The test will not pass through hard buried objects so in some instances it can be difficult to determine whether refusal has occurred on an obstruction in the profile or on the natural rock surface. This is not expected to be an issue for the testing on this site. However, excavation and foundation budgets should always allow for the possibility that the interpreted ground conditions in this report vary from those encountered during excavations. See the appended "Important information about your report" for a more comprehensive explanation. The results are as follows:

The cut is to be permanently or temporarily supported along the N side before the excavation through rock commences. The support is to be installed systematically as the excavation progresses to ensure the integrity of the neighbouring property into the future. If the support is temporary, it is to remain in place until the retaining wall is built as a sacrificial-type system. See the site plan attached for the minimum required extent of the shoring.

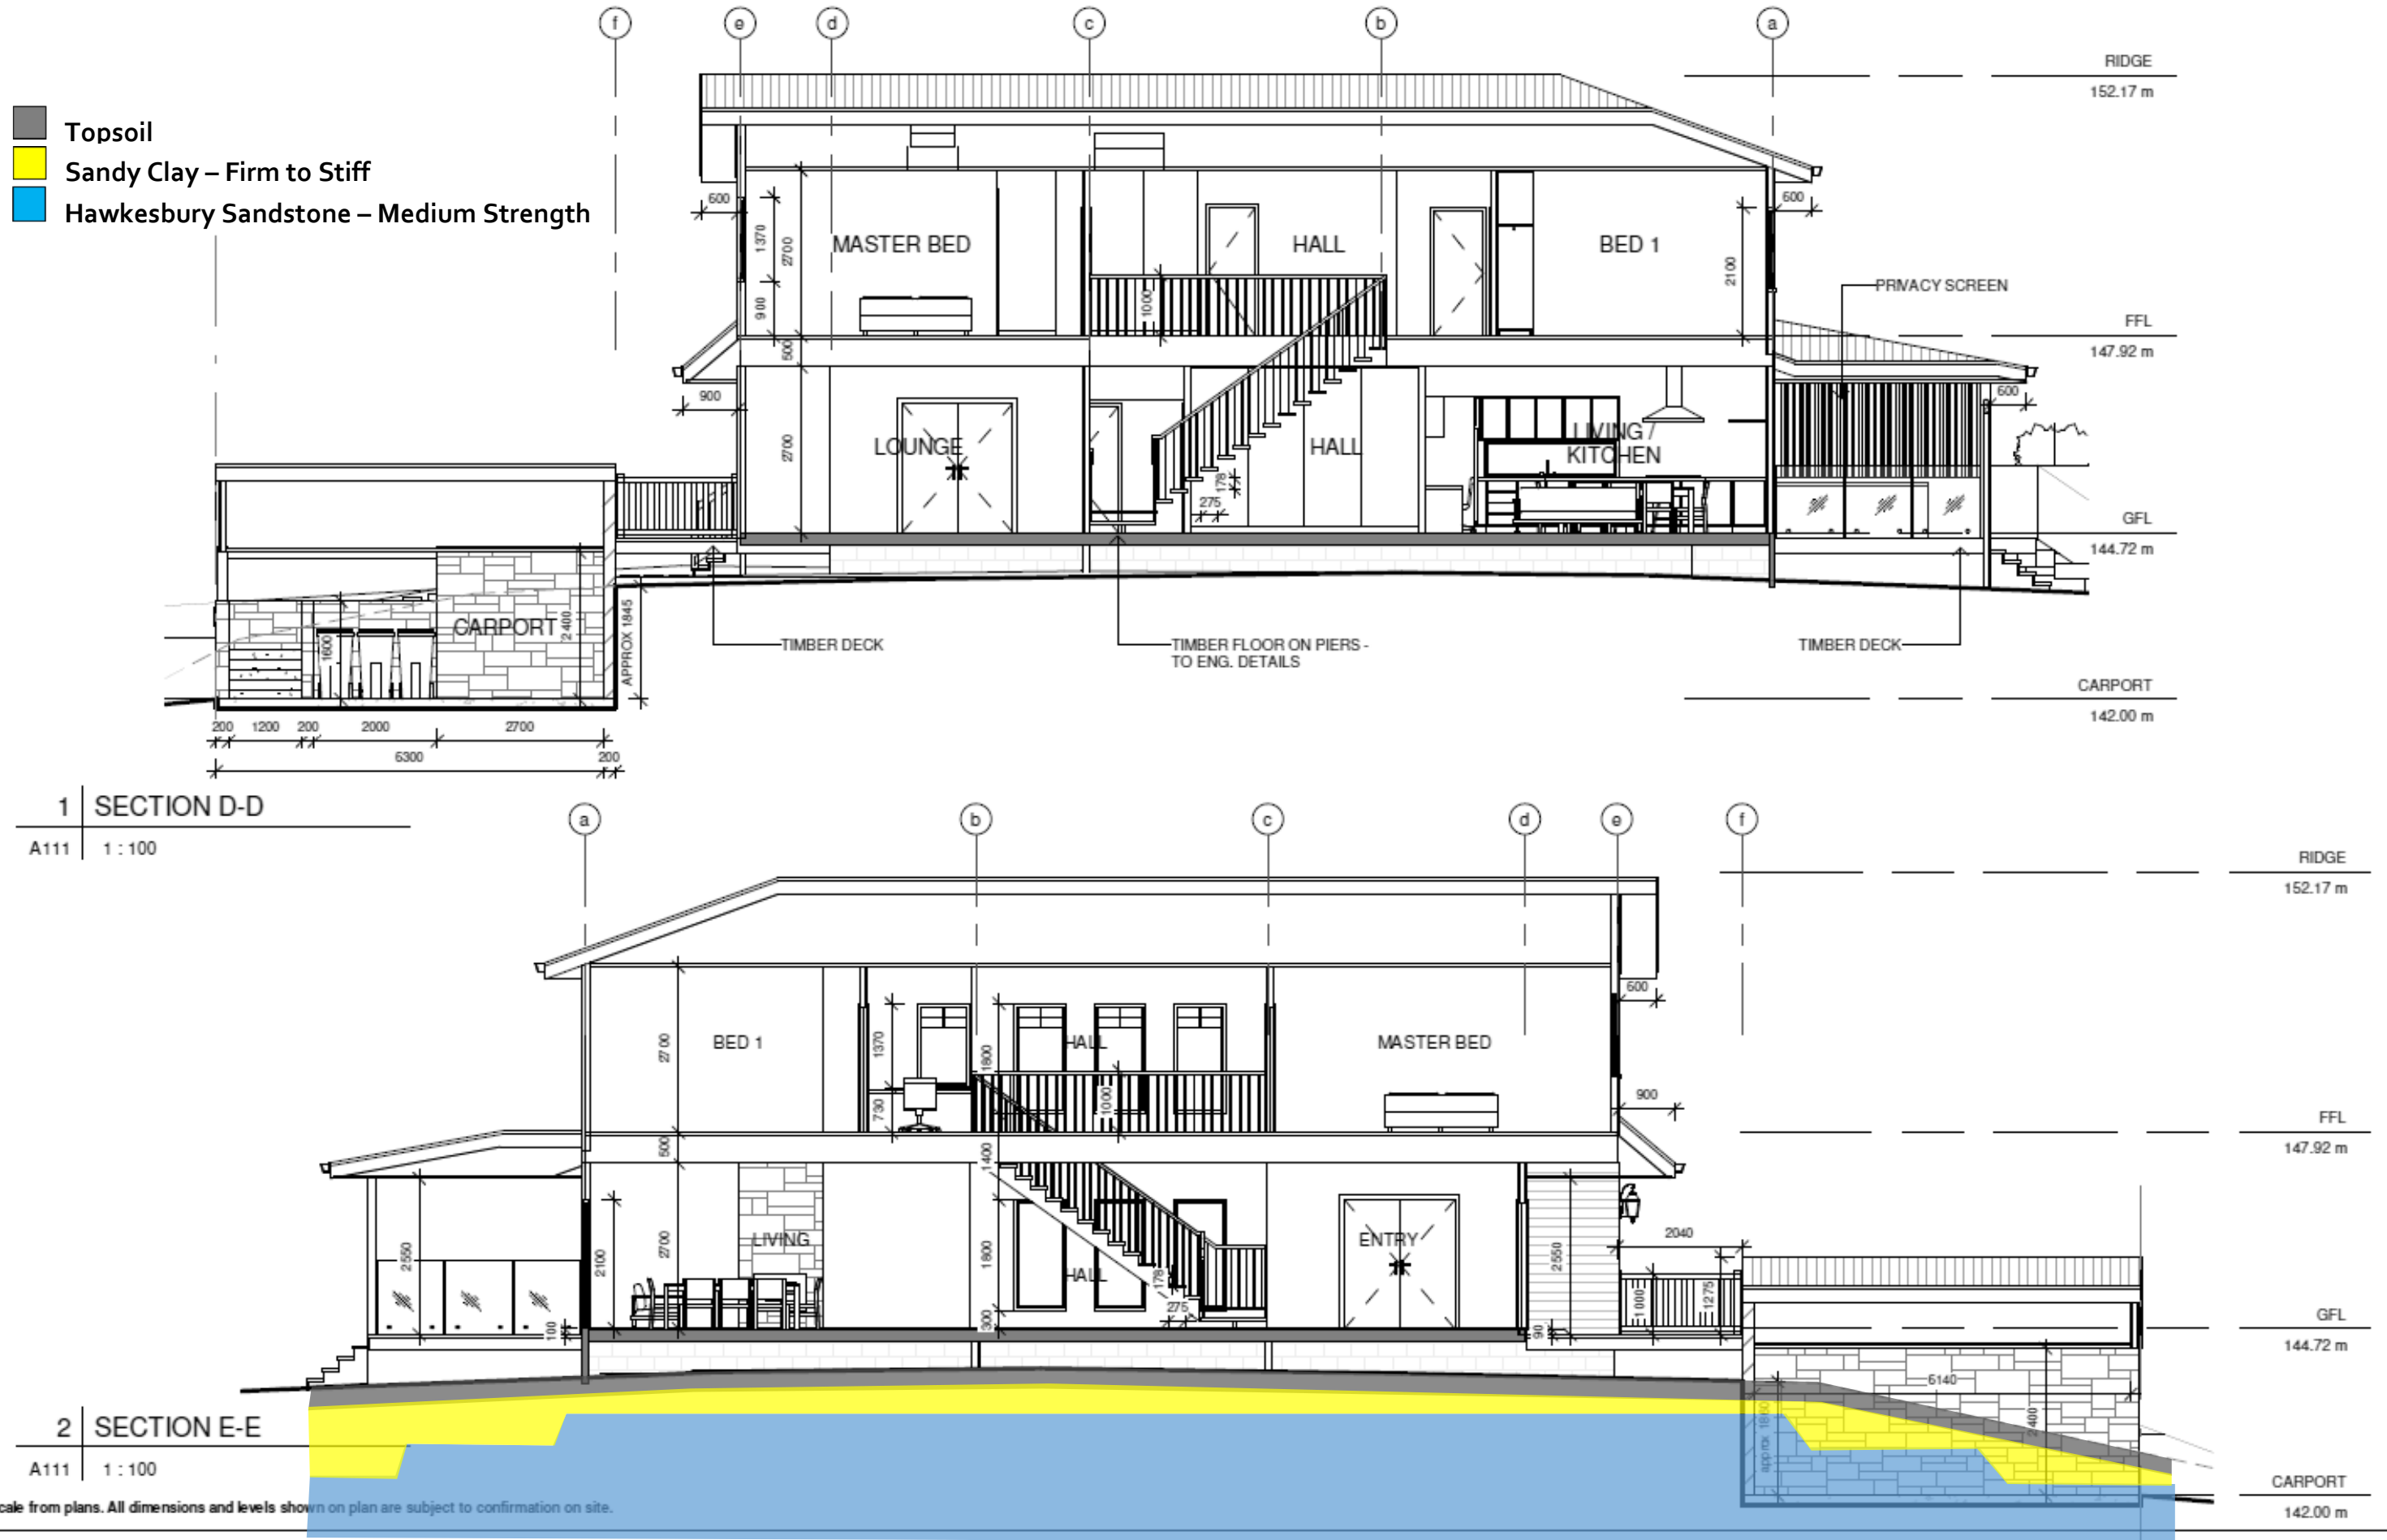
TYPE SECTION – Diagrammatical Interpretation of expected Ground Materials

The surface features of the block are controlled by the underlying sandstone bedrock that steps up the property forming sub-horizontal benches between the steps. Where the grade is steeper, the steps are larger and the benches narrower. Where the slope eases, the opposite is true. Where the rock is not exposed, it is overlain by a thin sandy soil over sandy clays that fill the bench step formation. In the test locations, the depth to rock ranged between 0.6 to 1.4m below the current surface, being slightly deeper due to the stepped nature of the underlying bedrock. DCP3 was most likely taken through a joint in the rock as it reached a much greater depth than the other tests. The sandstone underlying the property is estimated to be Medium Strength or better as most of the DCP tests encountered refusal at the end of the tests. A similar strength rock is expected to underlie the entire site. See Type Section attached for a diagrammatical representation of the expected ground materials.

- Topsoil
- Sandy Clay – Firm to Stiff
- Hawkesbury Sandstone – Medium Strength
