# Geotechnical Site Investigation

Lot. 40 / DP15762

136 Narrabeen Park Parade

Mona Vale NSW 2103

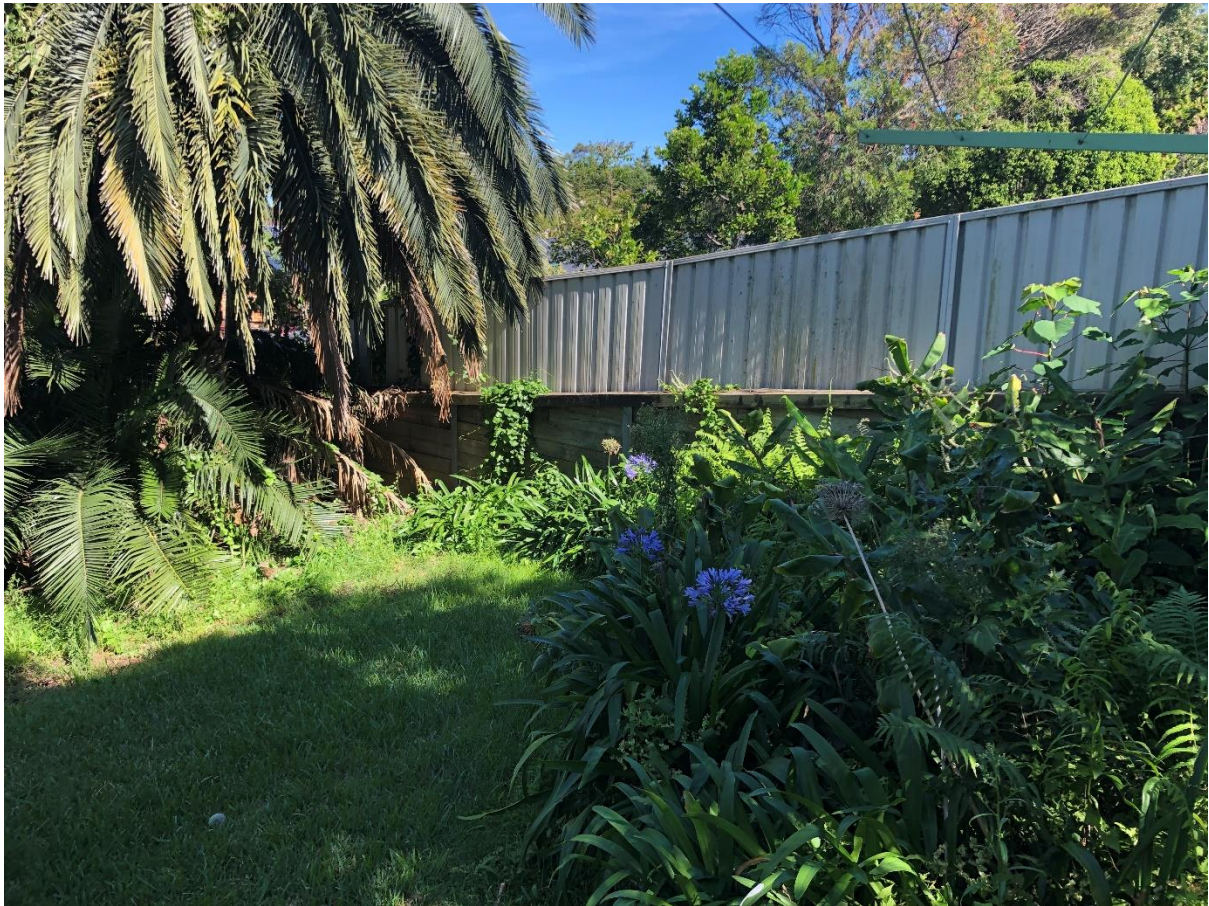
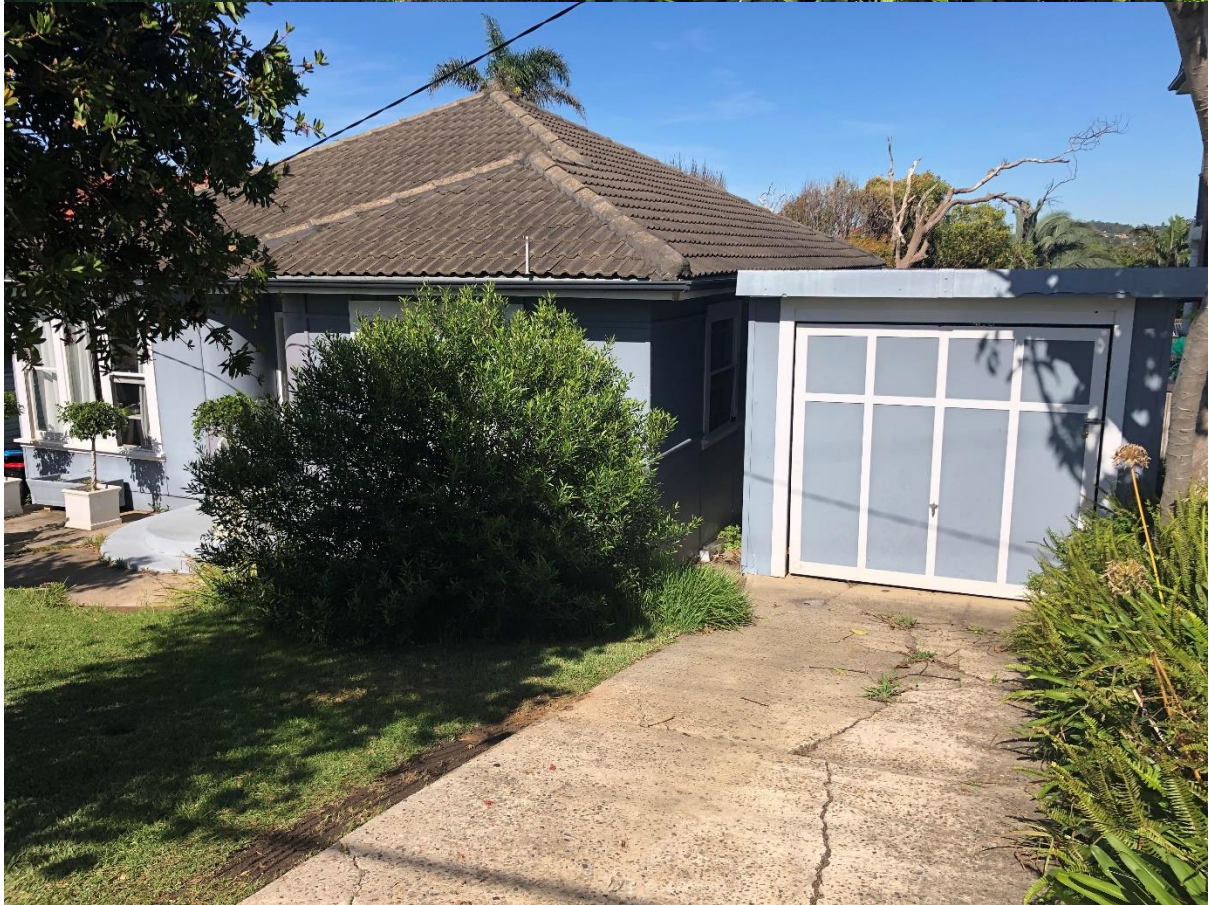
### Site Photography

The site is bound by Narrabeen Park Parade to the north east, and by residential dwellings to the north, south and west. At the time of the initial investigation, the site was occupied by a single storey residential dwelling with detached carport. The site slopes down toward the south west. A brick retaining wall was present along the north western boundary of the site, near the existing driveway. The retaining wall appeared to be in a good condition.
