# STRUCTURAL REPORT

*for the garage at  
81 Sydney Road,  
MANLY.*

<b>Reference Number:</b>	<i>RD: 2018/114-STR-RPT.1</i>
<b>Date Inspected:</b>	<i>Monday 16<sup>th</sup> July 2018</i>
<b>Date Prepared:</b>	<i>Wednesday 1<sup>st</sup> August 2018 Amended Friday 26<sup>th</sup> October 2018</i>
<b>Prepared for:</b>	<i>Link Housing</i>
<b>Prepared by:</b>	<i>Law &amp; Dawson Pty Ltd Consulting Structural &amp; Civil Engineers</i>
<b>Contact details</b>	
<b>Address</b>	<i>Suite 3 (1<sup>st</sup> Floor) 448 Pacific Highway ARTARMON NSW 2064</i>
<b>Phone</b>	<i>(02) 9419 3511</i>
<b>Fax</b>	<i>(02) 9419 6040</i>
<b>Email</b>	<i>enquiries@lawdawson.com.au</i>

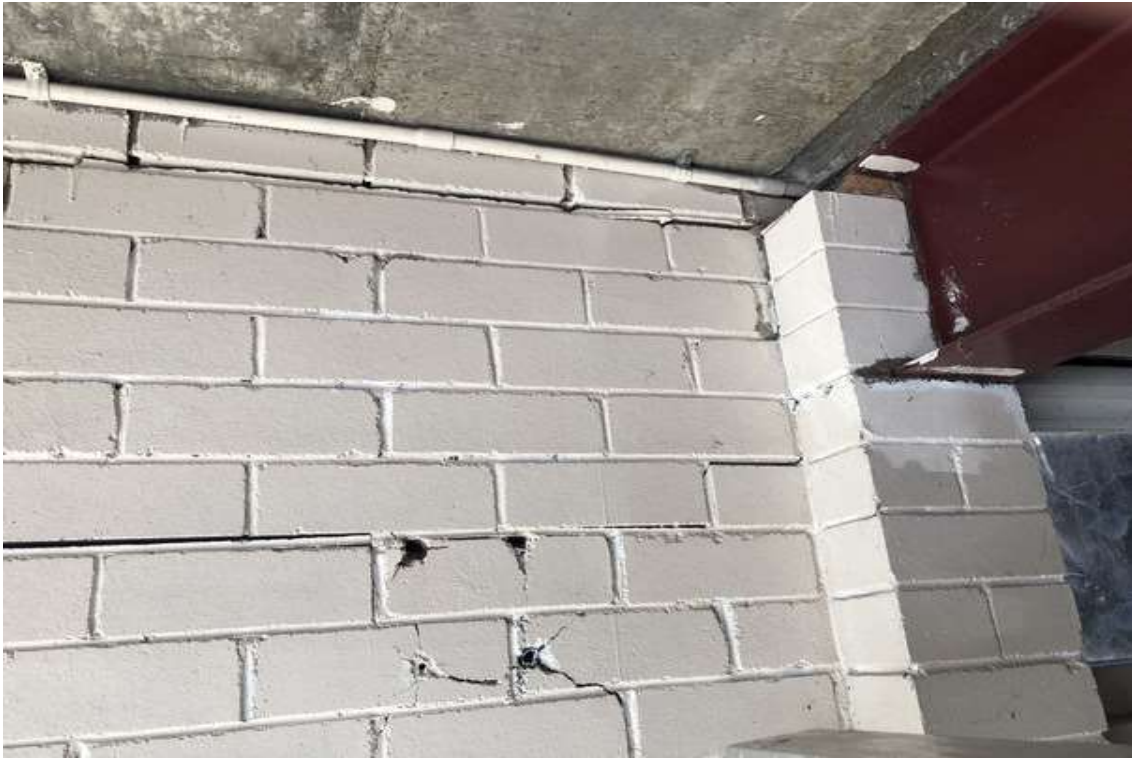
Photo (1):

Photo Number	Description
1,2,3,4,5,6,8,9,18,19,20, 21,22,23,25,26,38,39,40	Cracks in wall
1,6,14,41	Corroded steel beams
7,8	Damaged render to roof slab

- ii) The eastern and western garage masonry walls retain soil between 800mm and 1,300mm high. This soil pressure loading has caused masonry cracking in the masonry walls – refer to photos 1, 2.

- iii) The eastern retaining wall has also suffered horizontal cracking at the top of the wall, which appears to be the result of corrosion of the centre and front steel beams where they are embedded in the masonry wall – refer to photos 1, 2, 3, 4, 5, 6, 7, 18, 38, 41.

In our opinion, both the eastern and western garage walls should be demolished and re-constructed using reinforced concrete (or reinforced blockwork) walls to resist the soil pressure loading.

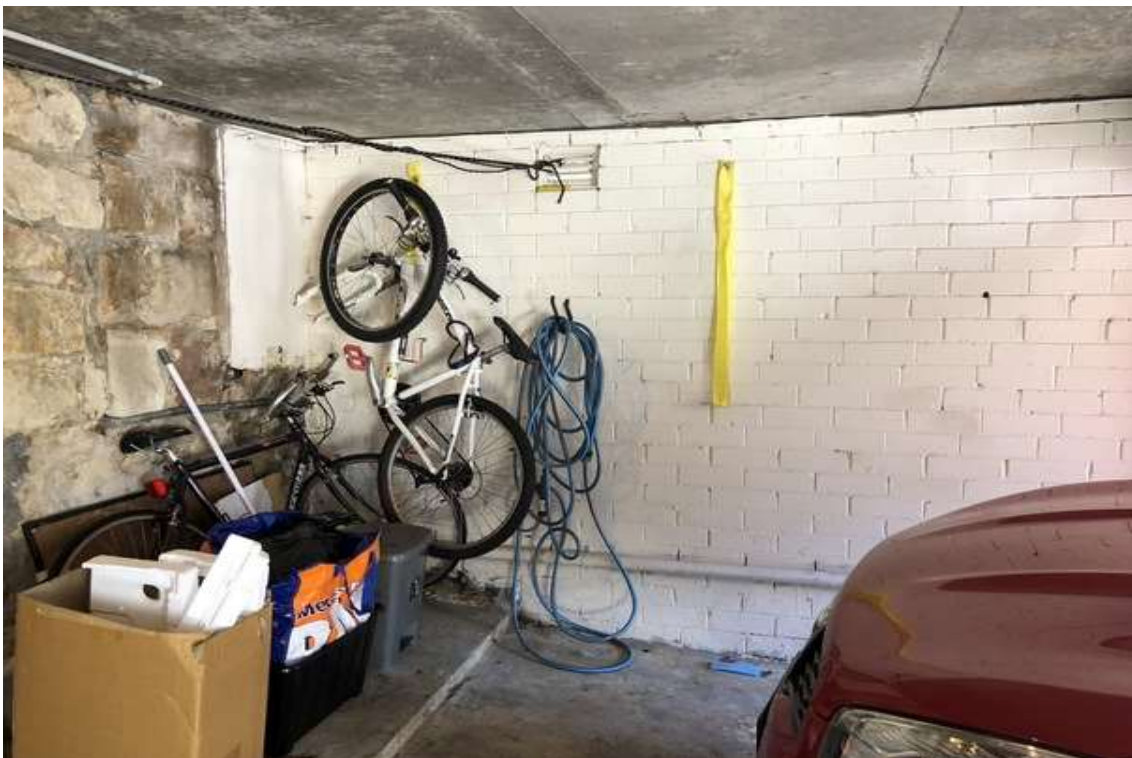
Photo (10):

Photo Number	Description
10,11,12,13,14,15,16,17	Cracks in wall

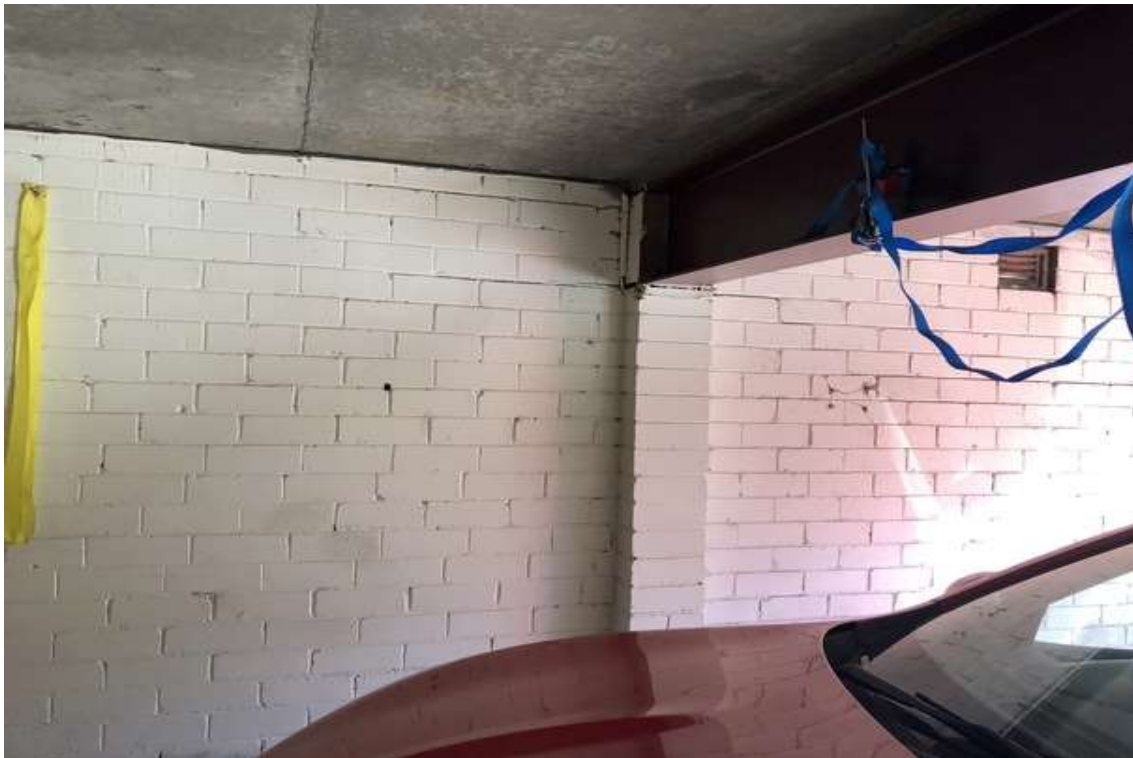
Photo (11):

- iv) The western garage wall has similar masonry cracking which is also due to its corrosion of the steel beams where they are embedded in the masonry wall. Refer to photos 11, 12, 13, 14, 15, 16, 17, 18, 19, 20, 22, 23. Structural integrity rating = 2.2.
- v) The steel beam which is located above the garage door has suffered extensive corrosion along its length due to its exposure to the elements, and it not being appropriately treated against corrosion. Structural integrity rating = 2.2.
- vi) The existing walls are founded on bedrock which is exposed beneath the rear eastern garage wall. Consequently, foundation settlement is not a cause of any of the defects.

Therefore, these beams will need to be removed and replaced with similar steel beams appropriately treated and protected from the elements, to prevent corrosion.

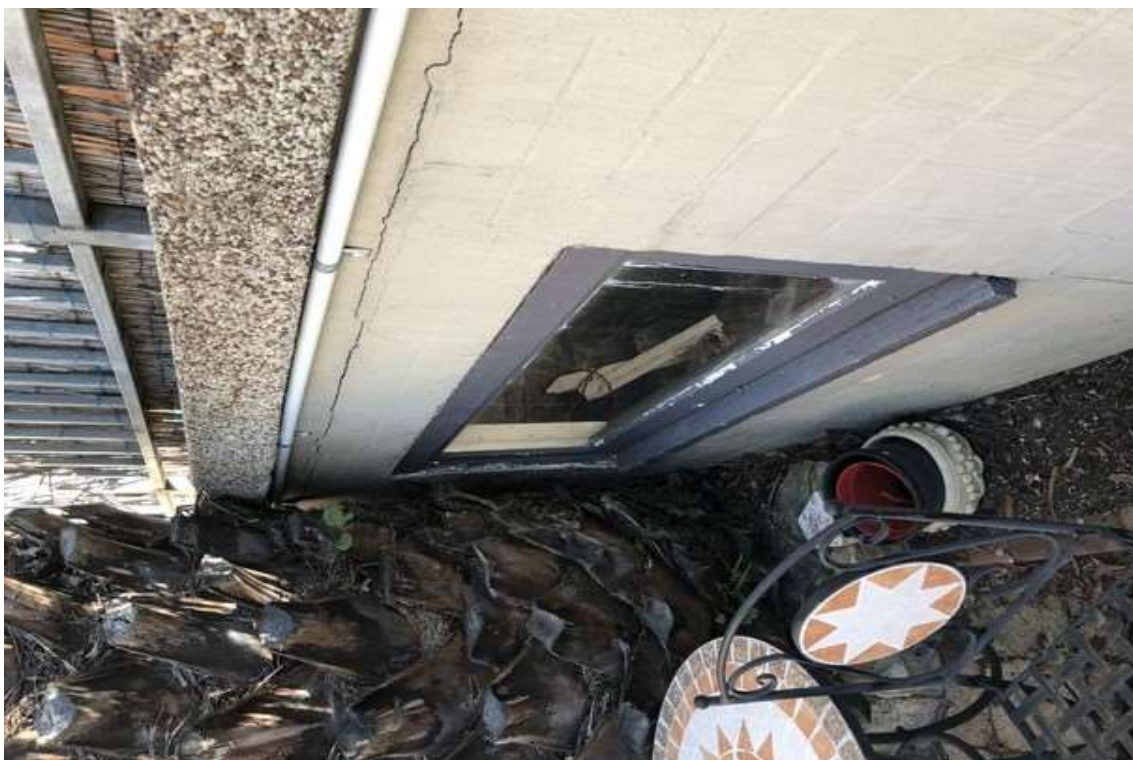
Photo (18):

Photo Number	Description
18,26,27,28	Tree against garage wall
29,30	Structure above garage slab
31,32,33,34,35	Sandstone foundation wall to building, at rear of garage
36,37	Street elevation

- i) The rear eastern masonry wall adjacent to the palm tree has suffered cracking and has an excessive 'bow' inwards. This 'bow' and localised masonry stepped cracking mid height in the wall is obviously caused by the roots of the palm tree applying lateral pressures against the masonry wall – refer to photos 18, 19, 21, 26, 27, 28, 39, 40. Structural integrity rating = 1.0.

The palm tree can then be removed, which will most probably require the removal of the brickwork retaining walls and paving to the landing adjacent to the tree.

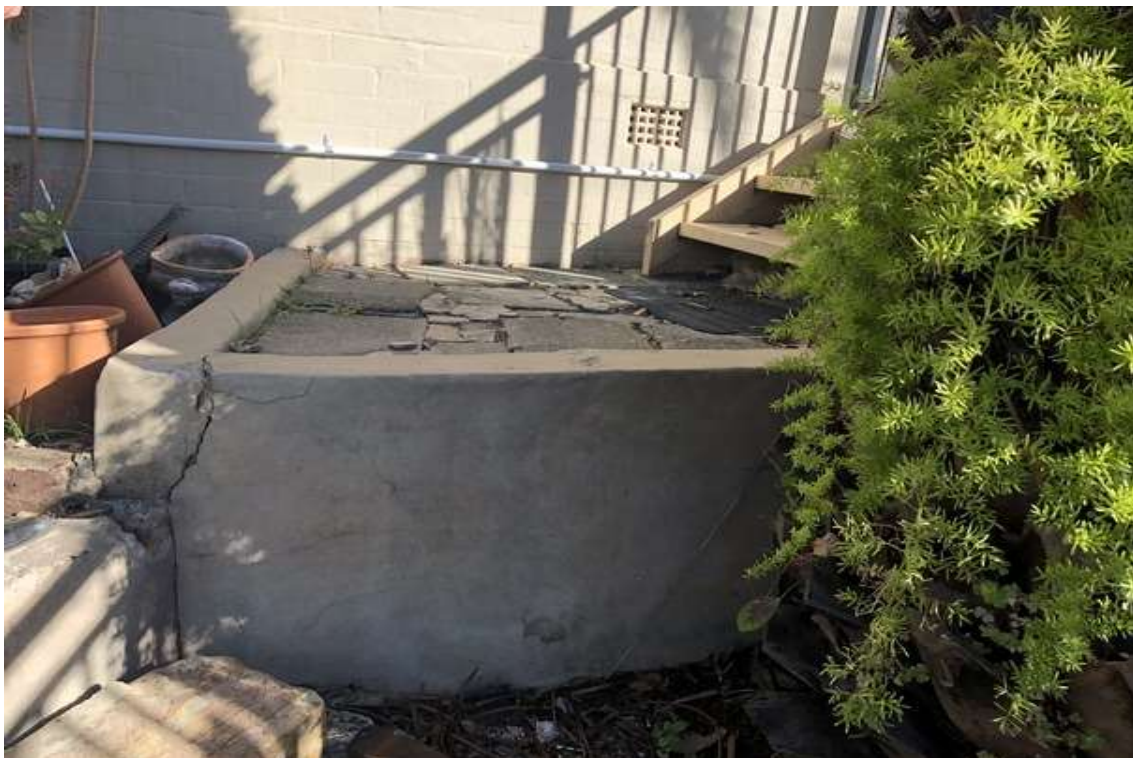
Photo (24):

Photo Number	Description
24	Cracks in wall
25	Pavers have settled

This landing can probably be re-built using timber framed construction.

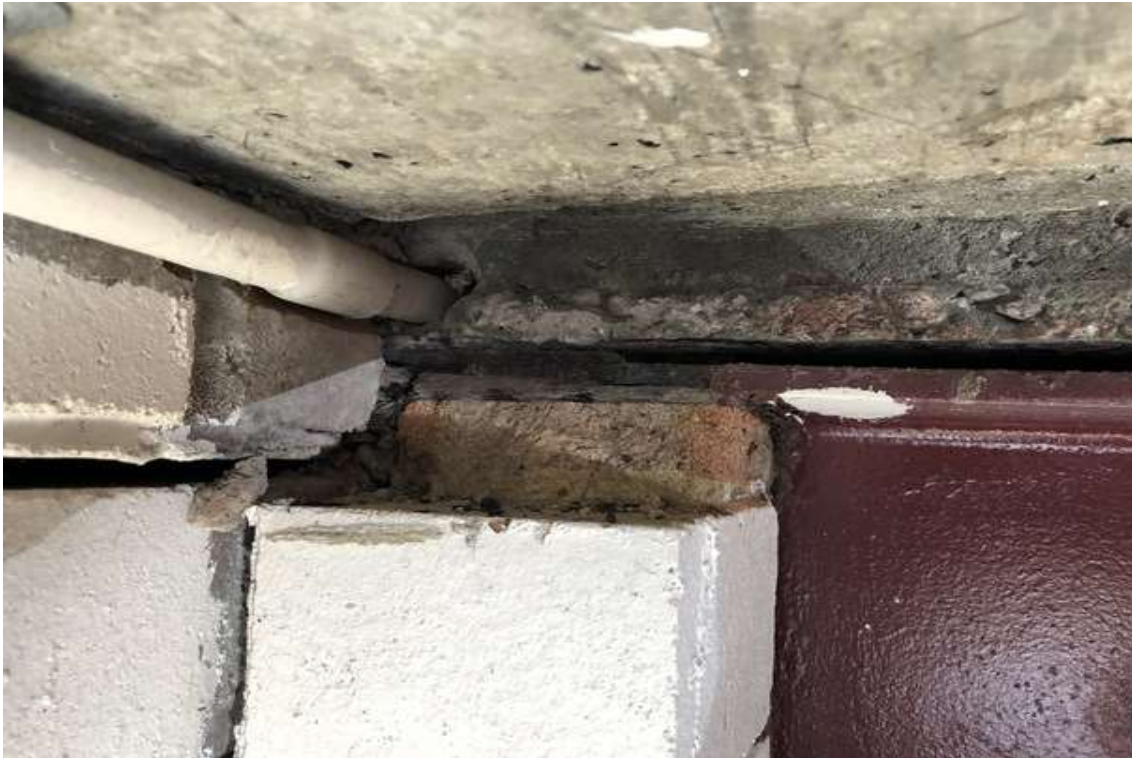
Photo (41):

This corrosion has cracked and raised the masonry wall and garage roof slab by approximately 10mm – refer to photo 41. Structural integrity rating = 2.2.

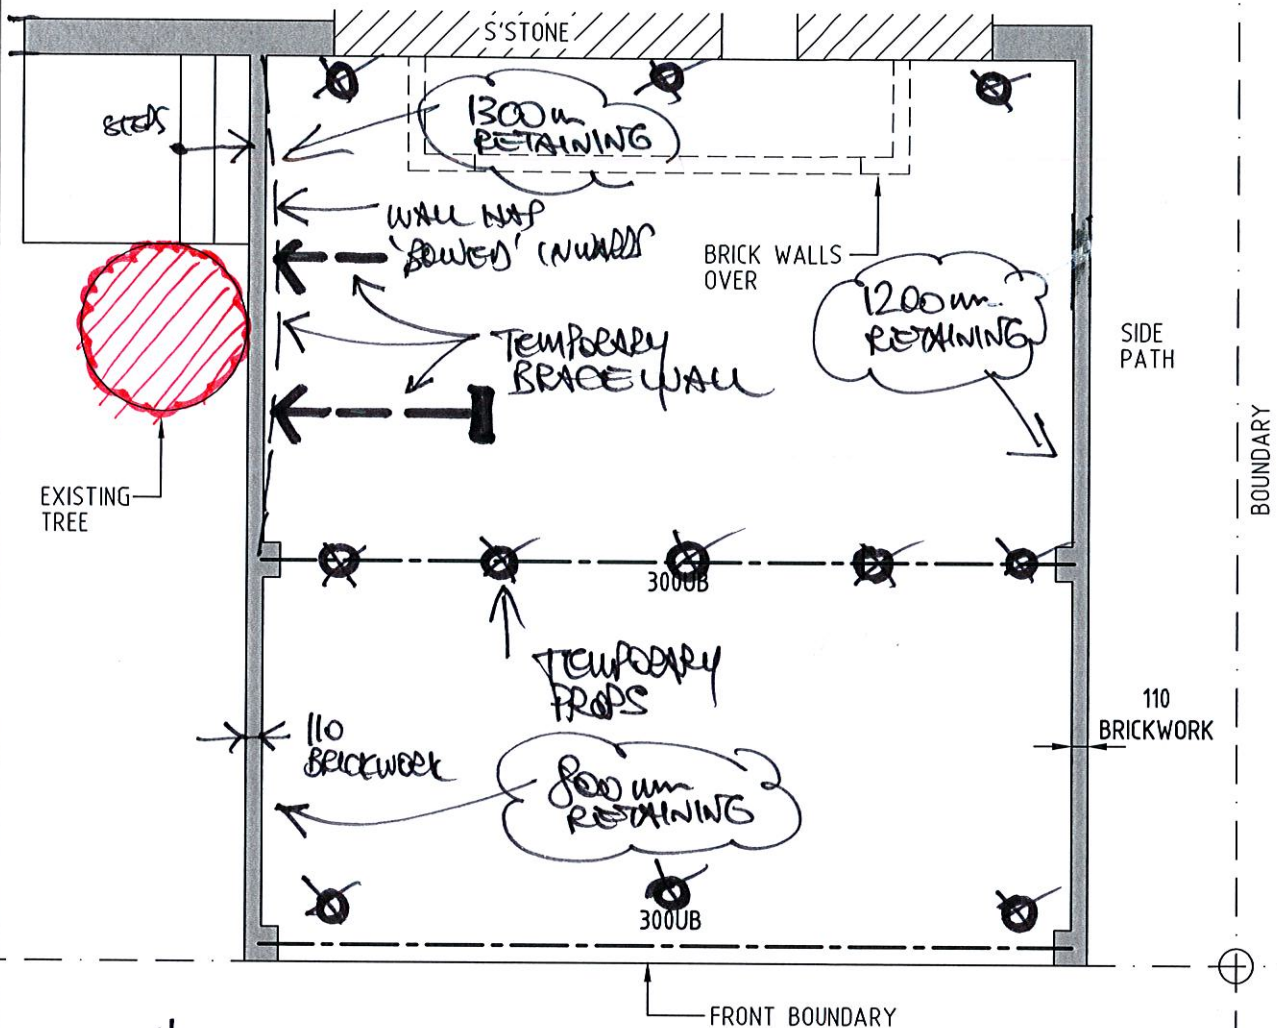
## GARAGE FLOOR PLAN

As discussed on site on 16<sup>th</sup> July, we recommend that the existing garage roof slab be temporary propped and the 'bowed' wall temporary propped as soon as practicable – refer to the attached sketch.

The stability of the eastern brick wall is of concern, due to the adverse effects of the soil pressure loading and the existing tree.

- ① PROVIDE TEMPORARY PROPS TO SUPPORT EXISTING BEAM & ROOF SUR. (20kN CAPACITY PROPS EACH)
- ② TEMPORARY BRACE 'BOWED' WALL WITH 20kN CAPACITY PROPS & WALL PLATE BOLTED TO BRICK WALL & SUR.
