DILAPIDATION REPORT

Pheasant Place, Warriewood

This report is intended to be a record of the council assets at Pheasant Place, Warriewood at the time of the inspection.

The inspection was carried out on 11 November 2024.

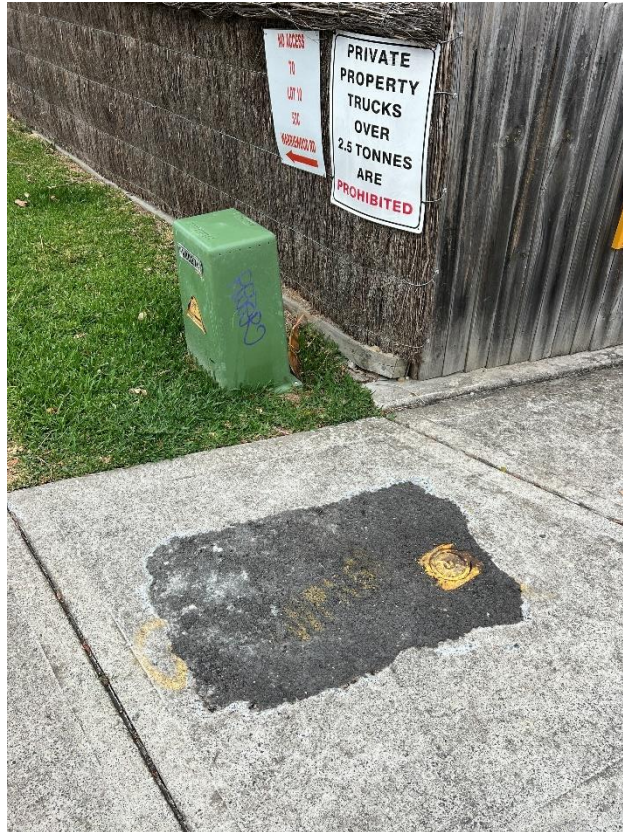
Figure 5 – General condition of the utility lid.

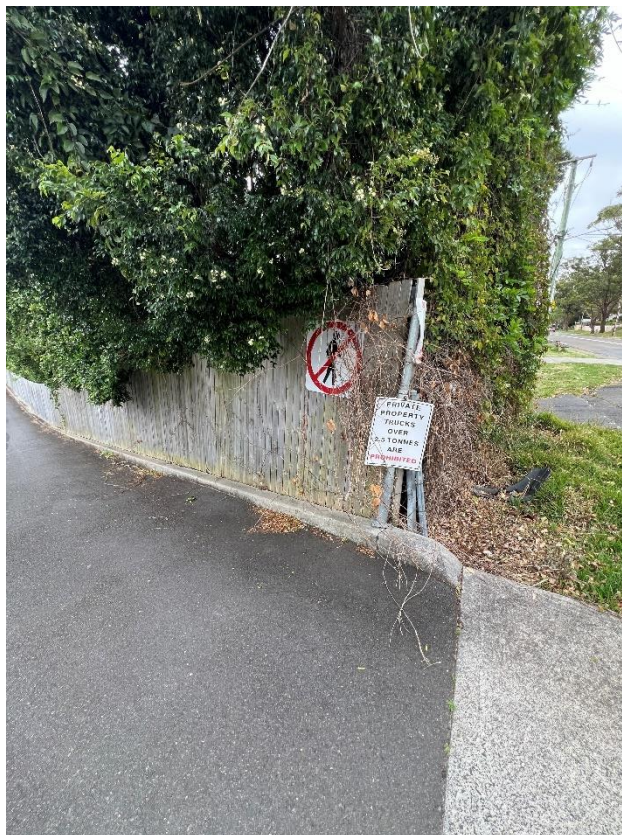
Figure 8 – General condition of the kerb/street signpost.

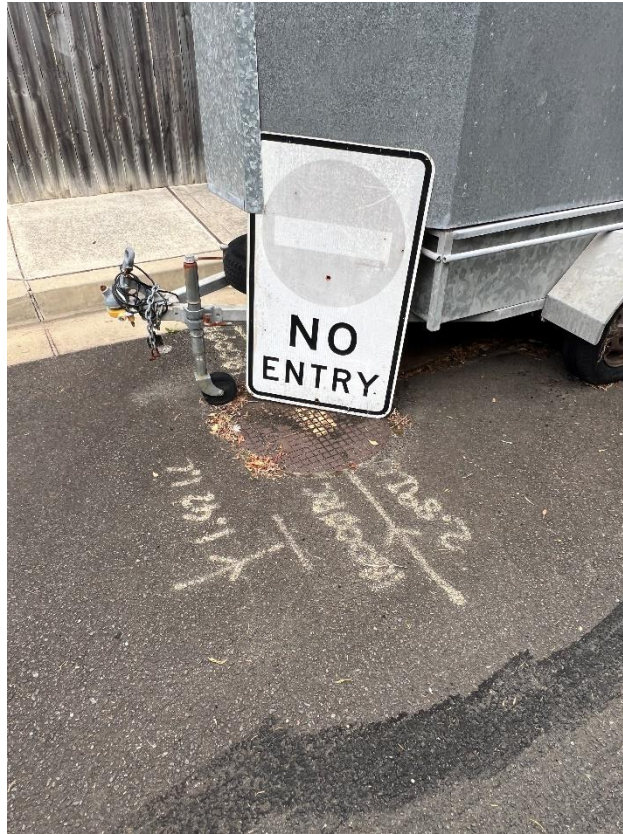
Figure 17 – General condition of the traffic signpost.

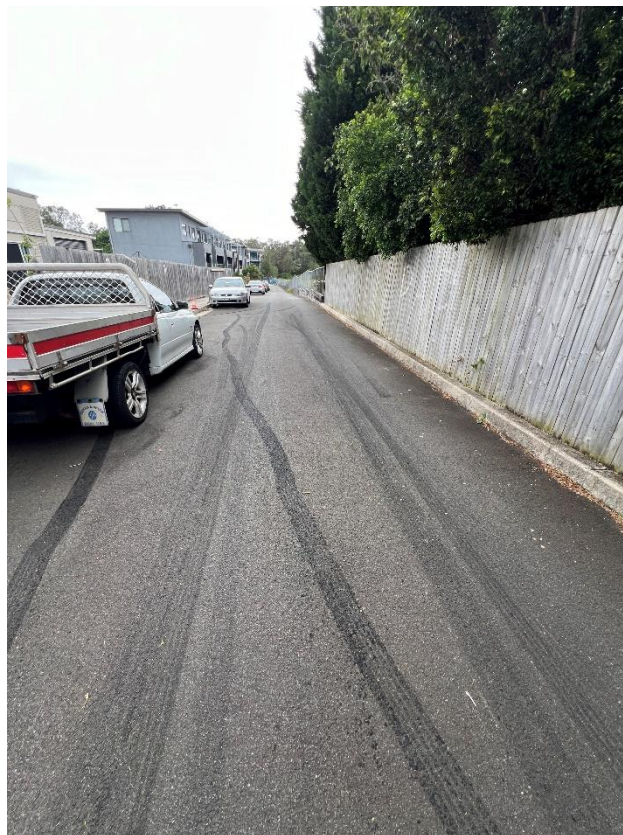
Figure 18 – General condition of the road.

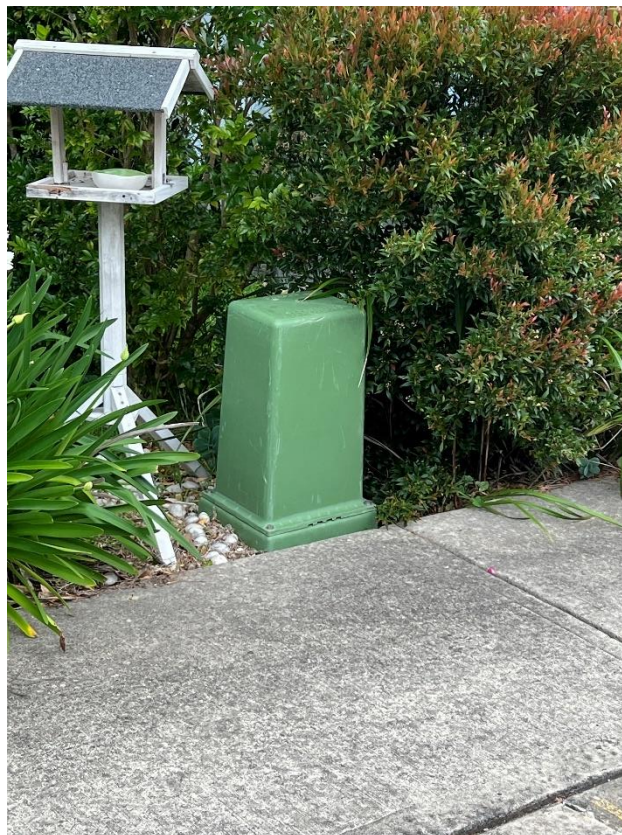
Figure 42 – General condition of the transformer box.
