Report Title: Geotechnical Report 55 Robertson Road, Scotland Island

Report Date: 12/8/20

GEOTECHNICAL INVESTIGATION:

Alterations and Additions at 55 Robertson Road, Scotland Island

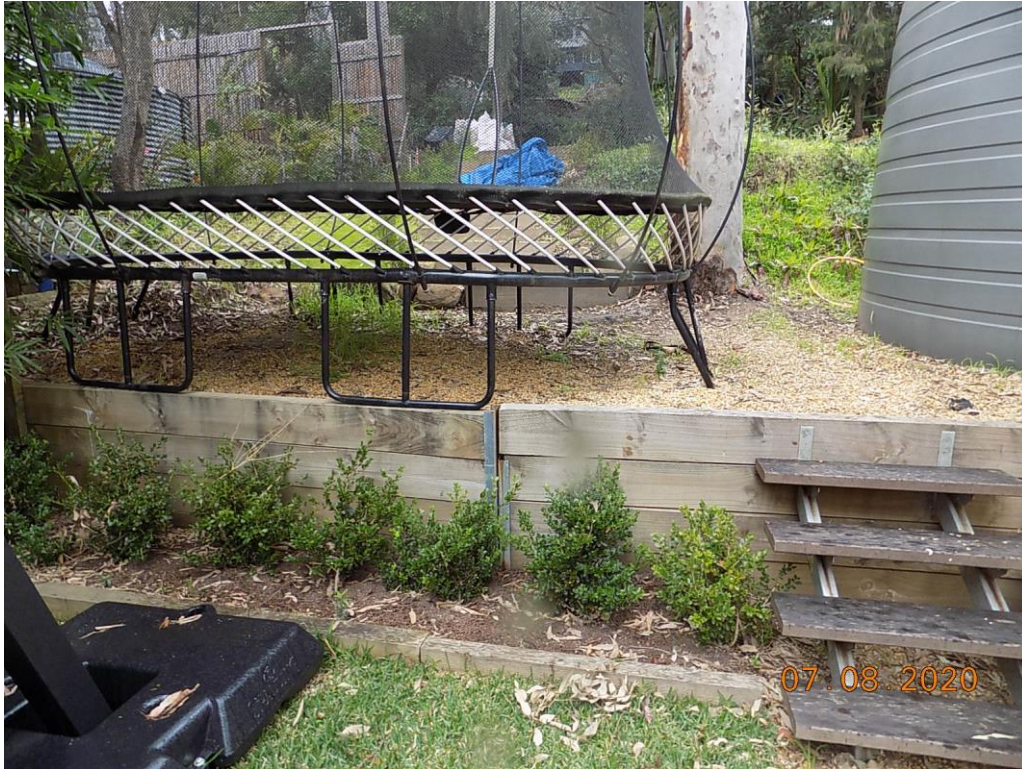
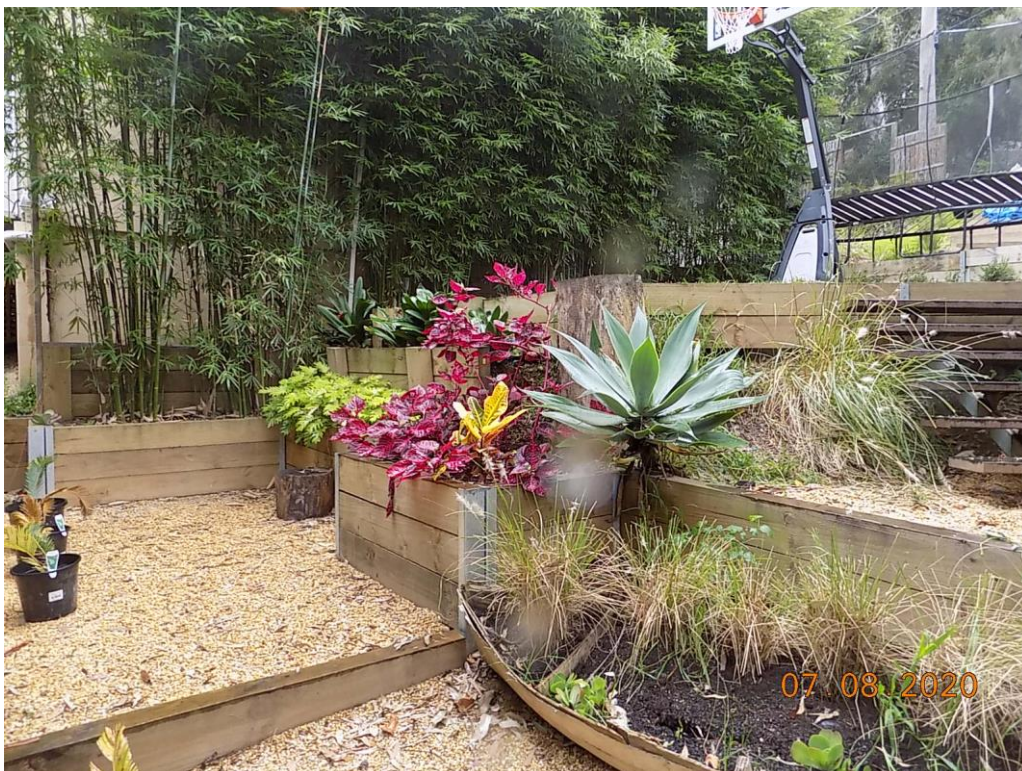
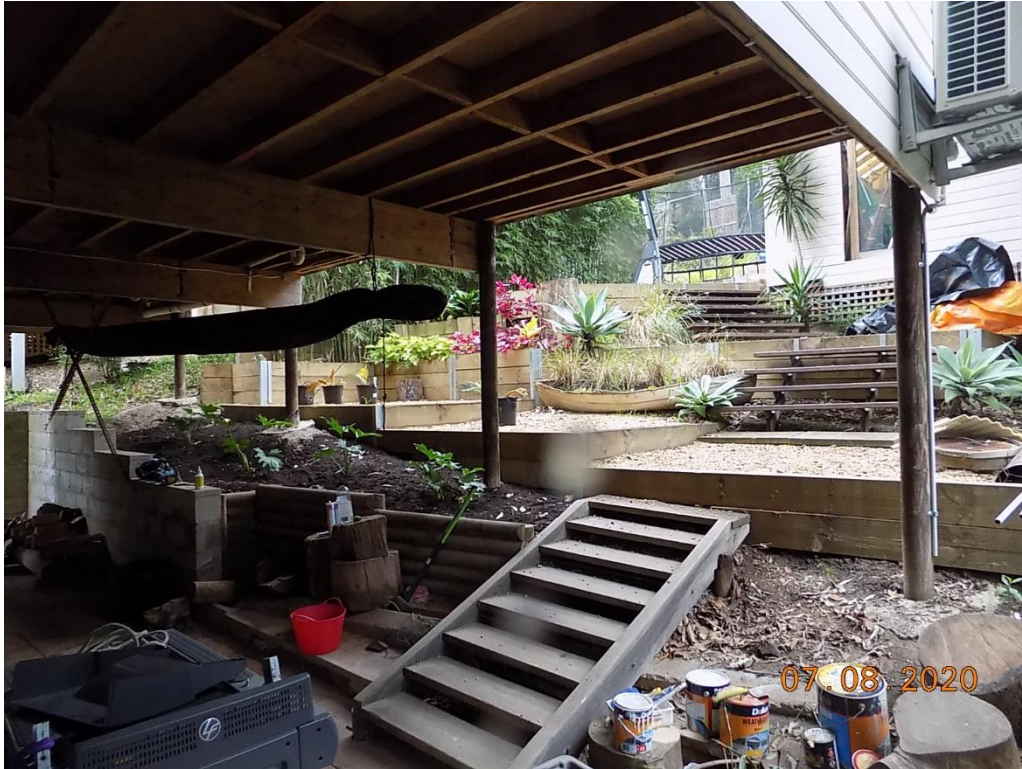
- 2.3** Between the road frontage and the house, the slope has been terraced with a series of stable treated timber retaining walls reaching ~0.6m high (Photos 1, 2, & 3). The part two-storey timber framed and weatherboard clad house is supported on stable timber posts (Photo 4). Excavations have been made in the slope to create level platforms for the ground floor and lower ground floor. The cuts are supported by stable concrete block and treated timber retaining walls reaching ~1.8m high (Photos 5 & 6). A gently sloping lawn has been cut into the slope on the downhill side of the house. The proposed timber deck that is the subject of this report has been

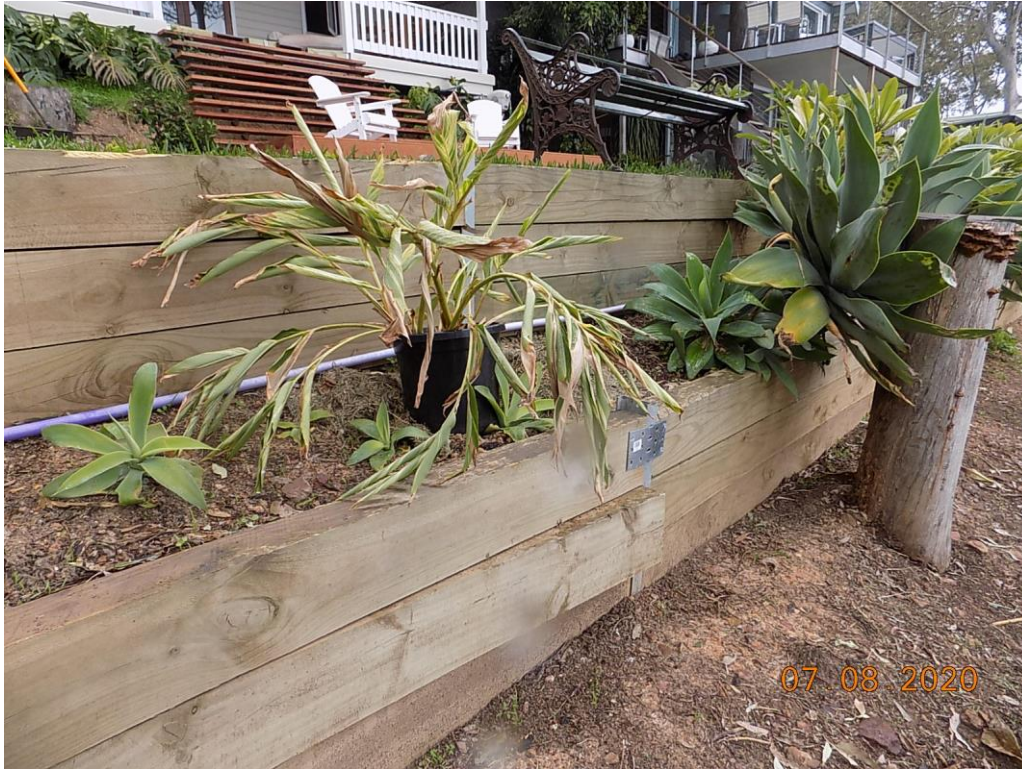
Photo 7

constructed in this location. A stable stepped treated timber retaining wall supports a fill for a garden bed below the deck. The steps are ~0.6m high (Photo 7). From the base of the wall, the slope falls steeply to the waterfront (Photo 8). Competent Medium Strength Sandstone was observed to be outcropping through the slope and at the beach below (Photos 9 & 10). The waterfront was undergoing remediation works at the time of the inspection due to a small landslide that had occurred earlier in the year. This involved installing a sandstone block wall. The incomplete works to date appear to have temporarily stabilised the site. Upon completion, the site can be considered permanently stabilised.

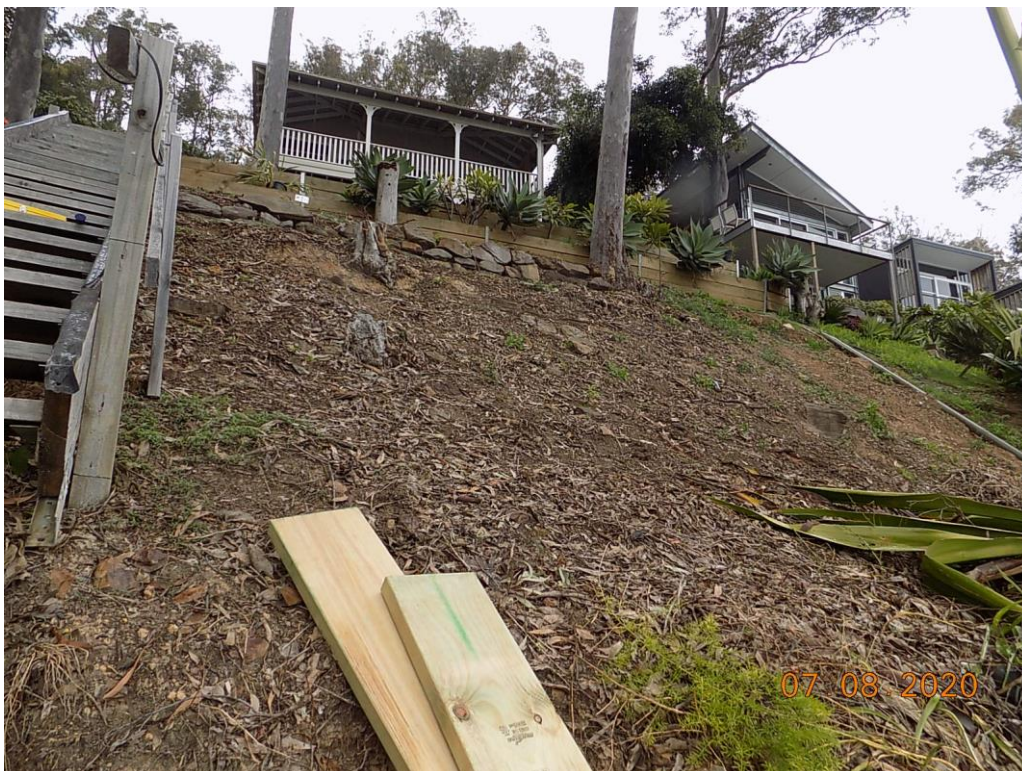
Photo 8

Where slopes approach or exceed 30°, such as on the downhill side of the property (Photo 8), it is prudent for the owners to occasionally inspect the slope (say annually or after heavy rainfall events, whichever occurs first). Should any of the following be observed: movement or cracking in retaining walls, cracking in any structures, cracking or movement in the slope surface, tilting or movement in established trees, leaking pipes, or newly observed flowing water, or changes in the erosional process or drainage regime, then a geotechnical consultant should be engaged to re-assess the slope. We can carry out these inspections upon request. The risk assessment in **Section 8** is subject to this site maintenance being carried out.

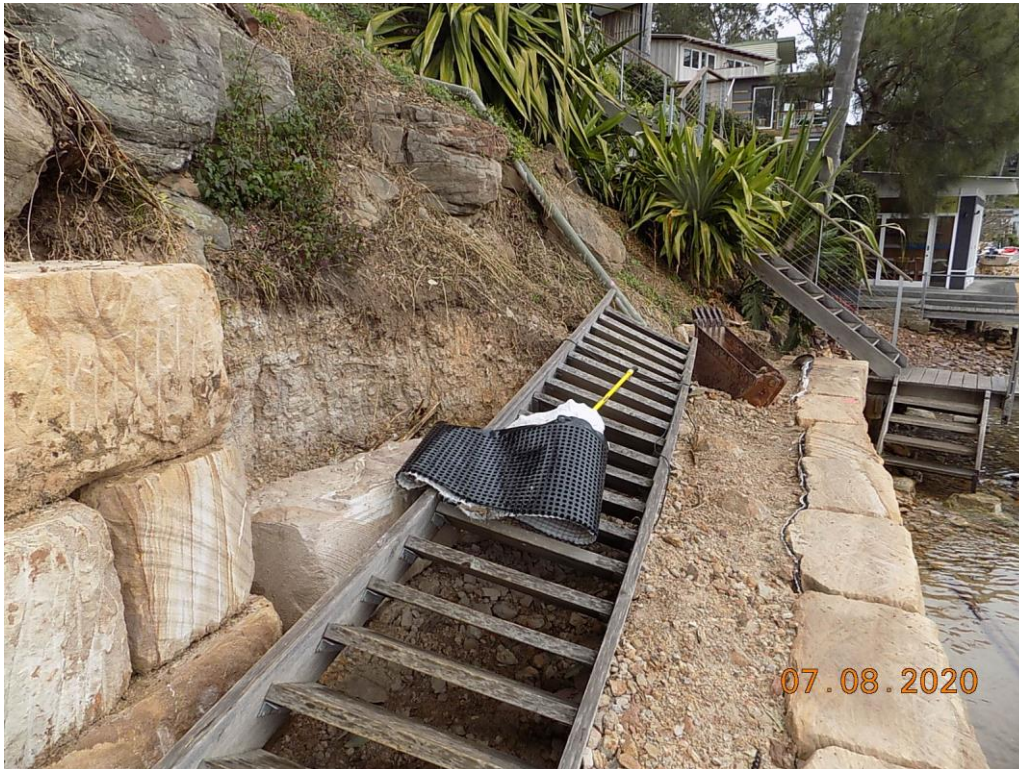
Photo 9: This portion of the slope is under construction as part of a separate DA.

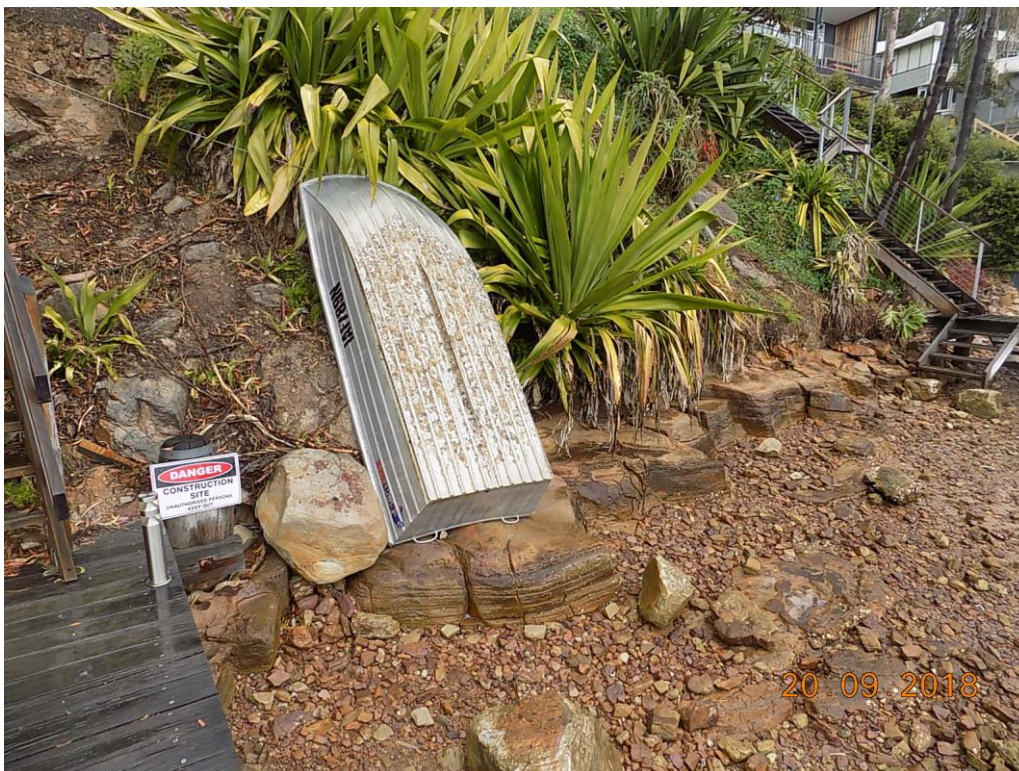
Photo 10: This photo was taken prior to the construction works to show the outcropping sandstone.

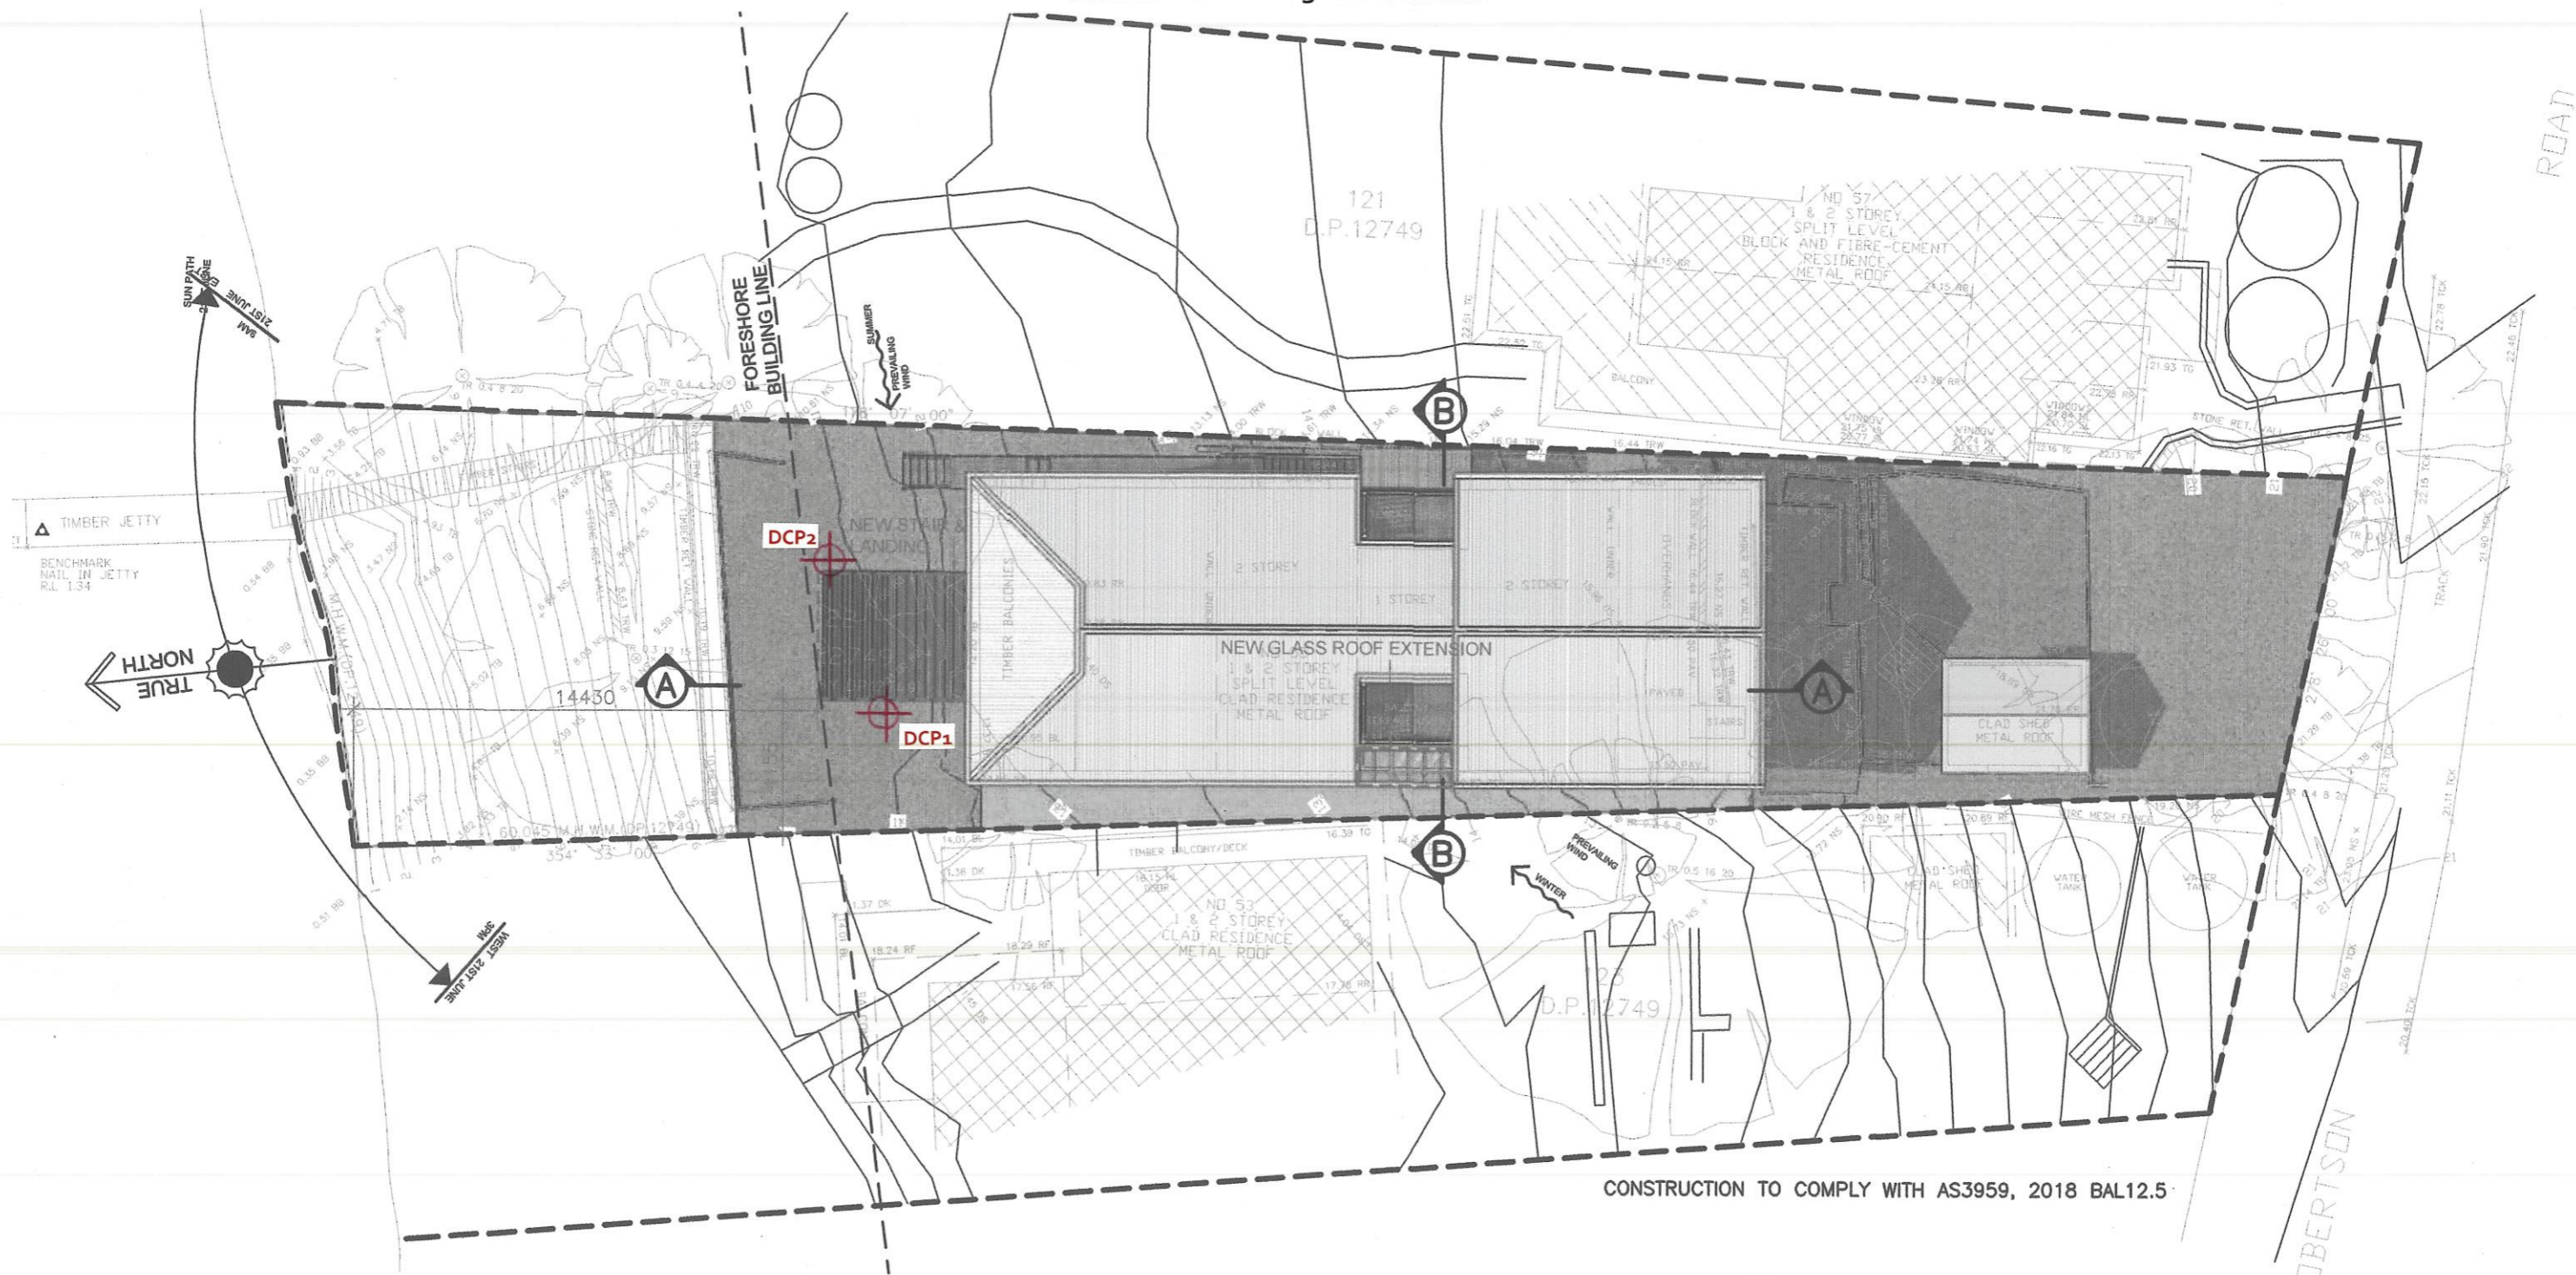
SITE PLAN – showing test locations

Two Dynamic Cone Penetrometer (DCP) tests were put down to determine the relative density of the overlying soil and the depth to weathered rock. The locations of the tests are shown on the site plan. It should be noted that a level of caution should be applied when interpreting DCP test results. The test will not pass through hard buried objects so in some instances it can be difficult to determine whether refusal has occurred on an obstruction in the profile or on the natural rock surface. This is not expected to be an issue for the testing on this site. However, excavation and foundation budgets should always allow for the possibility that the interpreted ground conditions in this report vary from those encountered during excavations. See the appended "Important information about your report" for a more comprehensive explanation. The results are as follows:

DCP TEST RESULTS – Dynamic Cone Penetrometer		
Equipment: 9kg hammer, 510mm drop, conical tip.		Standard: AS1289.6.3.2 - 1997
Depth(m) Blows/0.3m	DCP 1 (~RL10.9)	DCP 2 (~RL10.8)
0.0 to 0.3	3	6
0.3 to 0.6	13	17
0.6 to 0.9	17	25
0.9 to 1.2	30	30
1.2 to 1.5	#	#
	End of Test @ 1.2m	End of Test @ 1.2m

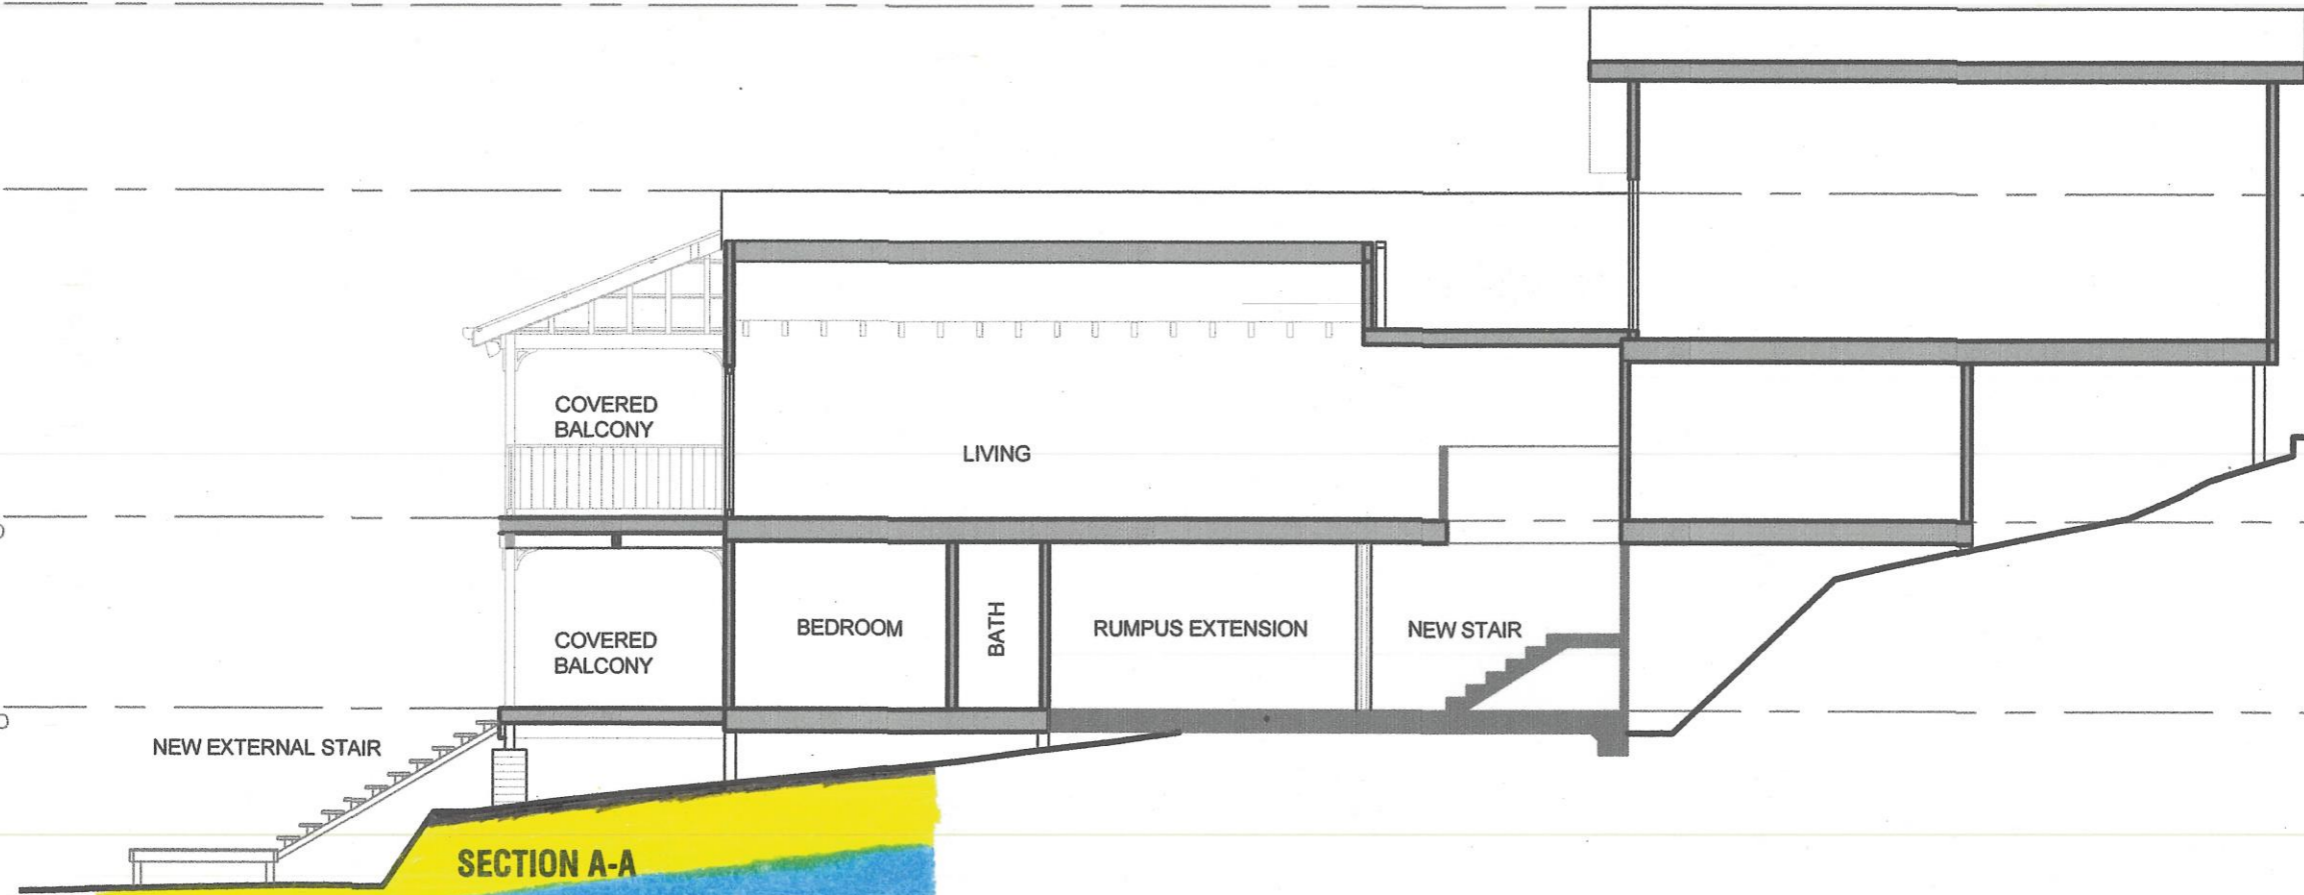
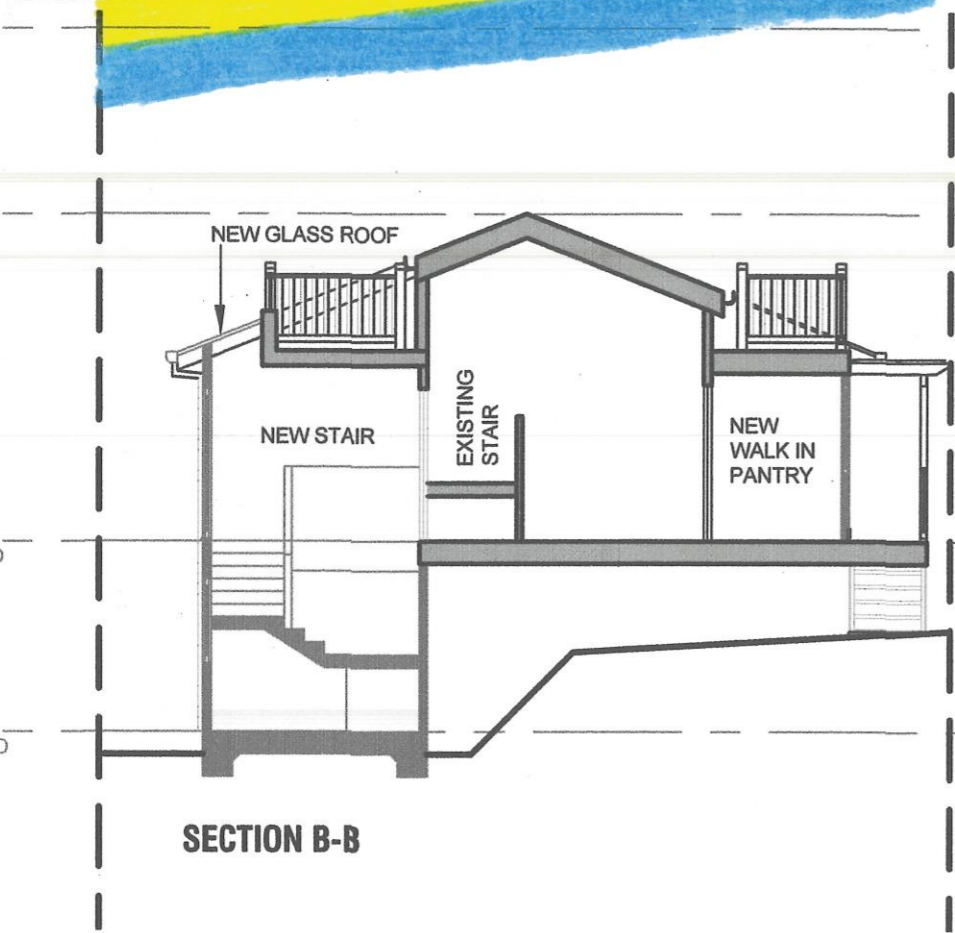
TYPE SECTION – Diagrammatical Interpretation of expected Ground Materials

The slope materials are colluvial at the near surface and residual at depth. In the location of the proposed works they consist of a thin topsoil over silty clays. In the test locations, the clays merge into the weathered zone of the underlying shale at an average depth of ~0.9m below the current surface. The weathered zone is interpreted as Extremely Low Strength Shale. It is to be noted that this material can appear as a mottled stiff clay when it is cut up by excavation equipment. See Type Section attached for a diagrammatical representation of the expected ground materials.

- Fill
- Topsoil
- Silty Clay – Firm to Stiff
- Narrabeen Group Rocks – Extremely Low Strength Shale - after being cut up by excavation equipment can resemble a stiff to hard clay.
