REPORT ON GEOTECHNICAL ASSESSMENT

PROPOSED ALTERATIONS AND ADDITIONS

13 CAPUA PLACE, AVALON BEACH

Project No.: 2020-027

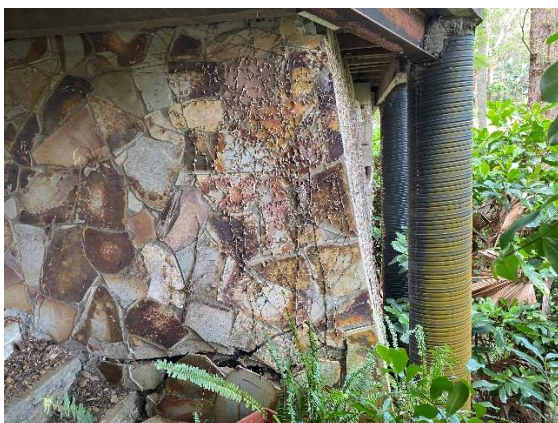
The existing garage is a single level brick structure over a concrete pavement and is formed directly adjacent to the low rock retaining wall at the base of the driveway slope. To the south of the driveway, concrete pavements extend several metres to create an open terrace and access to the site house. The outer southern side of the terrace is raised up to 4.0m above the slope and is supported via an apparent non-cored filled block wall and then a series of concrete columns. At the western end the block wall is not visible and appears covered by mortared flagging. The garage structure, terrace pavements, columns and the flagging appear in good condition however the exposed block wall contains significant open cracks and dislocation of blocks, indicating it was poorly constructed.

Photograph: 1 Terrace with flagging at west end and columns below south end.

The existing terrace adjacent to the garage appears part supported by a poorly built and deformed concrete block wall/retaining wall of significant height. It could not be confirmed whether or not this wall is retaining soils, though it does not appear to be, and it does not appear to be supporting the terrace above. The condition/situation of the wall appears to present a hazard to the site, however if there is no lateral soil retention or vertical support to the concrete terrace above, the hazard is purely a safety issue for the residents within the garden bed adjacent to the wall base. It is therefore recommended that the wall and ground conditions to its rear be investigated during the garage construction works with geotechnical and structural engineering assessment.

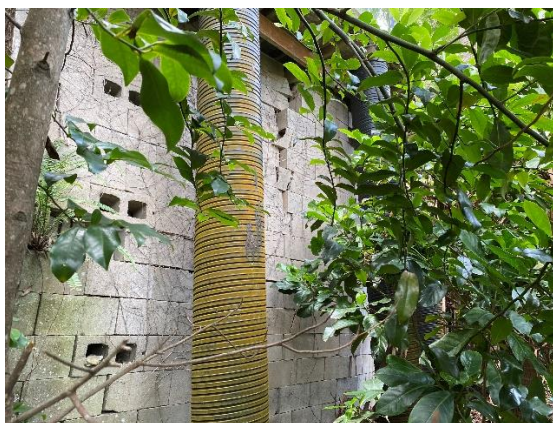
Photograph: 2 Showing dis-located block work and columns supporting terrace.

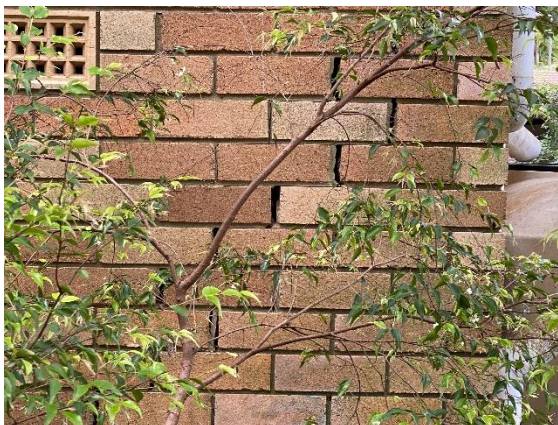
The existing house is a one and two storey brick structure that appears of 1960-1970's construction, with a lower floor level formed below the southern half over a sub-floor cavity due to the ground surface slope to the south. The house is formed with brick external walls to brick strip footings with some internal brick footing walls along with isolated brick columns to pad footings supporting timber internal floors. The house generally appears in good condition however several open, diagonal cracks are evident at the south-west corner and along the lower southern wall.

Photograph: 3 Showing crack at south-west corner1

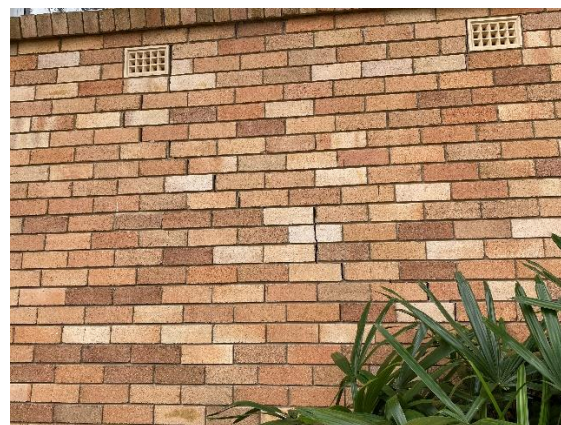
Photograph: 4 Showing stepped crack southern wall

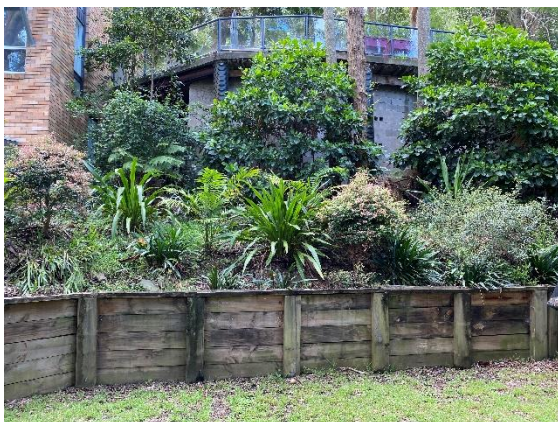
Moderate ($\leq 18^\circ$) sloping gardens with scattered medium size trees and low vegetation extend down the western side of the house into the south-west corner of the property including around the lower southern side of the house. In the south-east corner of the site is a near level lawn that appears excavated into the slope with a low (<1.20m) timber sleeper retaining wall supporting garden beds above its northern side. There were no signs of excess creep, surface erosion or instability identified in this part of the site.

Photograph: 5 Showing lawn and then wall supporting gardens, looking north from south corner.

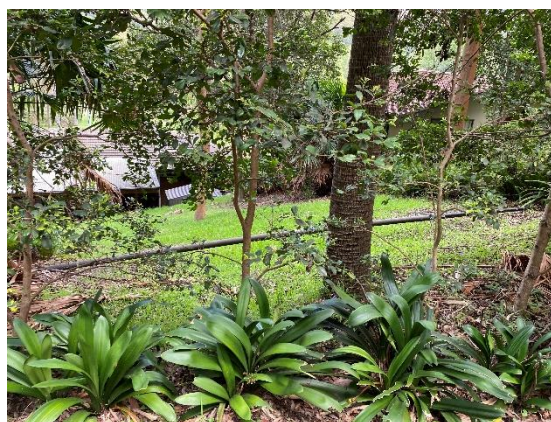
Photograph:6 Showing properties downslope to south.
