SEASONED TREE CONSULTING

ARBORICULTURAL IMPACT ASSESSMENT REPORT

Site Address-
**Lot 1, 128 Elanora Road,
Elanora Heights, NSW 2101**

<u>Prepared by</u>	David Gowenlock AQF5 (Director of Seasoned Tree Consulting)
<u>Address</u>	PO BOX 3044 Asquith NSW 2077
<u>Mobile</u>	0415 961 074
<u>Email</u>	david@seasonedtreeconsulting.com.au
<u>ABN</u>	73 606 422 351
<u>Date</u>	6 February 2020

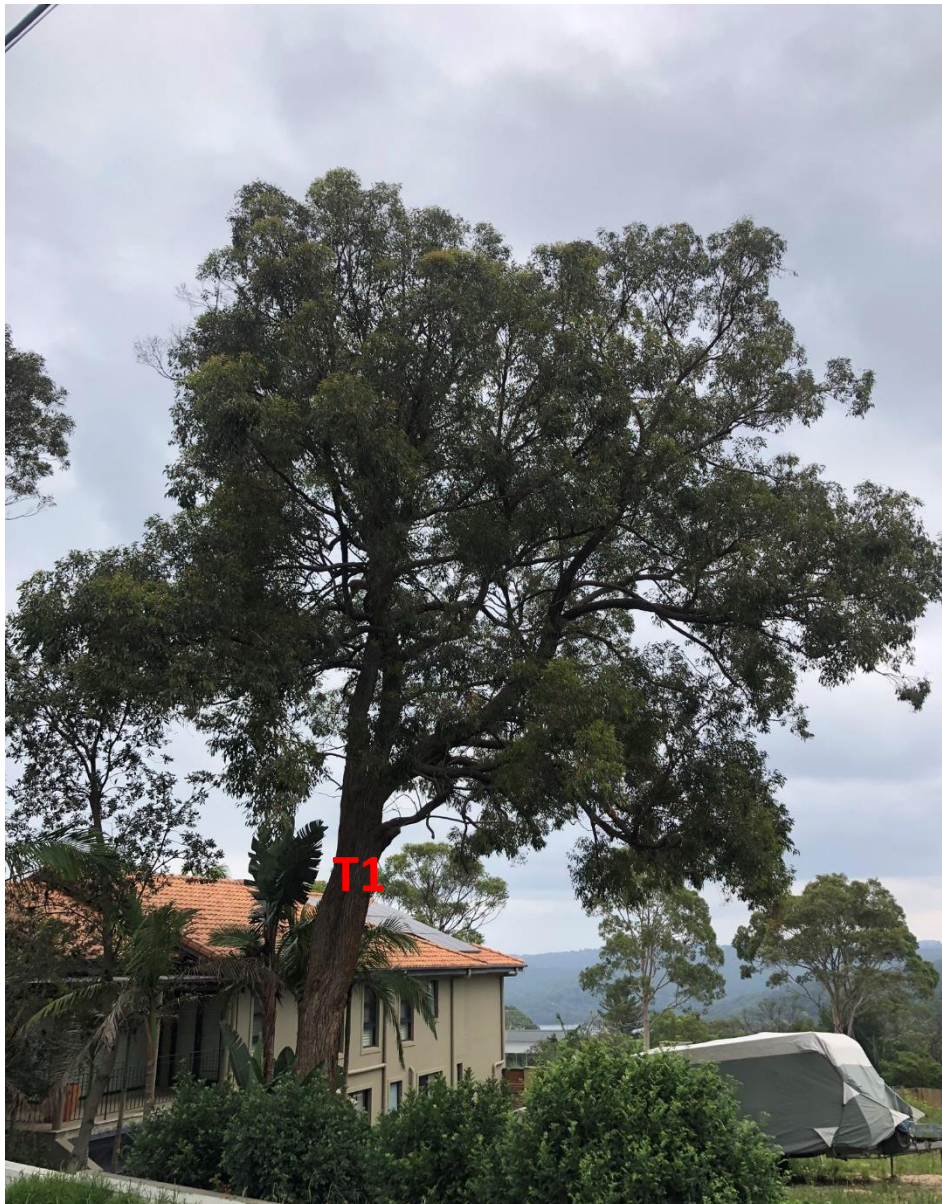
Tree #1 is located along the front fence line and is a healthy mature *Eucalyptus microcorys* (Tallow Wood). The tree possesses a High Landscape Significance Rating and subsequently a very high retention value and must be retained and protected. The tree has a fair form as the crown spread is biased towards the west. The tree has deadwood throughout the crown that needs removal to lower the risk of falling dead branches.

Figure 2- T1 showing unbalanced canopy form

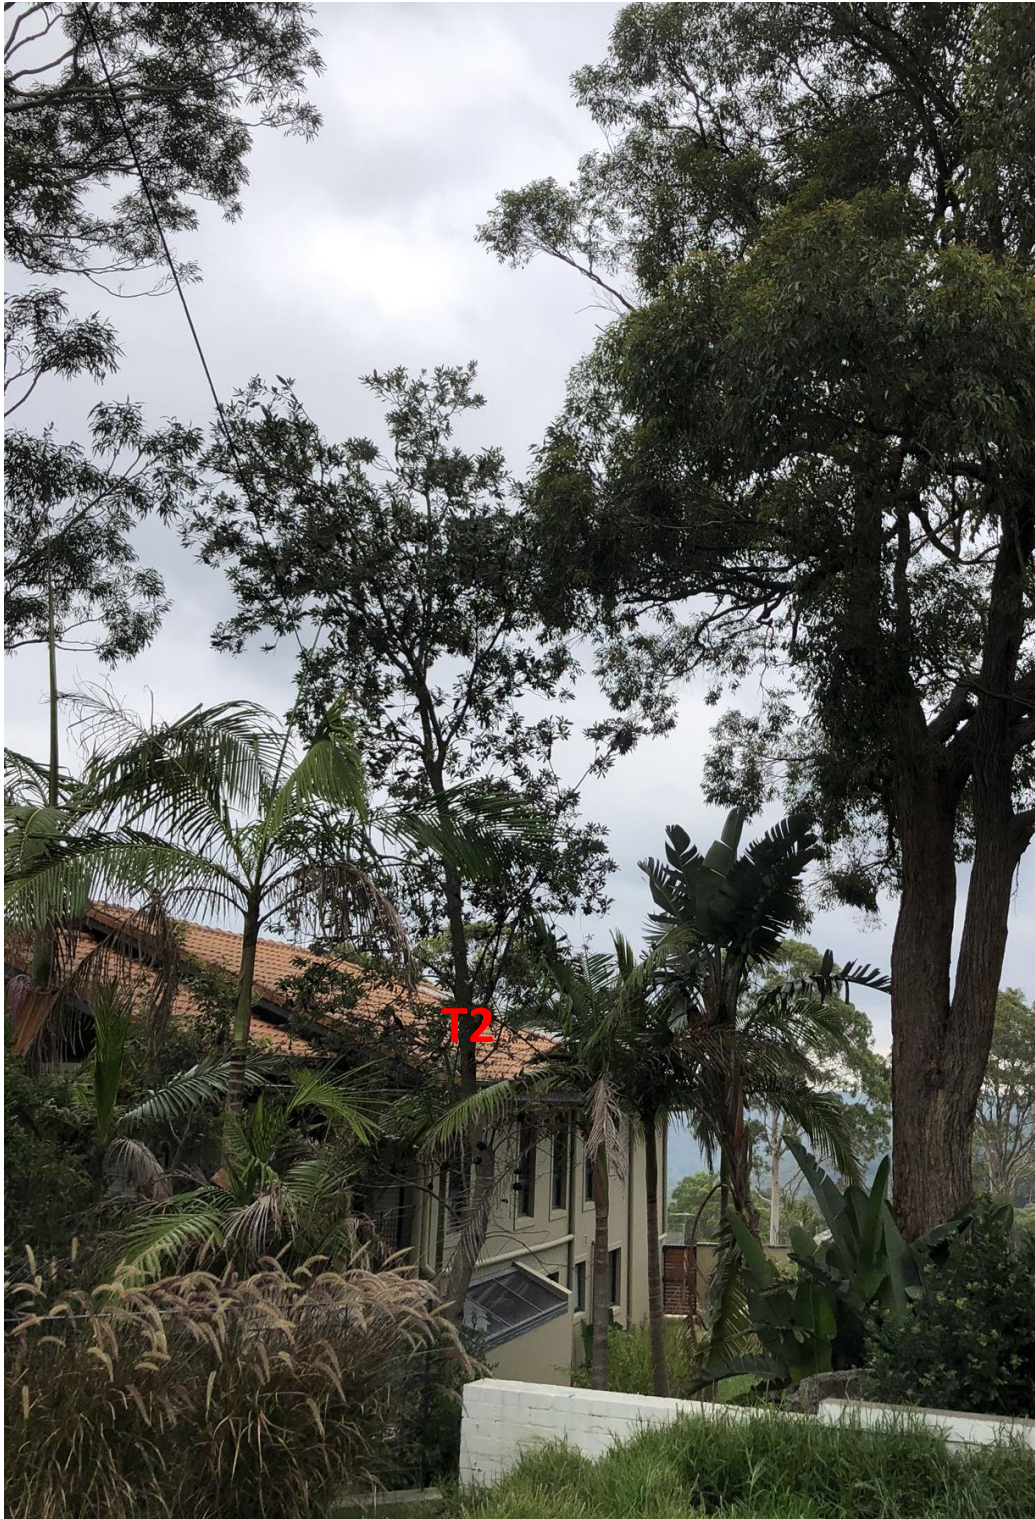
Tree # 2 is located beside T1, in the front left hand corner of the yard . The tree is a semi-mature *Banksia integrifolia* (Coastal Banksia), exhibiting good health and form.

The tree is located away from proposed construction impacts, and due to its species and good health and form is recommended to be retained.

Figure 3- T2 surrounded by small palms and strelitzias

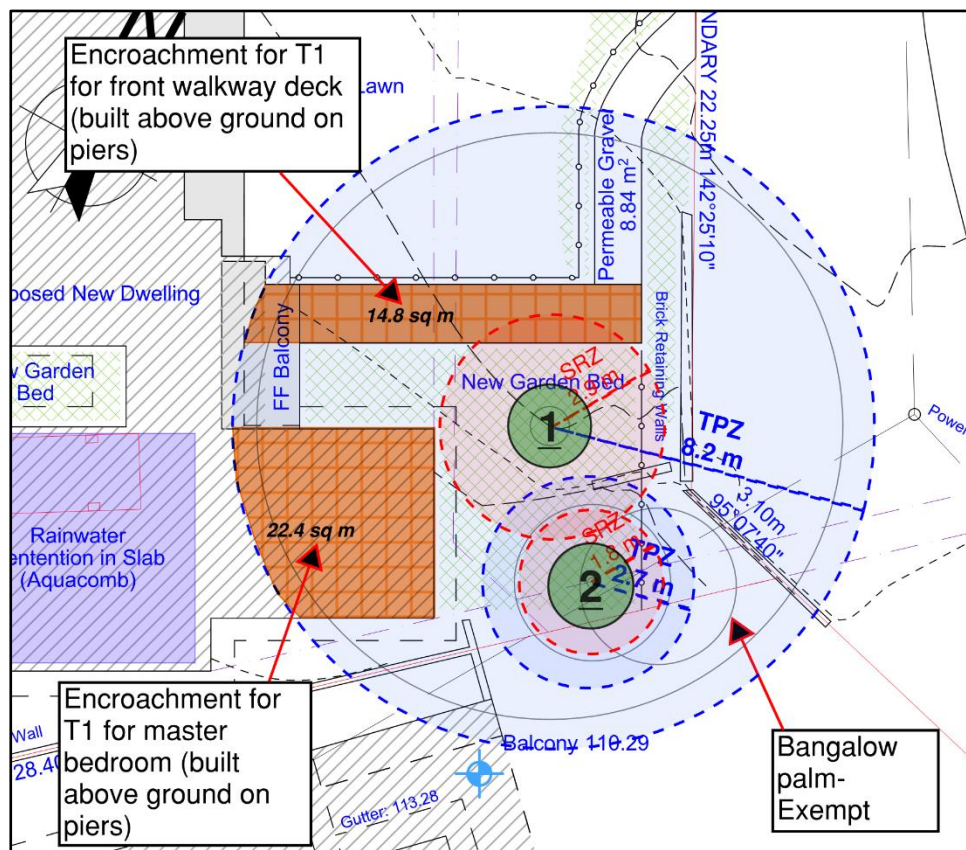
Tree # 1 has a calculated amount of impact of 17% (37.2 sq metres- see diagram below). This is due to the proposed front walkway and siting of the bedroom.

As the front walkway passes through the SRZ of T1, this is technically deemed a major impact and would trigger the need for further investigation to be undertaken.

But as the proposed front walkway will be built on a pier and floating deck building style (above ground level), it could be built with no impact within the SRZ.

As such further investigation work is not recommended. The style of building method will also lower the overall calculated TPZ encroachment. The bedroom is likewise proposed to be built on a pier and suspended floor style building method (above ground level)- likewise lowering the encroachment calculation.
