Report Title: Geotechnical Report 23 Park Avenue, Avalon Beach  
Report Date: 16/12/24

## **GEOTECHNICAL INVESTIGATION:**

### **Alterations and Additions at 23 Park Avenue, Avalon Beach**

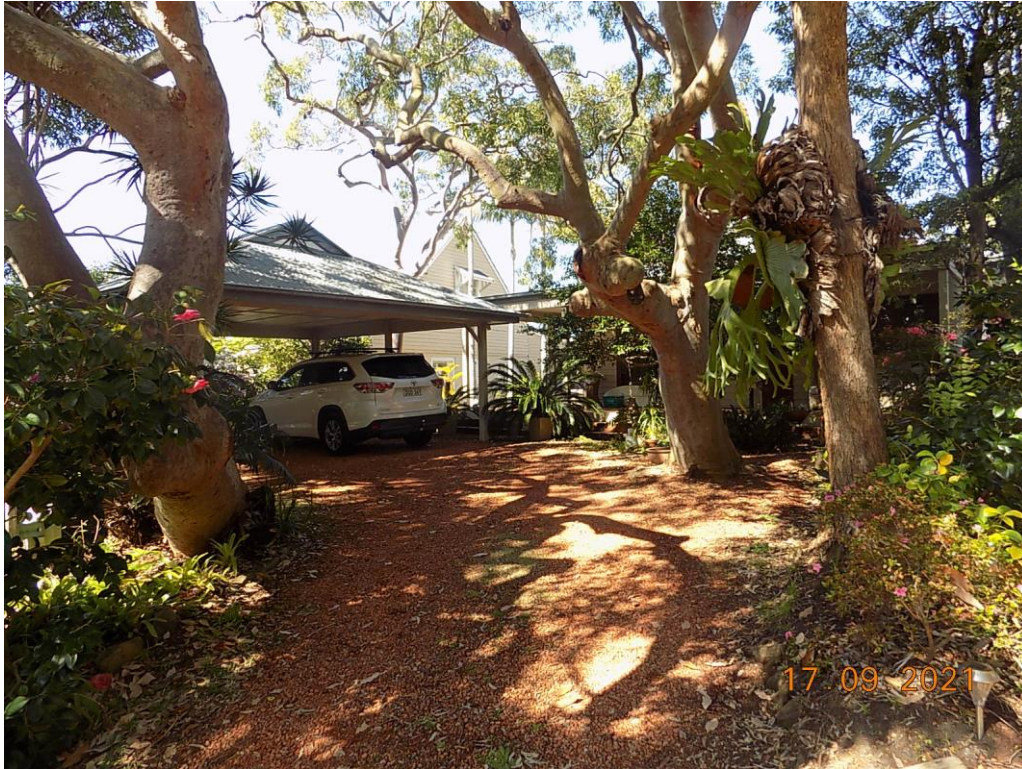
Photo 1

- 2.3** At the road frontage, a gravel driveway runs across the slope to a timber framed carport on the uphill side of the property (Photo 1). The part two-storey brick and timber clad house is supported on brick walls and brick piers. The brick walls show no significant signs of movement and the brick piers stand vertical (Photo 2). Some of the supporting piers were observed to be supported directly onto outcropping Medium Strength Sandstone (Photo 3). A gently sloping lawn extends from the downhill side of the house to the lower common boundary (Photo 4). Sandstone can be seen outcropping through the slope in several places (Photo 5).

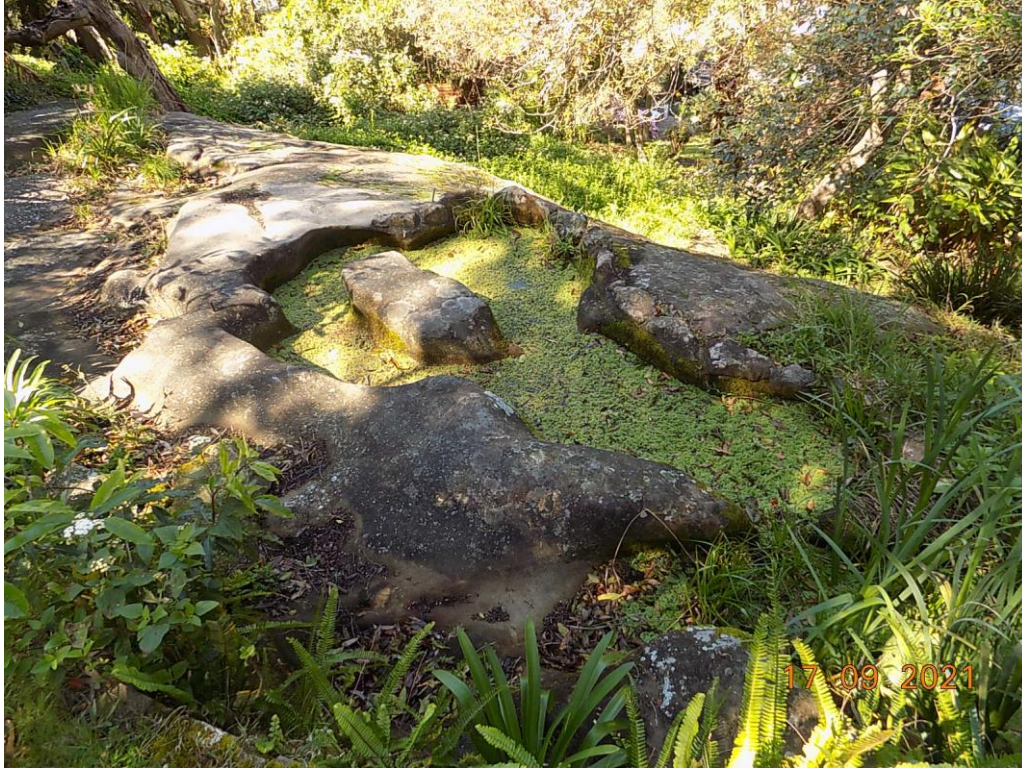
Photo 5

Sandstone bedrock outcrops under the house and through the slope below the property. This is an unusually thick sandstone bed within the Narrabeen Group of Rocks. The rock is overlain by silty soils and clayey sands that fill the bench-step formation. In the test locations, the depth to Medium Strength Sandstone ranged between 0.3 to 0.9m below the current surface, being deeper due to the stepped nature of the underlying bedrock. The sandstone underlying the area of the proposed development is estimated to be medium strength. See Type Section attached for a diagrammatical representation of the expected ground materials.

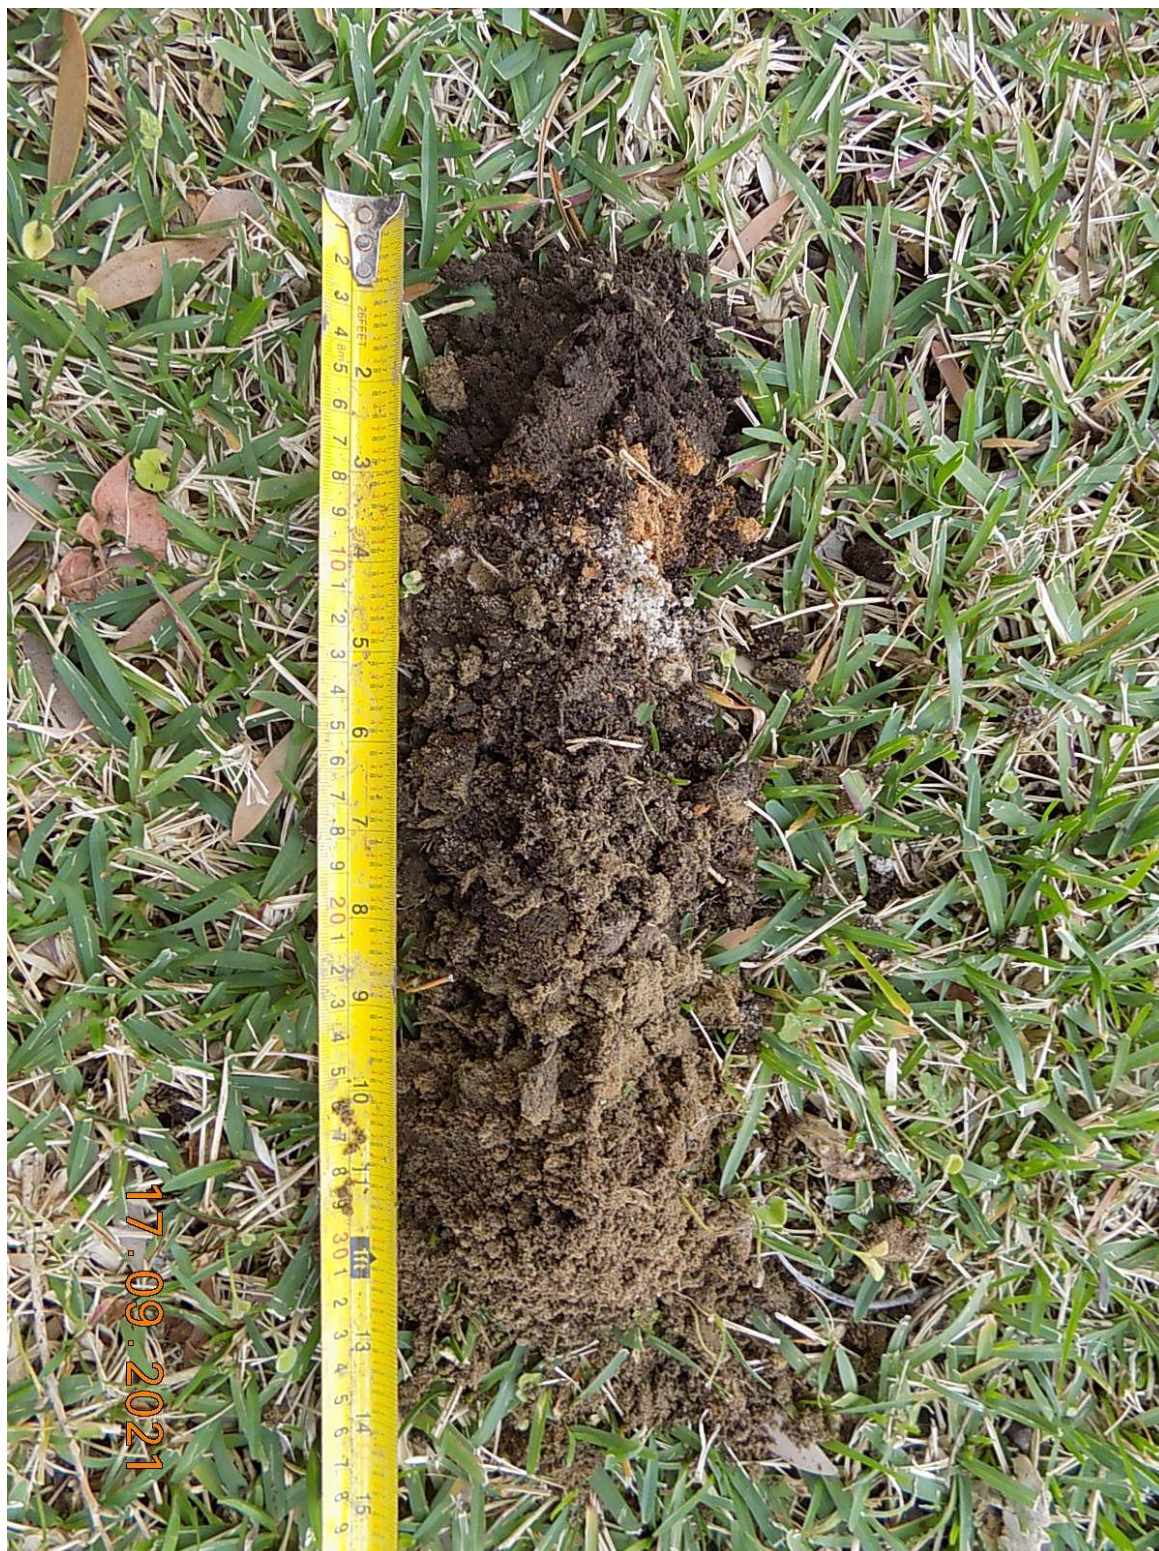
Photo 6 (Top is top of hole)

#### AUGER HOLE 1 (~RL37.8) – AH1 (Photo 6)

Depth (m)	Material Encountered
0.0 to 0.15	<b>SILTY SOIL</b> , dark brown, orange, grey, fine to coarse grained, loose to medium dense, dry.
0.15 to 0.3	<b>CLAYEY SAND</b> , brown, rock fragments, fine to medium grained, medium dense, dry.

Refusal on rock @ 0.3m. No water table encountered.

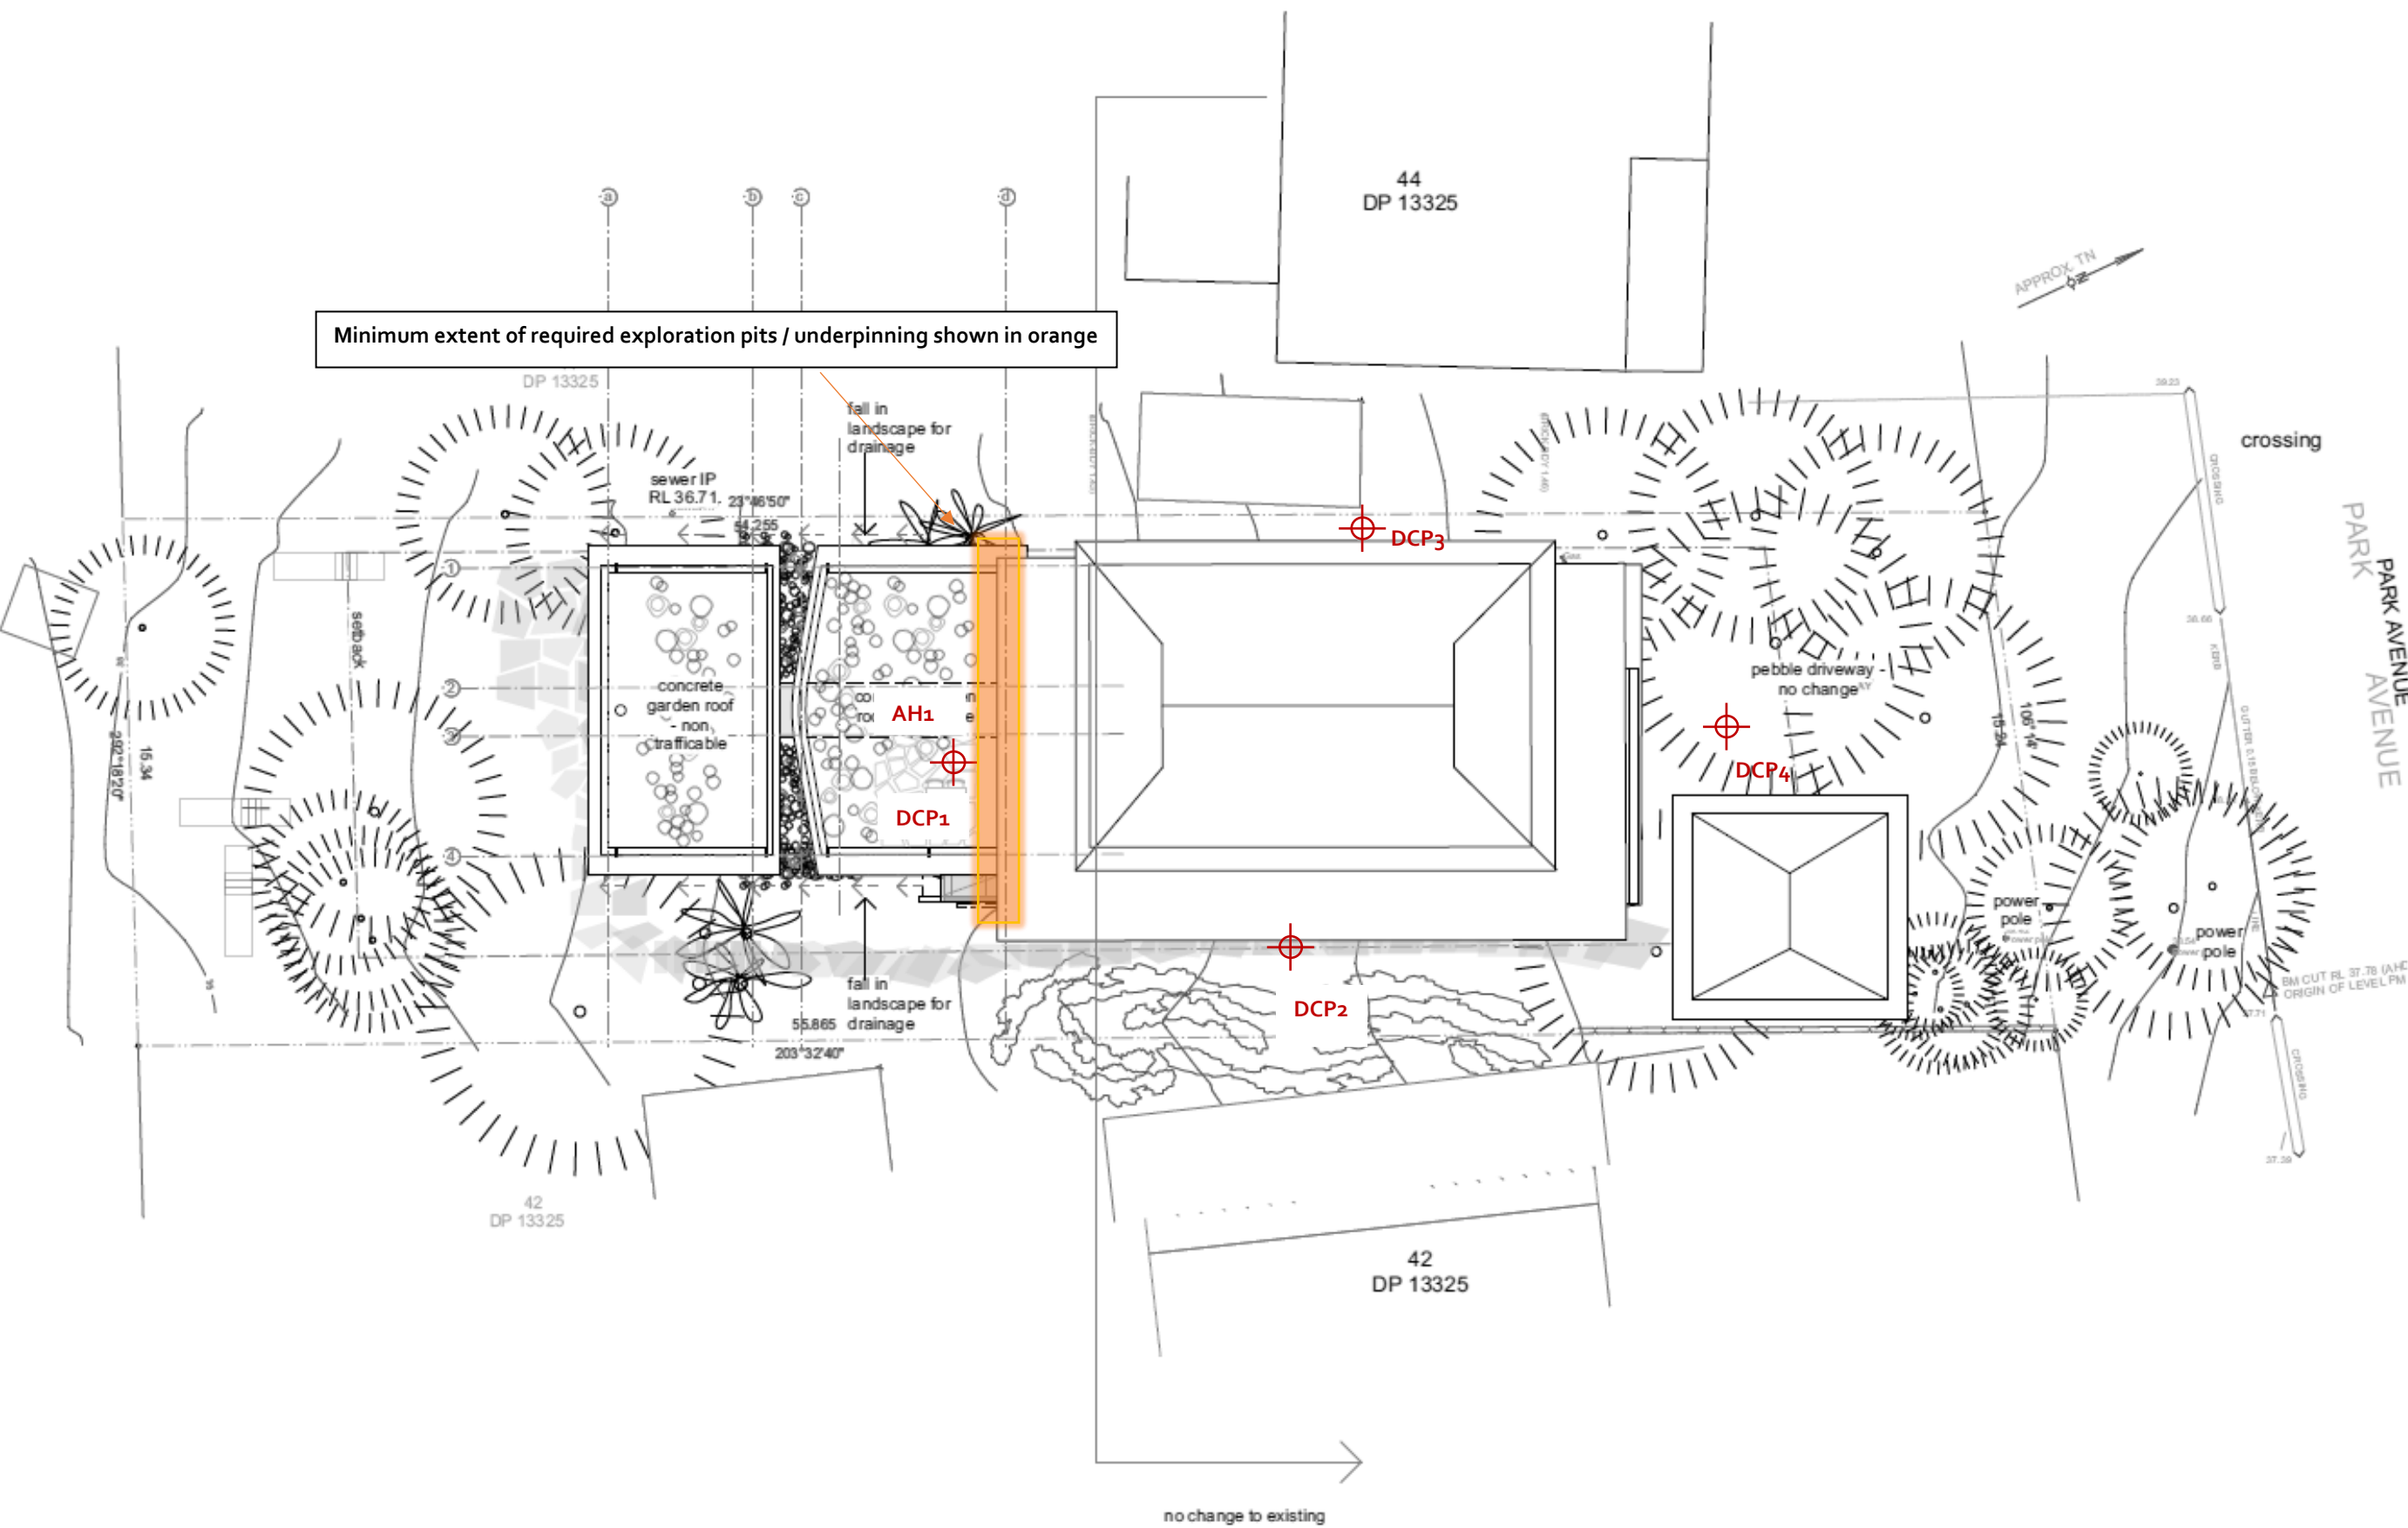
Drawing  
site plan

As such, the supporting posts of the subject deck will lie within the zone of influence of the proposed excavation. In this instance, the zone of influence is the area above a theoretical 30° line from the base of the excavation or top of Medium Strength Rock, whichever is encountered first, towards the surrounding structures and boundaries.

Given the shallow depth to rock, we think it is likely the deck is supported on rock. However, to be sure, Where the posts fall within the zone of influence of the excavation, exploration pits next to the posts will need to be put down by the builder to determine the foundation depth and material. These are to be inspected by the geotechnical consultant.

If the foundations are confirmed to be supported on rock, the excavation may commence. If they are not, the supporting posts of the deck will need to be underpinned to rock prior to the excavation commencing. See the site plan attached for the minimum extent of the required exploration pits/underpinning.
