**GEOTECHNICAL RISK MANAGEMENT POLICY FOR PITTWATER  
FORM NO. 1 – To be submitted with Development Application**

Report Title: Geotechnical Report 3 Bakers Rd, Church Point  
Report Date: 29/11/19  
Author: BEN WHITE  
Author's Company/Organisation: WHITE GEOTECHNICAL GROUP PTY LTD

## **GEOTECHNICAL INVESTIGATION:**

### **Alterations and Additions at 3 Bakers Road, Church Point**

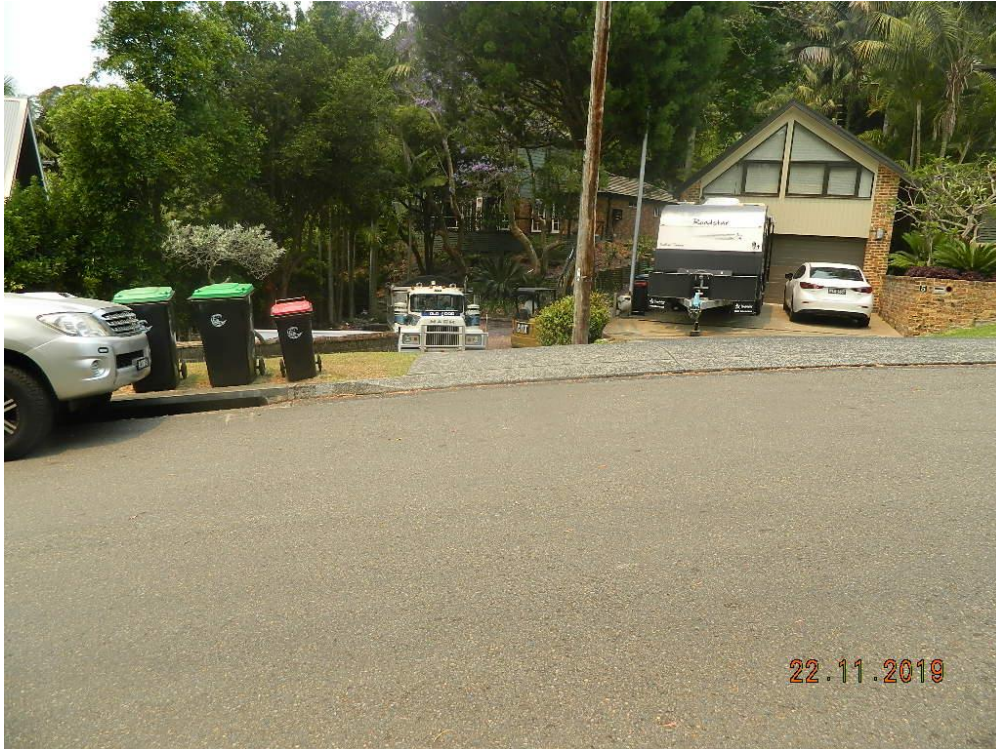
Photo 1

- 2.3** From the road frontage a concrete driveway runs down the slope to a level paved area (Photo 1). A low brick retaining walls lines the toe of the hillslope that rises to the house (Photo 2). A treated timber retaining wall in good condition terraces the hillslope and the cut batter for the driveway (Photos 3 & 4). The treated timber retaining wall extends from the level area up to the other side of the slope beside the house and extending to a paved parking area on the uphill side of the house. The retaining walls appear to be in good condition and show no significant signs of movement. The brick and timber clad house is supported on brick walls

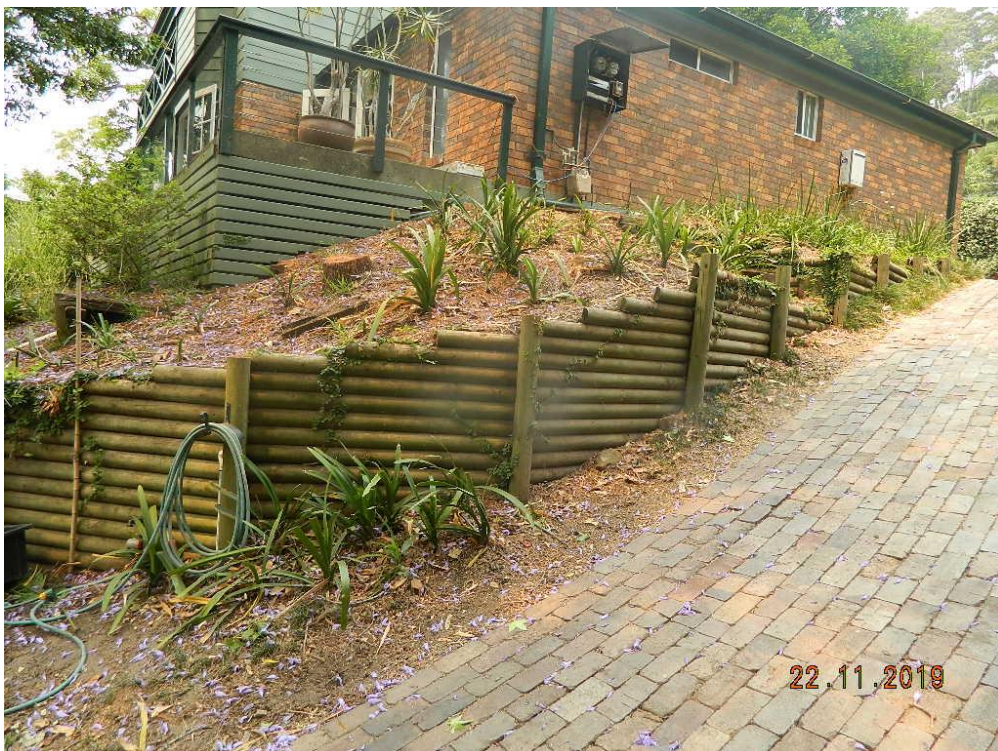
Photo 4

(Photos 5 & 6). The external brick supporting walls show no significant signs of movement. A suspended concrete deck extends off the downhill side of the house and shows no significant signs of movement (Photos 4, 7 & 8).

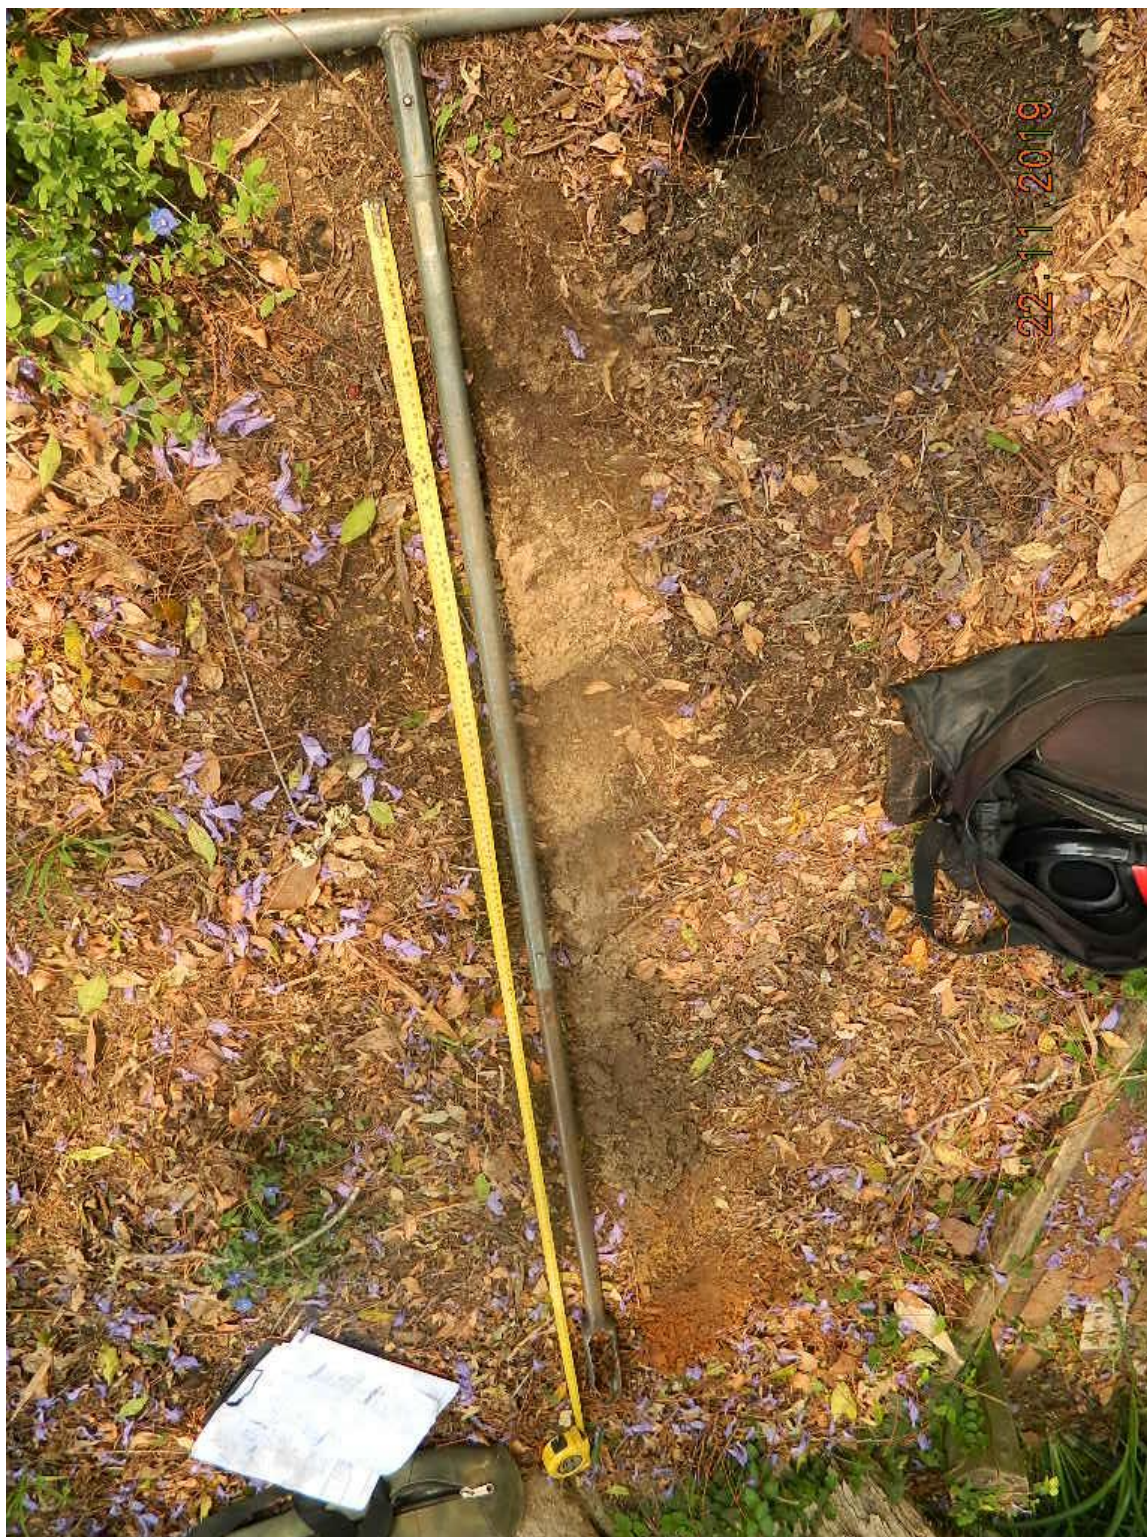
#### AUGER HOLE 1 (~RL9.2) – AH1 (photo 9)

Depth (m)	Material Encountered
0.0 to 0.3	<b>SANDY SOIL</b> , brown, fine grained.
0.3 to 0.9	<b>SAND</b> , grey brown, fine grained.
0.9 to 1.5	<b>SAND</b> , grey brown, medium grained.
1.5 to 1.8	<b>SANDY CLAY</b> , orange brown, firm, moist.

End of hole @ 1.8m in firm sandy clay. No watertable encountered.

Photo 9: AH1 – Downhole is from top to bottom

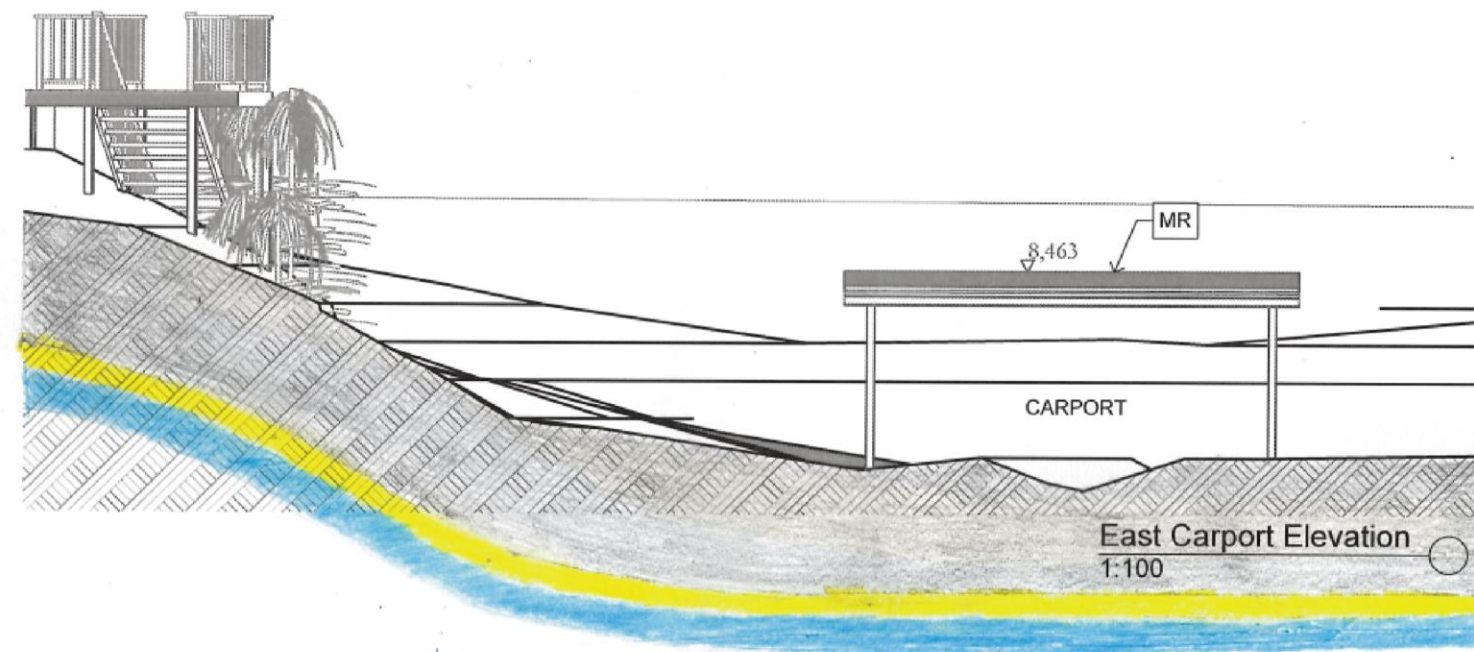
# TYPE SECTION – Diagrammatical Interpretation of expected Ground Materials

The slope materials are colluvial at the near surface and residual at depth. In the test locations, the ground materials consist of very loose to loose sands over sandy clays. Loose sand is expected to transition to sandy clay at a maximum depth of ~1.8m below the current surface. The clays merge into the weathered zone of the underlying rock at a maximum depth of ~2.1m below the current surface. DCP4 likely refused on an obstruction in the profile. The weathered zone is interpreted as Extremely Low Strength Shale. It is to be noted that this

material can appear as a mottled stiff clay when it is cut up by excavation equipment. See Type Section attached for a diagrammatical representation of the expected ground materials.

- Sand – Very Loose to Loose
- Sandy Clay – Firm to Stiff
- Narrabeen Group Rocks – Extremely Low Strength Shale - after being cut by excavation equipment can resemble a stiff to hard clay.
