GEOTECHNICAL INVESTIGATION:

New house and Granny Flat at 28 Stuart Street, Collaroy

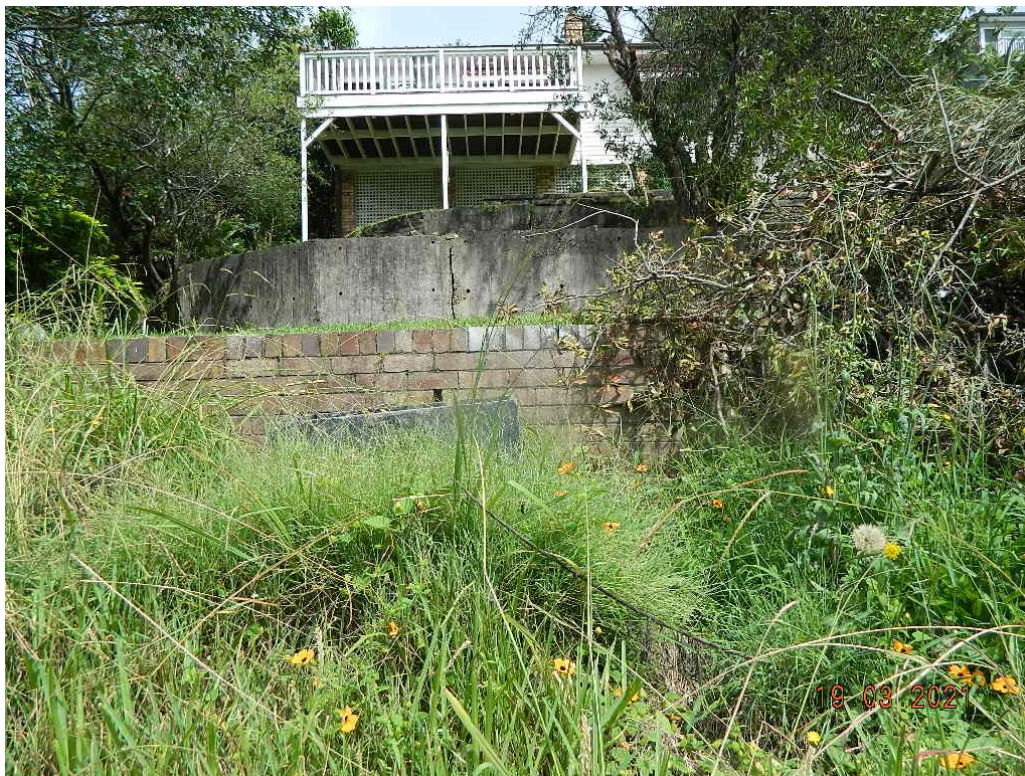
Photo 3

brick and concrete retaining walls up to ~1.4m high support the fill for a terraced lawn area between the road frontage and the house (Photos 3 to 5). The upper and middle concrete retaining walls displays vertical cracks up to ~30mm. It is expected that the walls will be demolished as part of the proposed works. The single storey brick and timber clad house is supported by brick walls, brick piers and steel posts (Photos 6 & 7). The supporting walls, piers and posts stand vertical and show no significant signs of movement (Photos 8 & 9). Brick and rendered brick retaining walls support a low cut for a storage area in the foundation space of the house.

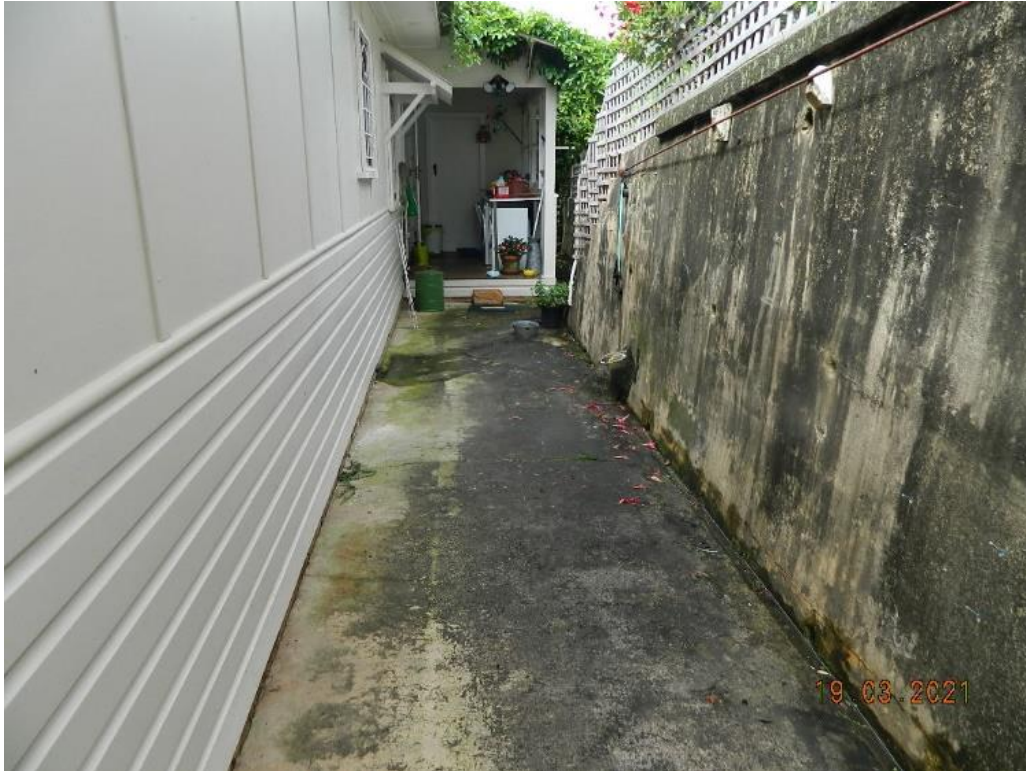
Photo 7

Formed concrete retaining walls up to ~2.2m high support a cut and fill on the uphill side of the house (Photos 7, 10 & 11). Weep holes have been installed in the walls to provide drainage. The southern walls display cracks up to ~30mm thick and a portion of one of the walls has separated ~35mm downslope, but the walls will be demolished as part of the proposed works (Photo 12). A gently sloping lawn and a single storey timber clad studio with storage room below is located on the uphill side of the retaining walls (Photos 13 & 14). The studio is supported by timber posts, concrete walls and brick piers. The supporting concrete walls display some minor cracking but are considered to be stable (Photo 15). Sandstone bedrock is outcropping in the foundation space (Photo 16). A lawn and garden area is located on the uphill side of the studio (Photo 17).

The house excavation requires the removal of the existing concrete retaining walls on the uphill side of the house (Photos 7, 10, 11) and the brick retaining walls supporting the cut for the existing garage (Photos 1 & 2). The retaining walls are to be demolished from the top down prior to the excavations commencing. The fill, soil and clay behind the walls is to be battered at 1.0 Vertical to 1.7 Horizontal (30°) as the walls are demolished.

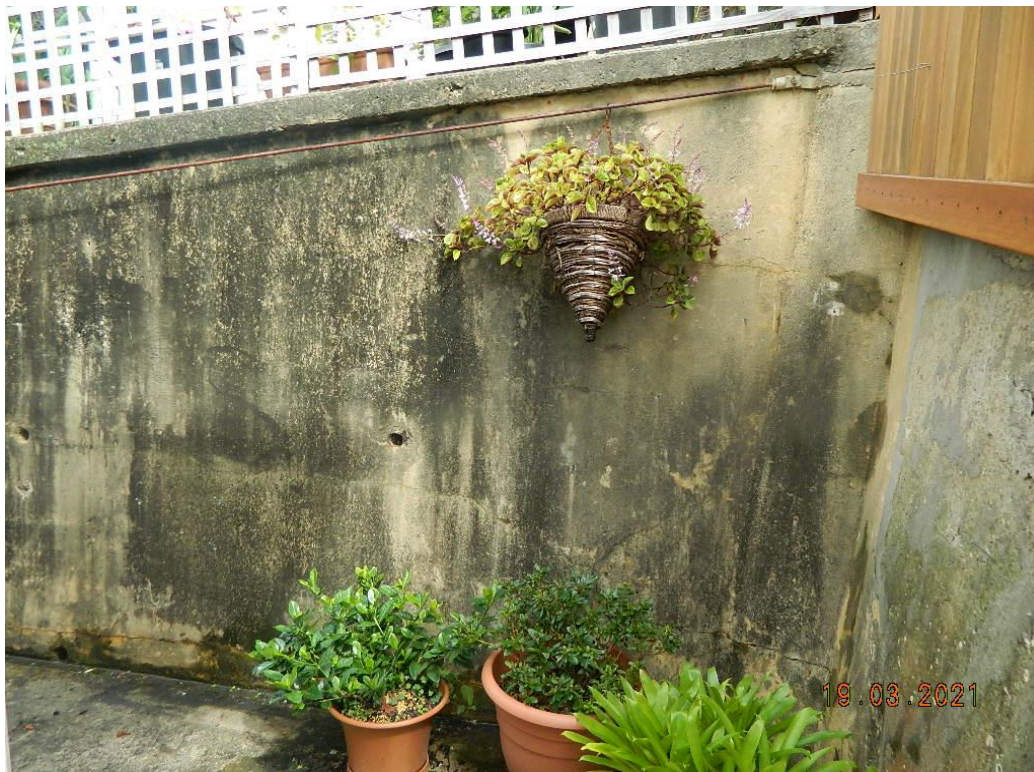
Photo 10

Allowing for backwall-drainage, the house excavation and is set back ~1.5m from the E common boundary, ~2.4m from the W common boundary, ~2.4m from the timber retaining wall that runs along part of the W common boundary (Photos 18 & 19) and ~0.7m from the subject concrete retaining wall (Photo 10).

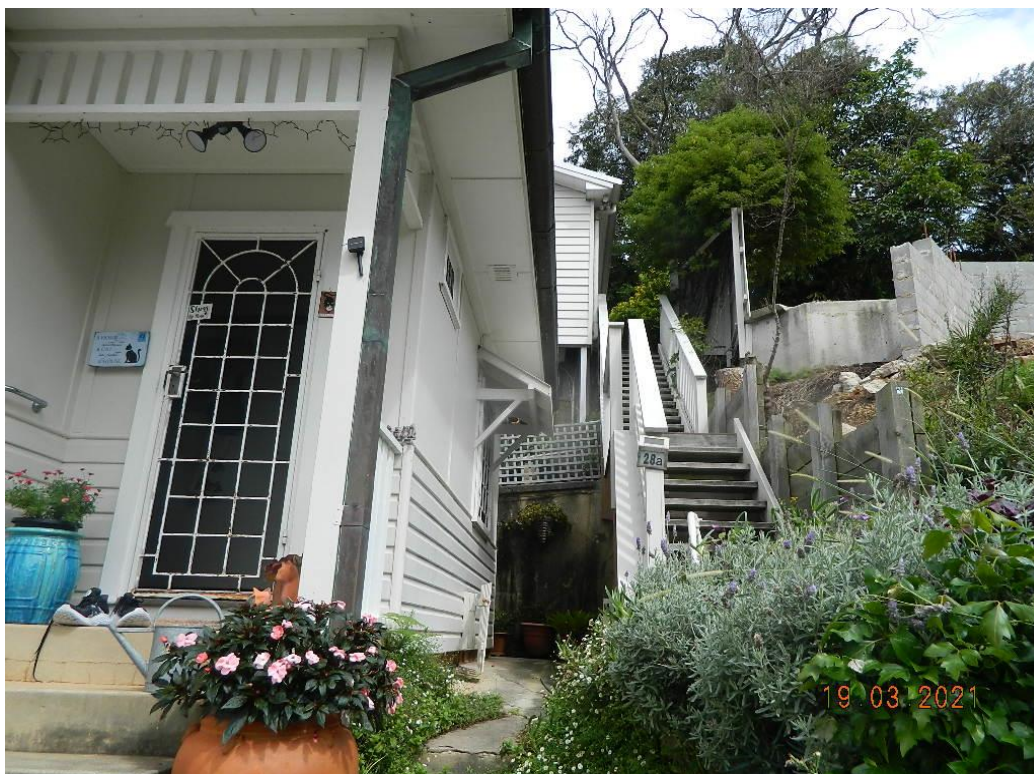
Photo 18

HAZARDS	Hazard Four	Hazard Five
TYPE	The proposed excavation for the house undercutting the concrete retaining wall on the W side of the house (Photo 21), timber retaining wall that runs along part of the W common boundary (Photos 18 & 19) and concrete block retaining wall that runs along part of the E common boundary (Photo 20).	The vibrations produced during the proposed excavations impacting on the surrounding structures.
LIKELIHOOD	'Possible' (10^{-3})	'Possible' (10^{-3})
CONSEQUENCES TO PROPERTY	'Medium' (35%)	'Medium' (15%)
RISK TO PROPERTY	'Moderate' (2×10^{-4})	'Moderate' (2×10^{-4})
RISK TO LIFE	8.3×10^{-5} /annum	5.3×10^{-7} /annum
COMMENTS	This level of risk to life and property is 'UNACCEPTABLE'. To move risk to 'ACCEPTABLE' levels, the recommendations in Section 13 are to be followed.	This level of risk to property is 'UNACCEPTABLE'. To move risk to 'ACCEPTABLE' levels the recommendations in Sections 11 & 12 are to be followed.

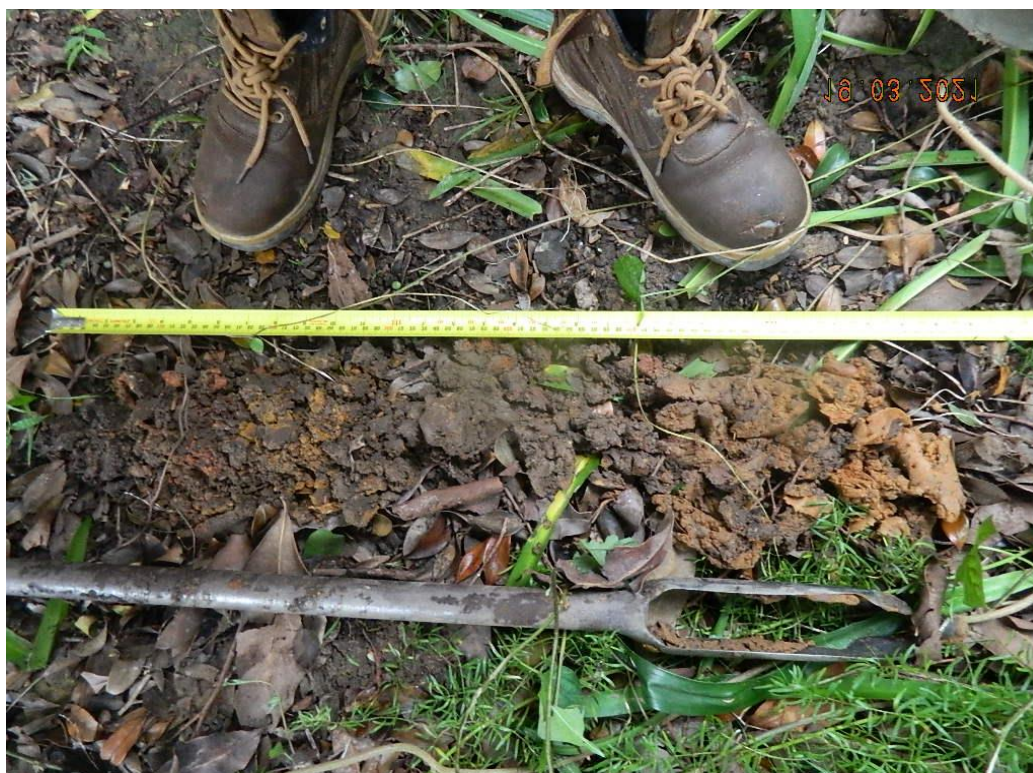
AUGER HOLE 1 (~RL31.7) – AH1 (Photo 22)

Depth (m)	Material Encountered
0.0 to 0.4	FILL , sandy soil and clayey soil with rock fragments, dark brown and orange, damp, fine to coarse grained.
0.4 to 0.5	SANDY SOIL , dark brown, damp, fine to medium grained.
0.5 to 0.8	SANDY CLAY , orange, firm to stiff, damp.

End of hole @ 0.8m in firm to stiff clay. No watertable encountered.

Photo 22: AH1 – Downhole is from left to right.

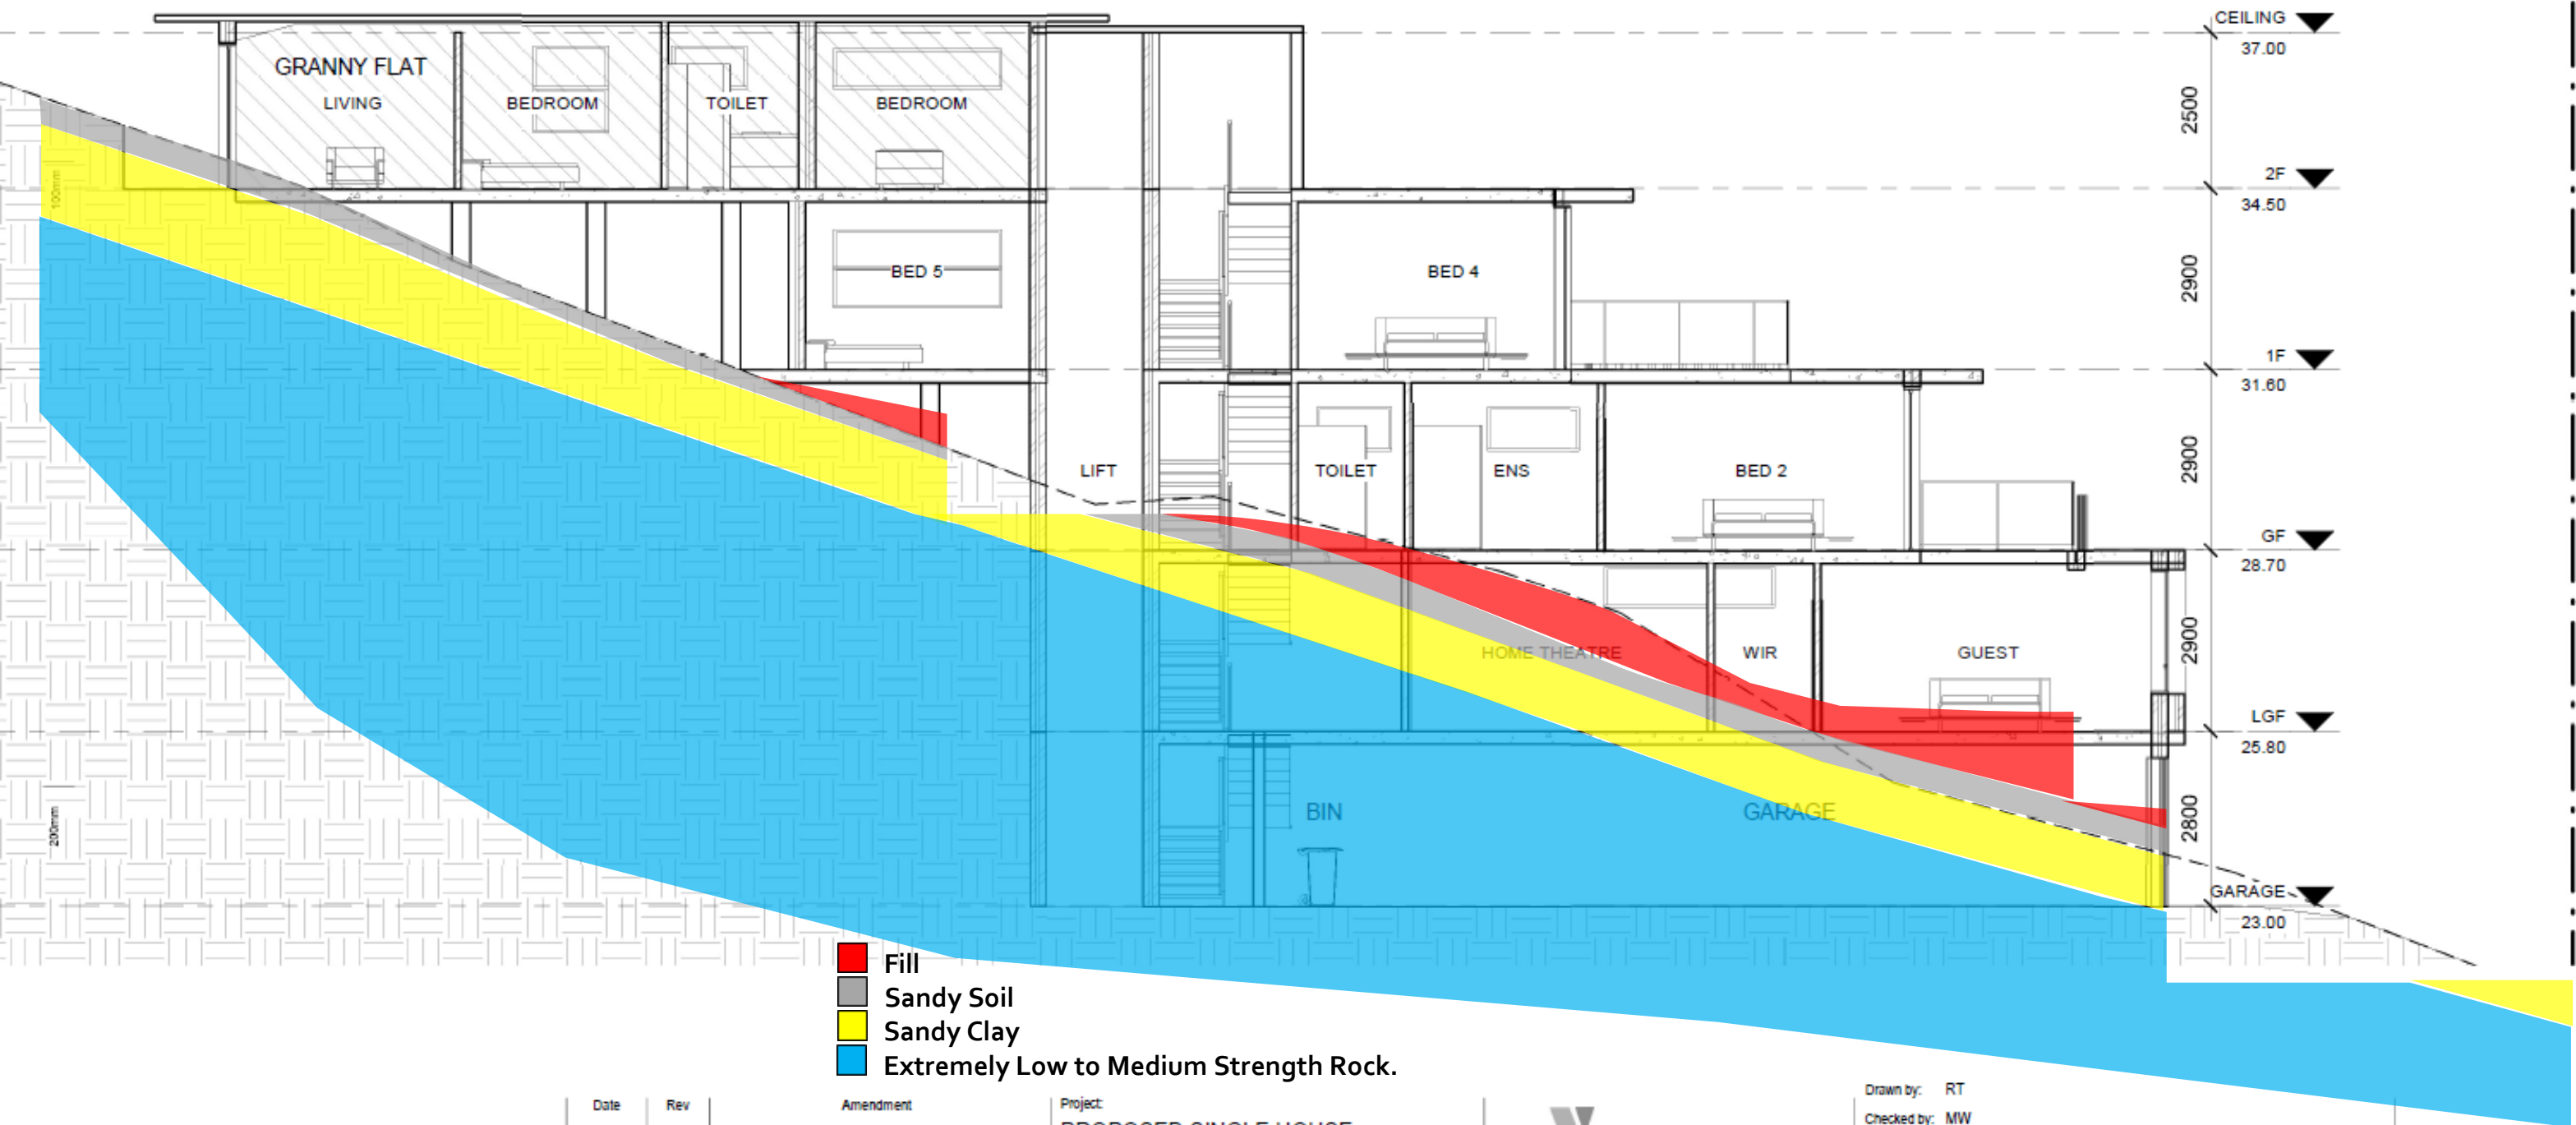
TYPE SECTION – Diagrammatical Interpretation of expected Ground Materials

The slope materials are colluvial at the near surface and residual at depth. In the test locations, the ground materials consist of fill and a sandy topsoil over sandy clays. Fill to a maximum depth of ~1.4m forms near level lawn areas across the property. The clays merge into the weathered zone of the under lying rocks at depths from between ~0.6m to ~2.1m below the current surface. The weathered zone of the underlying rock is interpreted as Extremely Low to Medium Strength Rock. See Type Section attached for a diagrammatical representation of the expected ground materials.
