# Jack Hodgson Consultants Pty Limited

MR 30611  
17<sup>th</sup> May, 2016  
Page 1

## **RISK ANALYSIS & MANAGEMENT FOR PROPOSED VEHICLE CROSSING, CAR PLATFORM AND STORAGE ROOM AT 101 BUNGAN HEAD ROAD, NEWPORT**

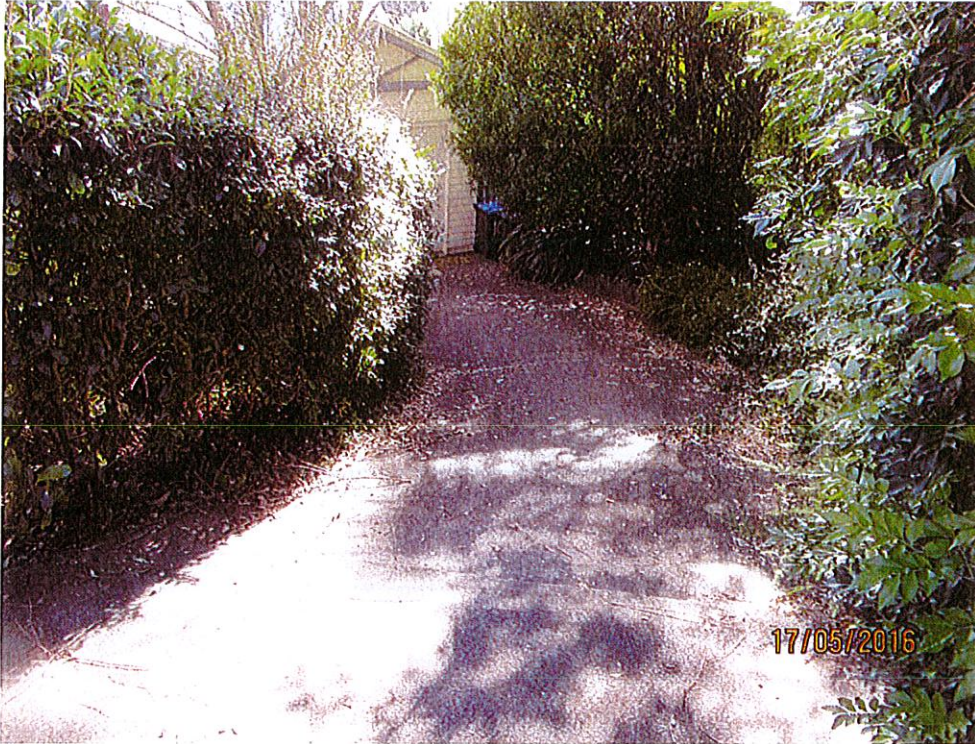
**Photo 1**

3.3 Vehicular access to the property is via concrete driveway that descends from the road frontage and terminates in a garage as part of the main residence (Photo 1). Pedestrian access to the block is via a set of paver stairs that descend from the road frontage through a densely vegetated garden containing small shrubs and trees, before terminating in a paved courtyard that extends along the southern side of the residence (Photos 2 & 3). Access along the western side of the residence is via a paved set of stairs and paved courtyard (Photo 4). The cut for the stairs is supported by a stable timber crib retaining wall (Photo 4). A paved area extends along the northern side of the residence (Photo 5). A set of garden beds are located below the paved area and are supported by stable treated timber retaining walls (Photo 6). From the garden beds a lawn area gently falls toward the northern boundary (Photo 7). Access along the eastern side of the residence is via a concrete pathway (Photo 8).

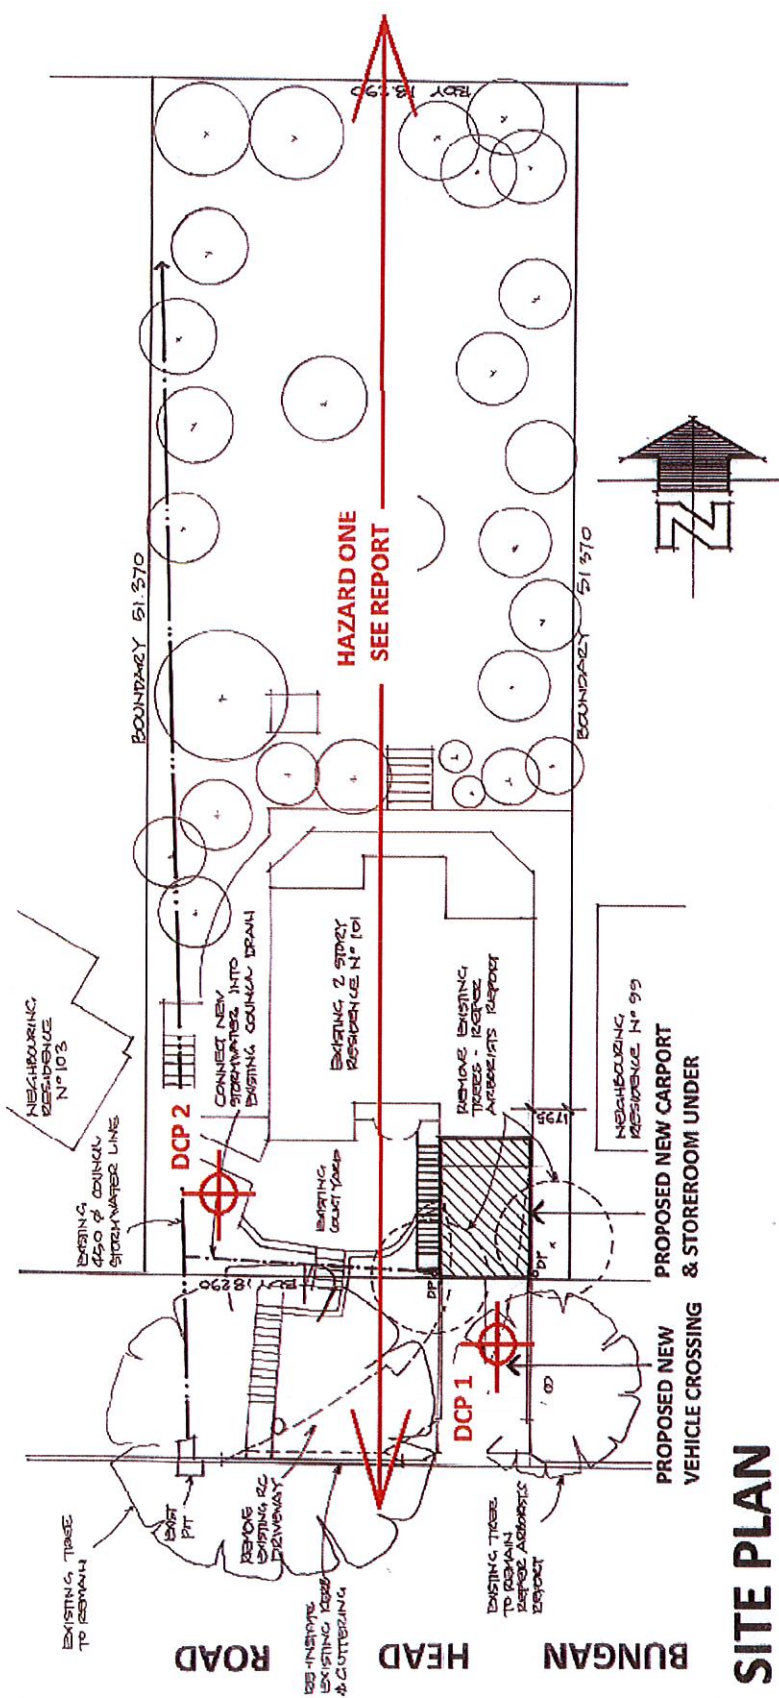
SITE PLAN - HAZARD AND DCP LOCATIONS			
Job No	Address		
	101 BUNGAN HEAD ROAD		
	NEWPORT		
Scale	NTS	NSW

5.1 Two Dynamic Cone Penetrometer (DCP) tests were put down to determine the nature of the subsurface profile. The locations of these tests are shown on the site plan provided and the results are as follows:

**DCP1:** Refusal on weathered rock @ 0.70m. Fine grained red impact dust on dry tip. No evidence of water table.

**DCP2:** Refusal on weathered rock @ 1.30m. Fine grained red/orange impact dust on dry tip. No evidence of water table.
