Report Title: Geotechnical Report 100 Hilltop Road, Avalon
Report Date: 24/8/22
Author: BEN WHITE
Author's Company/Organisation: WHITE GEOTECHNICAL GROUP PTY LTD

GEOTECHNICAL INVESTIGATION:

New House at **100 Hilltop Road, Avalon**

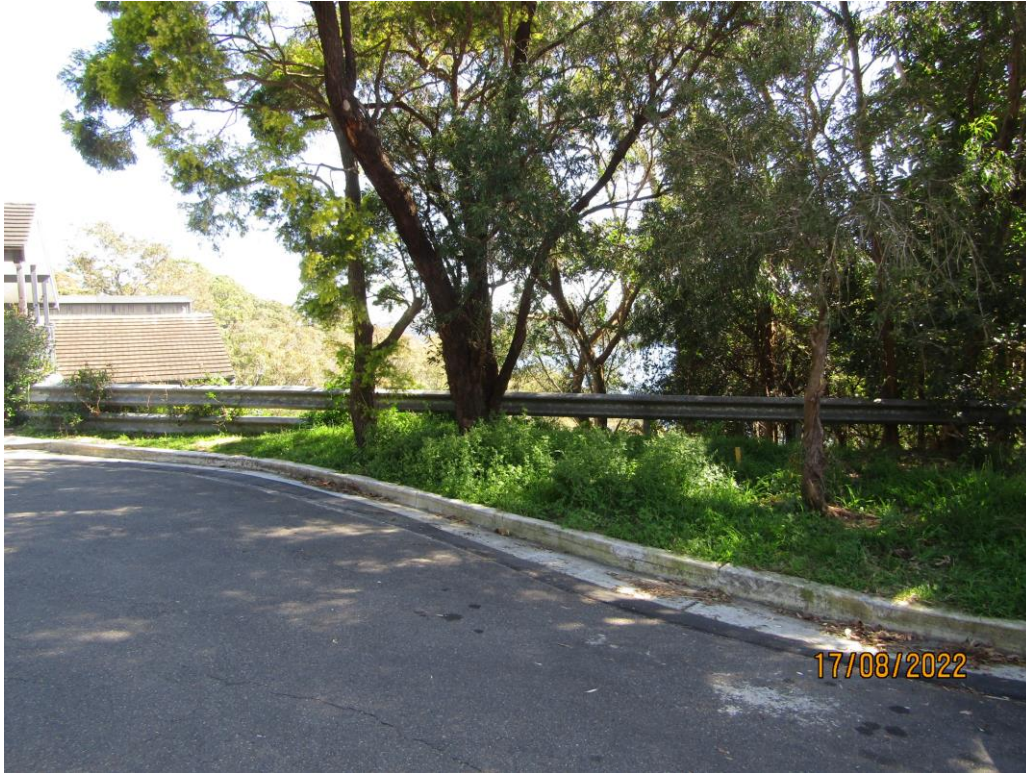
Photo 1

- 2.3** Fill provides a level platform for the road and road reserve (Photo 1). The fill is supported by a concrete crib retaining wall that is estimated to be up to ~4.0m high (Photo 2). Part of the wall is obscured by vegetation and could not be adequately assessed. The visible portion of the wall appears to be currently stable. The vacant block is thickly vegetated (Photos 3 & 4). Sandstone bedrock is outcropping at the upper middle portion of the property (Photo 5). Detached sandstone joint blocks are embedded in stable positions in the slope (Photos 6 & 7).

the property. The required pier depths on the uphill side of the driveway are expected to be ~5m to ~6m deep due to the presence of ~3m to ~4m of fill at the road reserve (Photos 1 & 2). A maximum allowable bearing pressure of 600kPa can be assumed for piers embedded into Extremely Low Strength Rock or better. It should be noted that this material is a soft rock and a rock auger will cut through it so the builders should not be looking for refusal to end the footings.

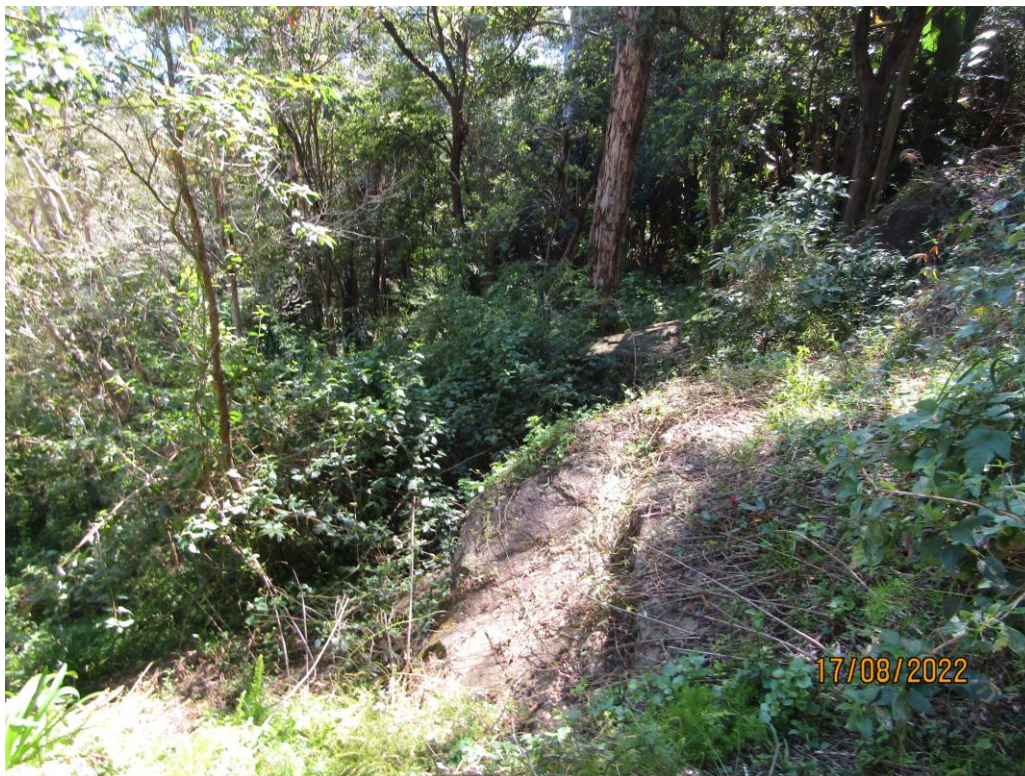
Photo 5

The slope materials are colluvial at the near surface and residual at depth. In the test locations, the ground materials consist of colluvium over firm to stiff clays. Medium Strength Sandstone bedrock is outcropping at the upper middle portion of the property (Photo 5). This is expected to be a band of sandstone in an otherwise shale dominated profile. In the test locations, the depth to weathered rock ranged from ~0.7m to ~1.3m below the current

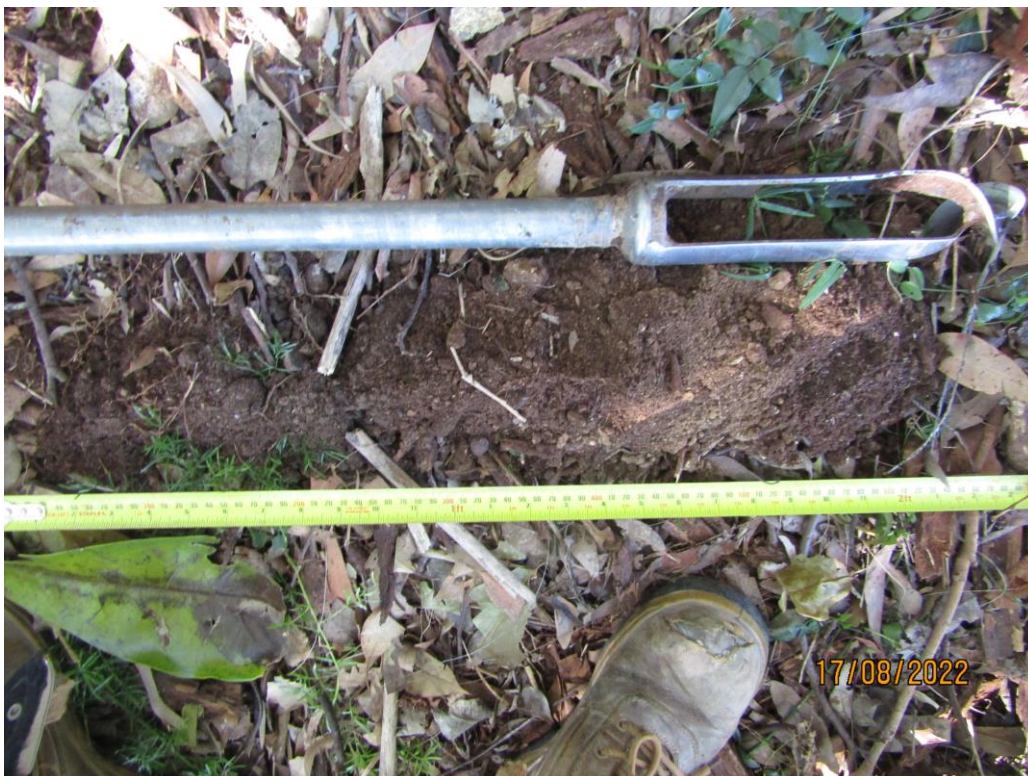
AUGER HOLE 1 (~RL71.8) – AH1 (photo 8)

Depth (m)	Material Encountered
0.0 to 0.6	COLLUVIUM , soil and clay, dark brown, orange, dry, fine to coarse grained.

Refusal @ 0.6m in colluvium. No watertable encountered.

Photo 8: AH1 – Downhole is from left to right.

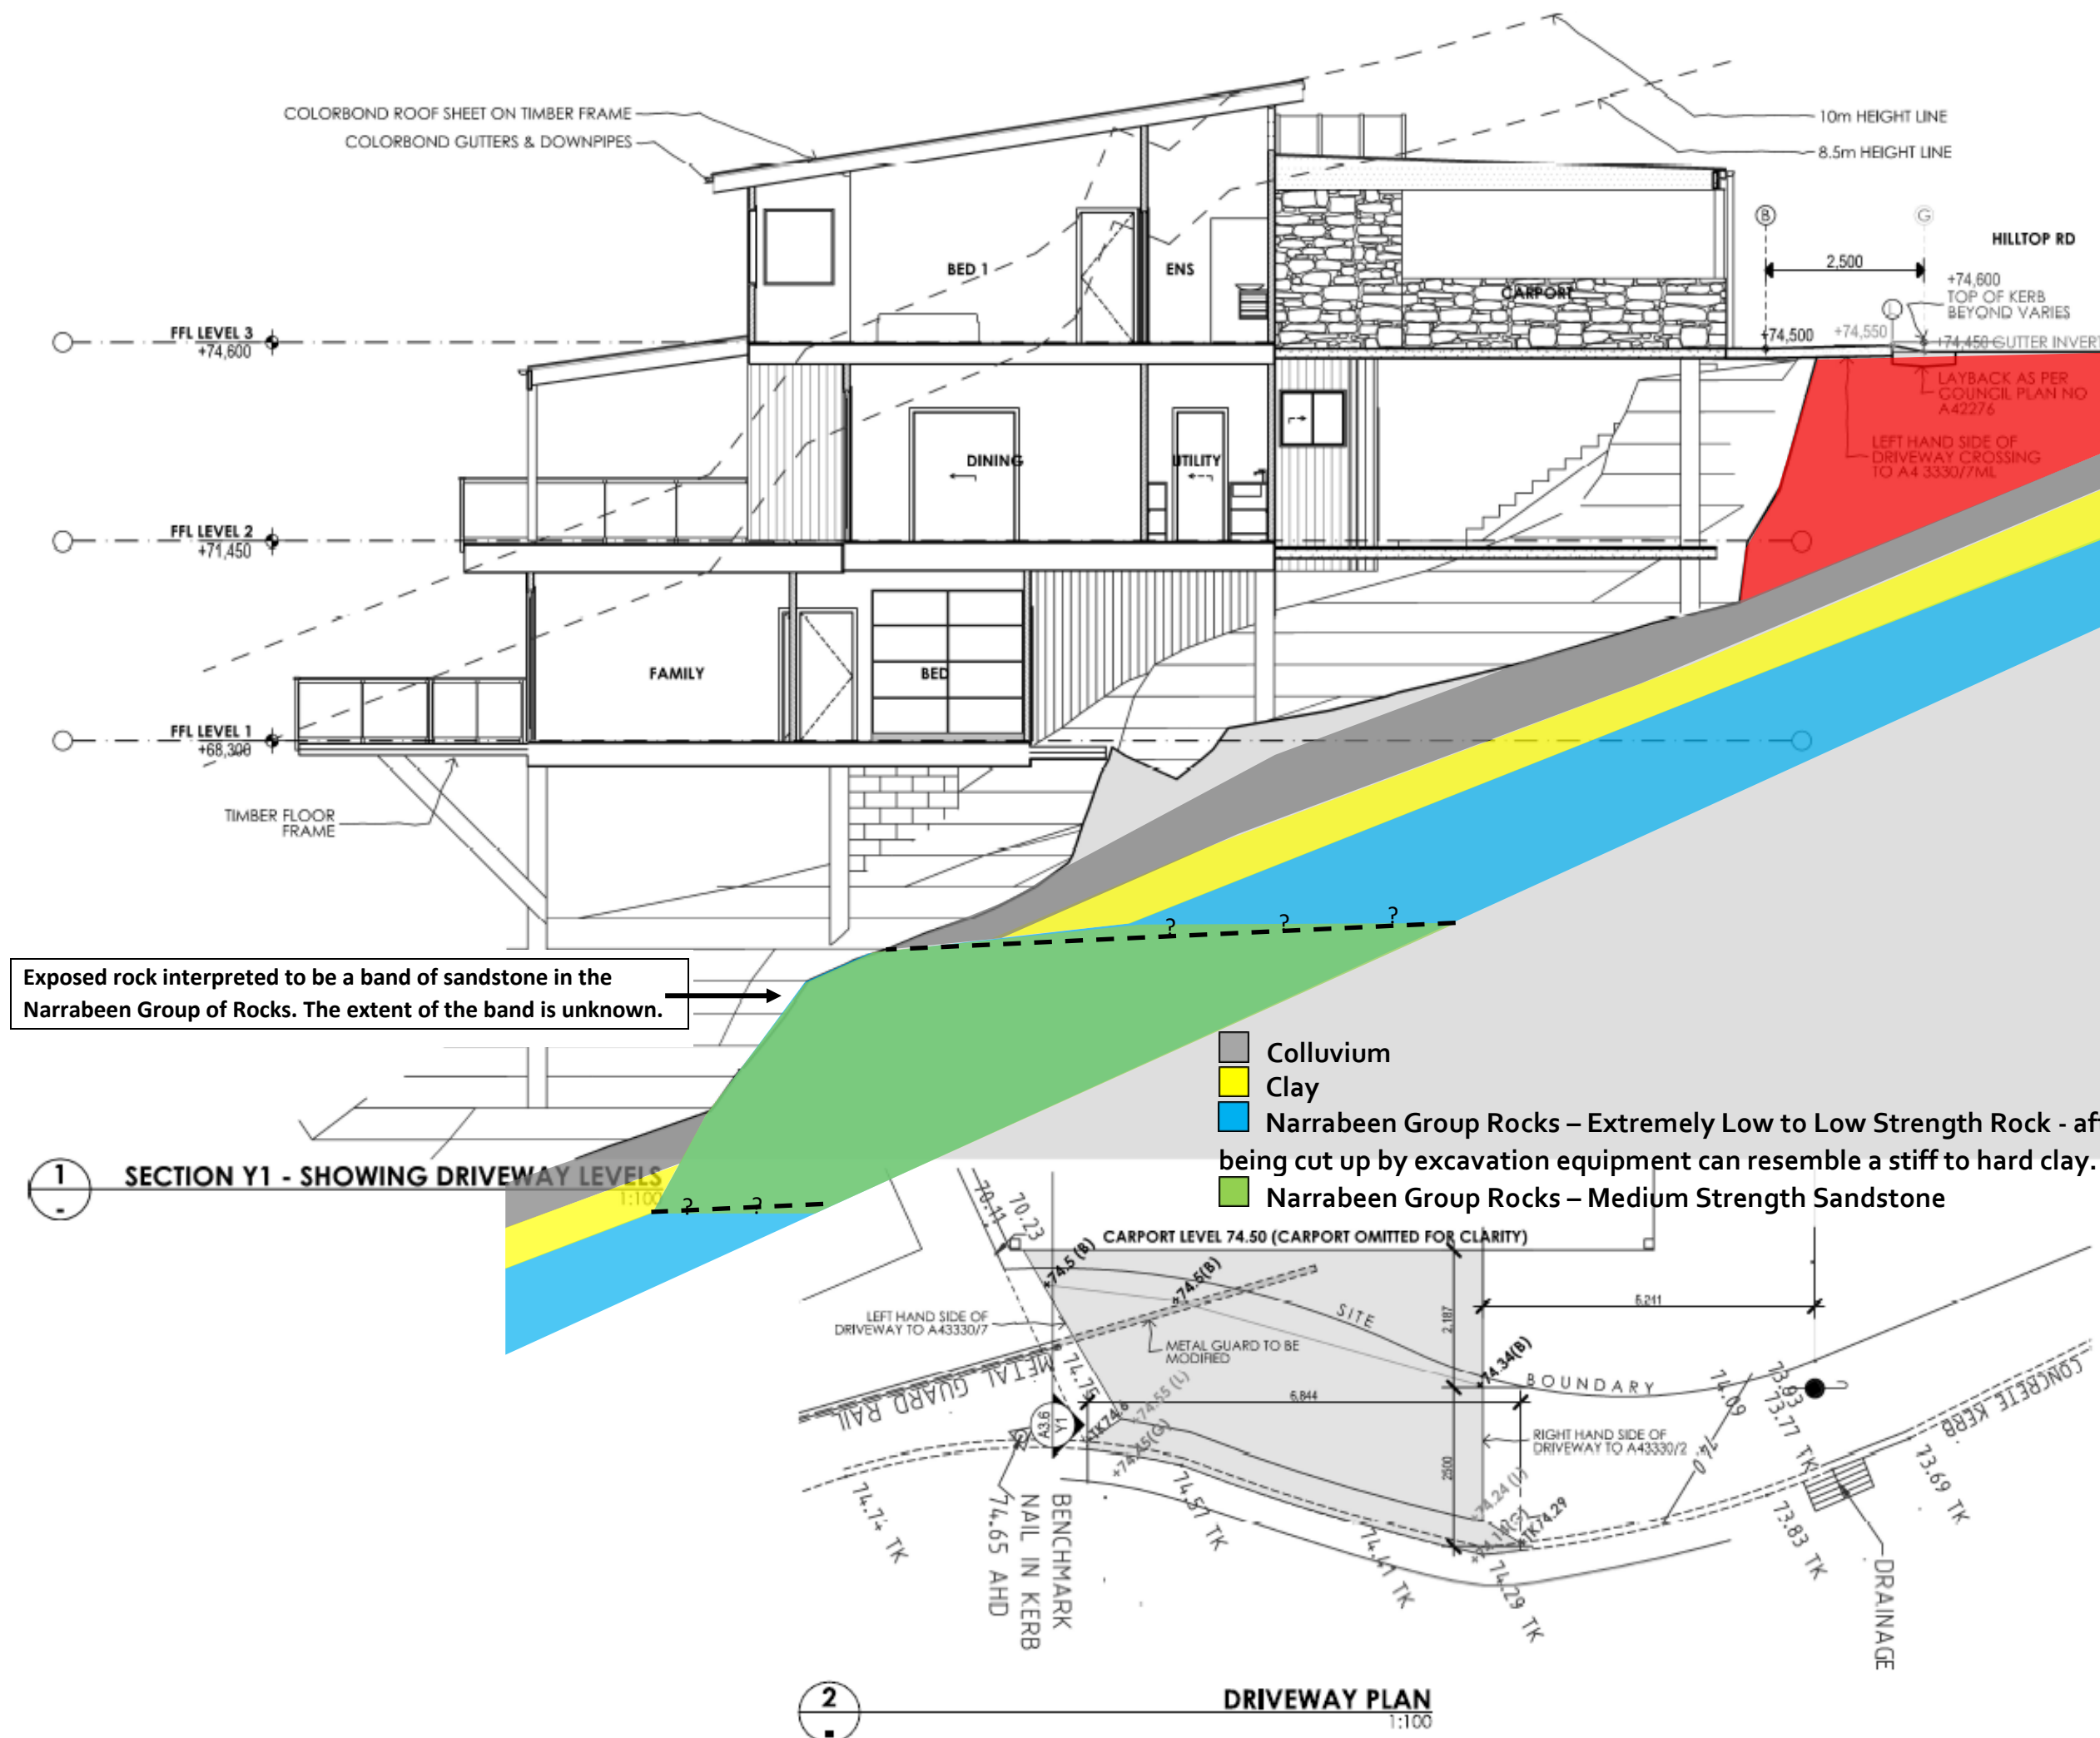
TYPE SECTION – Diagrammatical Interpretation of expected Ground Materials

surface, being shallower near where sandstone is outcropping (DCP4). The weathered zone of the underlying rock is interpreted as Extremely Low to Low Strength Rock. It is to be noted that this material is a soft rock and can appear as a mottled stiff clay when it is cut up by excavation equipment. See Type Section attached for a diagrammatical representation of the expected ground materials.
