Report Title: Geotechnical Report 57 Hillside Road, Newport

Report Date: 30/11/20

GEOTECHNICAL INVESTIGATION:

Alterations and Additions at 57 Hillside Road, Newport

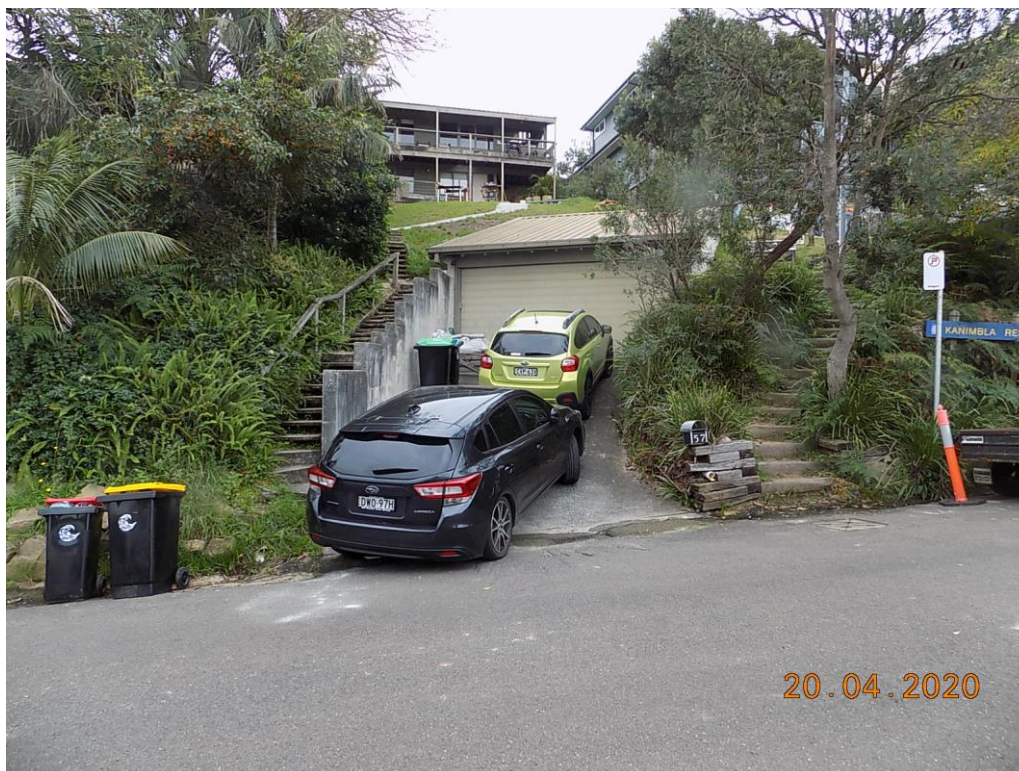
Photo 1

- 2.3** At the road frontage, a concrete driveway runs to a garage that has been cut into the slope (Photo 1). The cut for the driveway and garage is supported by a concrete block retaining wall reaching ~3.6m high (Photo 2). Between the garage and the house is a gentle to moderately-sloping lawn (Photo 3). The two-storey house is supported on brick walls (Photo 4). The supporting brick walls display no significant signs of movement. A ~2.0m excavation has been made for a small courtyard near the uphill side of the house. The cut is supported by a stable dintel retaining wall (Photo 5). Between the house and the upper boundary is a moderately sloping lawn and garden area (Photo 6).

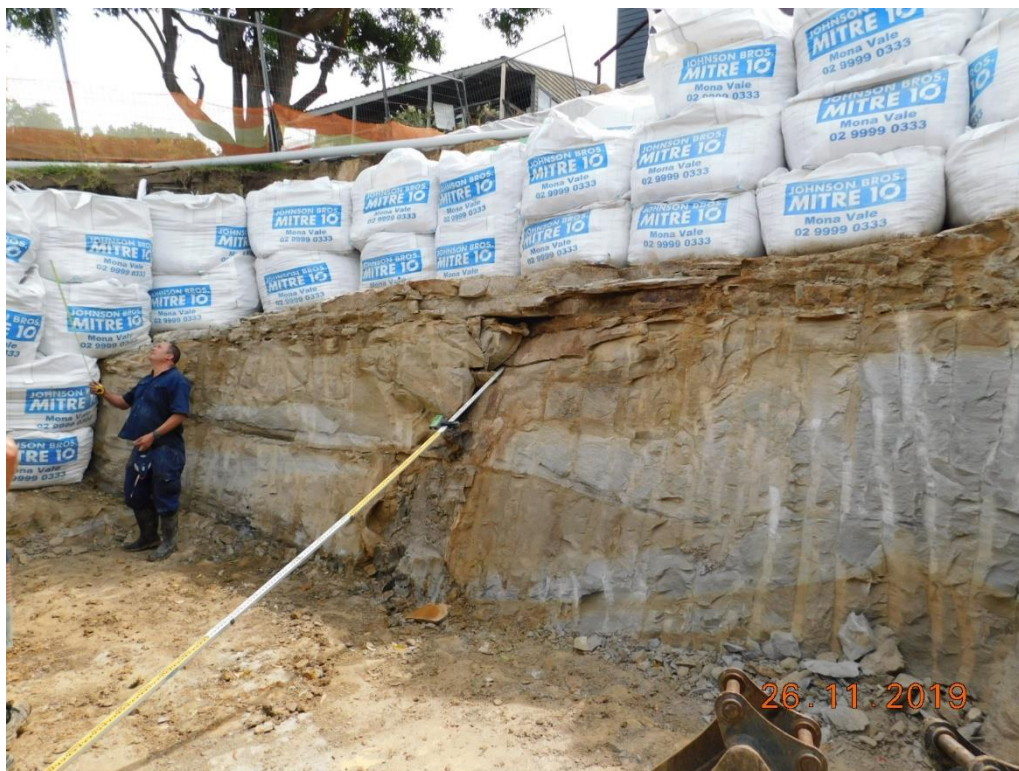
The Sydney 1:100 000 Geological sheet indicates the site is underlain by the Newport Formation of the Narrabeen Group. A band of sandstone was observed through an excavation on the N neighbouring property that likely extends under the subject property (Photo 7). This band extends through the otherwise shale-dominated profile.

A band of Medium Strength Sandstone was observed to be exposed through an excavation on the N neighbouring property and is expected to continue under the subject property (Photo 7). This is an unusually thick sandstone bed within the Narrabeen Group of rocks. The extent of the band is not known. See Type Section attached for a diagrammatical representation of the expected ground materials.

Photo 7: Excavation on N neighbouring property.

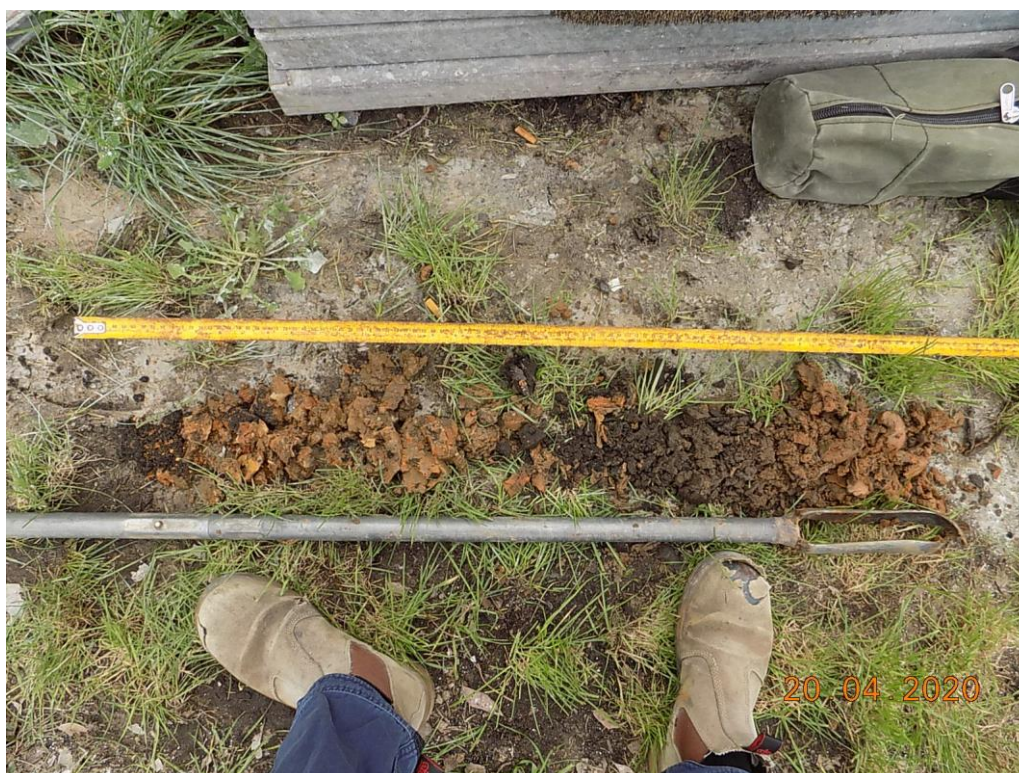
AUGER HOLE 1 (~RL61.8) – AH1 (Photo 8)

Depth (m)	Material Encountered
0.0 to 0.6	FILL , disturbed clay, dark brown, brown, and orange, very soft to soft, dry, fine to medium grained with fine trace organic matter.
0.6 to 0.8	CLAYEY SOIL , dark brown, stiff, dry, fine to medium grained with fine trace organic matter.
0.8 to 1.0	CLAY , weathered shale, stiff, dry, fine grained.

End of test @ 1.0m in weathered shale. No watertable encountered.

Photo 8: AH1 – Downhole is from left to right.
