# Jack Hodgson Consultants Pty Limited

MU 31713.  
24<sup>th</sup> May, 2019.  
Page 1.

## **RISK ANALYSIS & MANAGEMENT FOR PROPOSED ALTERATIONS, ADDITIONS AND DRIVEWAY AT 13 AMIENS ROAD, CLONTARF**

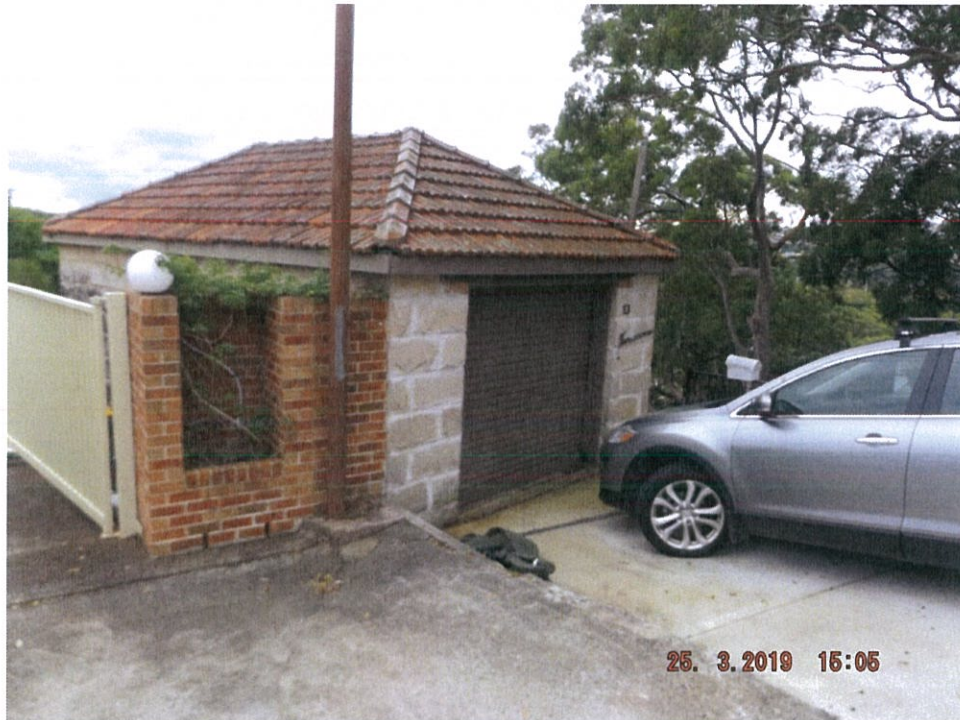
Photo 1

3.3 At the road frontage the short concrete driveway leads to the single garage at just below the road level, Photo 1. The driveway and the eastern front boundary and the edge of the Amiens Road are supported by several rock stacked retaining walls,

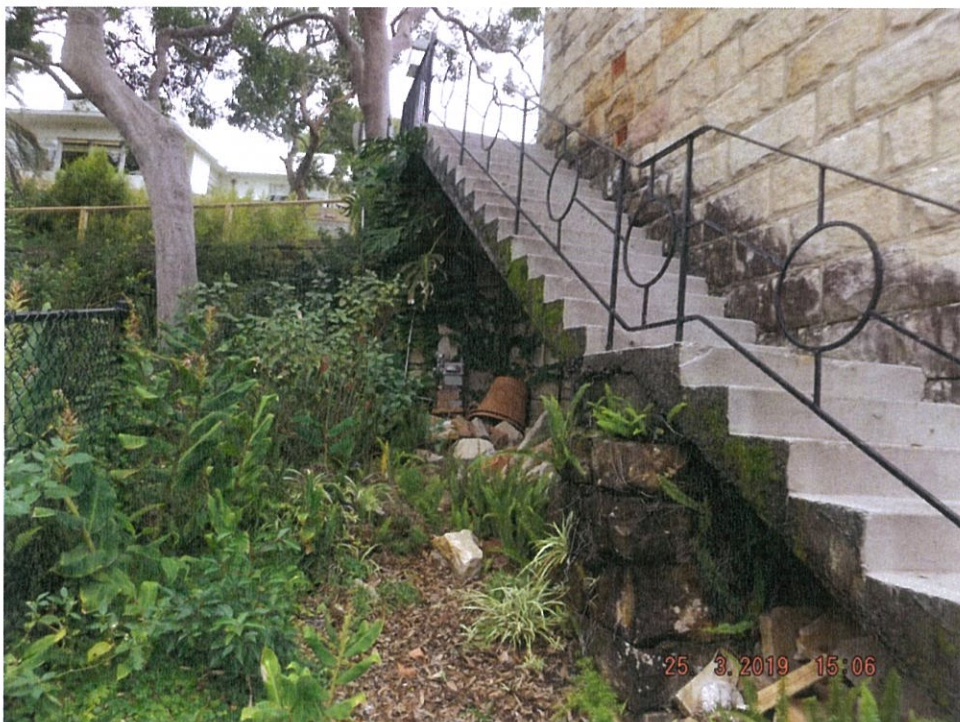
Photo 2

Photo 2. At the rear of the garage a gentle sloping lawn areas is accessed by a set stairs of the western side of the garage, Photo 3. This lawn area is created by use of retaining walls along the western and northern edges and the use of fill material placed over the existing bedrock. A storage area is under the existing garage. The sandstone walls of the storage room are also retaining walls. An elevated driveway runs adjacent the southern side boundary on the neighbouring property with low rock retaining wall supporting material along this boundary, Photo 4. A set stairs on the southern side of the property leads down a patio in front of the existing residence siting at the toe of the visible rock shelf, Photo 5. No access to the rear the property is possible on the southern side of the existing residence, Photo 6. A set stairs provides access to the rear of the property on the northern side of the existing residence, Photo 7. An elevated balcony and swimming pool is at the rear of the residence, Photo 8. On the northern underside of the elevated rear patio an old masonry retaining wall is observed to be out of vertical, Photo 9. This retaining wall maybe no longer required but we were unable to determine this at the time of our inspection and further investigation would be required. A set stairs on the southern side of the swimming pool provides access to the rear of the site. The landscaped stairs have been carved out of the exposed sandstone bedrock in some places, Photo 10. Some terraced rock stacked retaining walls provide support along the southern side boundary toward the south western rear corner. These retaining walls were observed stable at the time of inspection, Photo 11. A stable batter was observed underneath of the swimming pool where we also observed the piers that support the swimming pool, Photo 12.
