Ref: 240851

**RE: CONSULTING STRUCTURAL ENGINEER SERVICES
INSPECTION & CERTIFICATION OF UNAUTHORISED STUDIO AT 34 KING STREET, MANLY
VALE**

Appendix 1: Existing alterations & additions as inspected on 25.09.2024

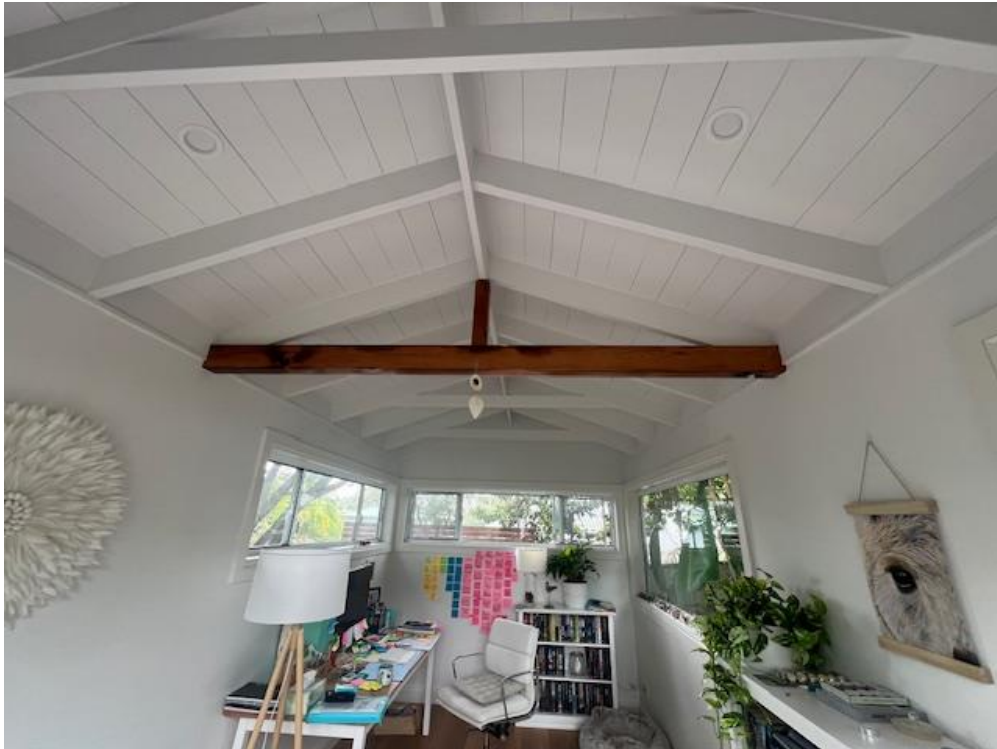
Photo 1: Existing conditions of studio roof framing

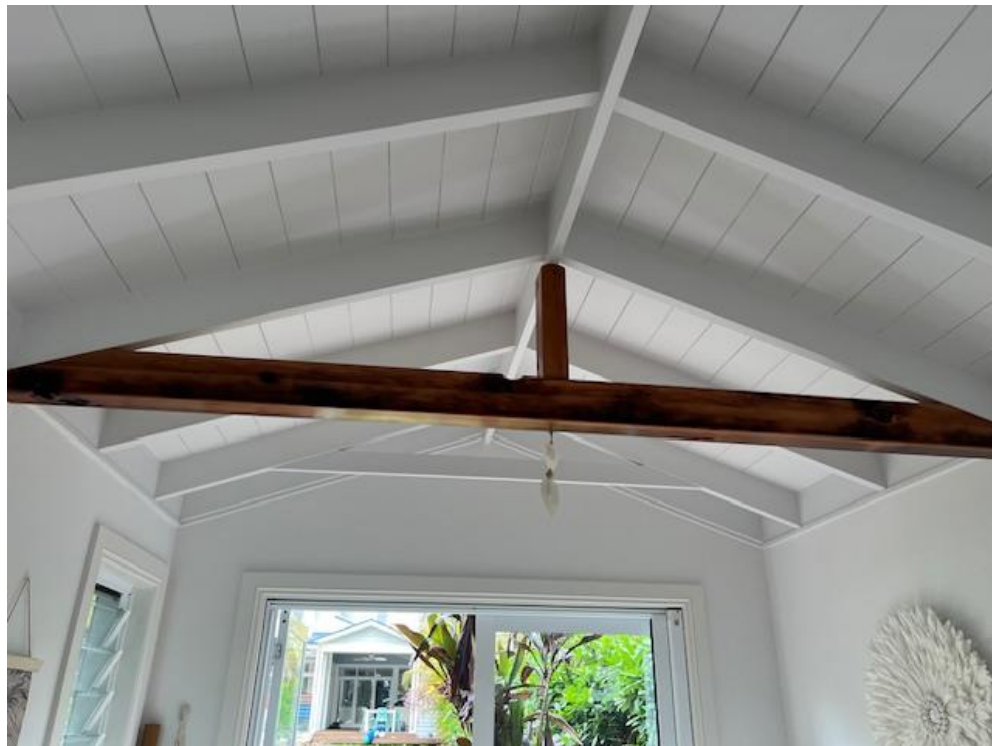
Photo 2: Existing conditions of studio roof framing & opening

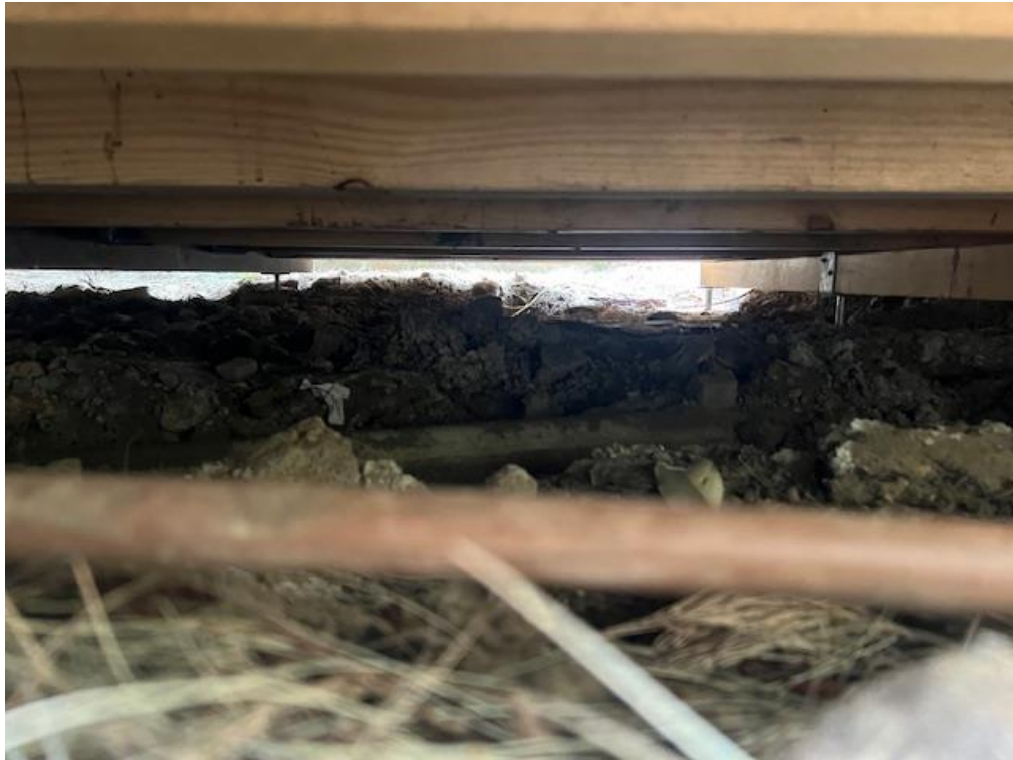
Photo 3: Existing conditions of studio floor joists

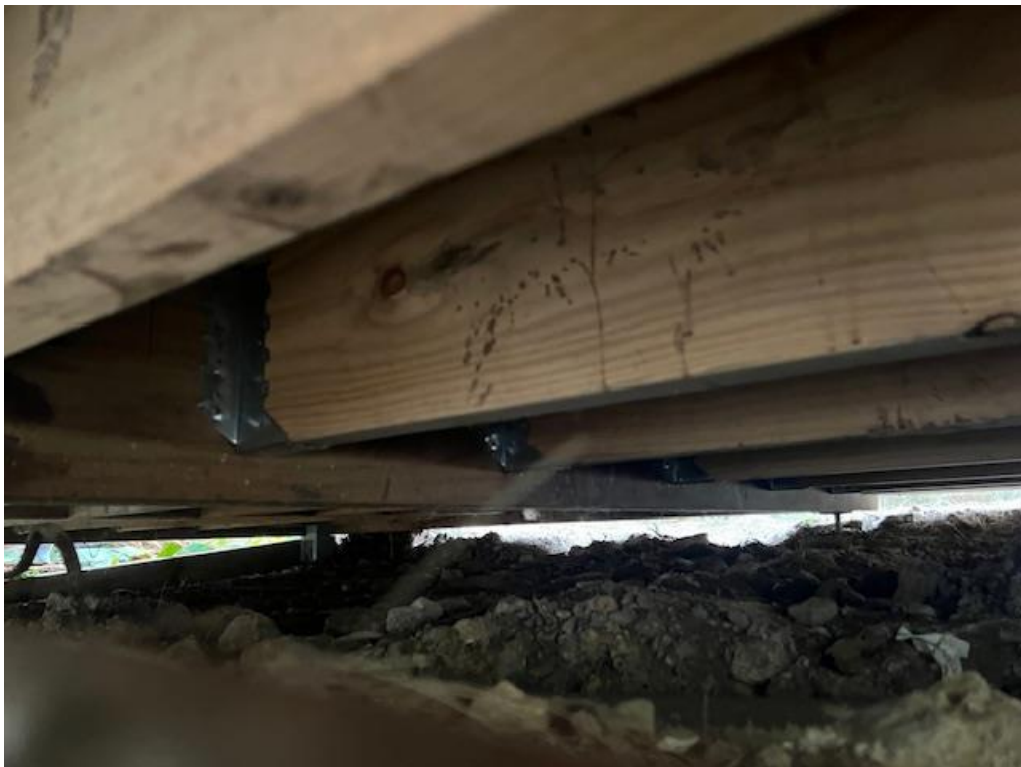
Photo 4: Existing conditions of joist hangers & bearer
