Geotechnical Assessment

Project: New Dwelling
12 Molong Street, North Curl Curl NSW

Ref: AG 25041
6 February 2025

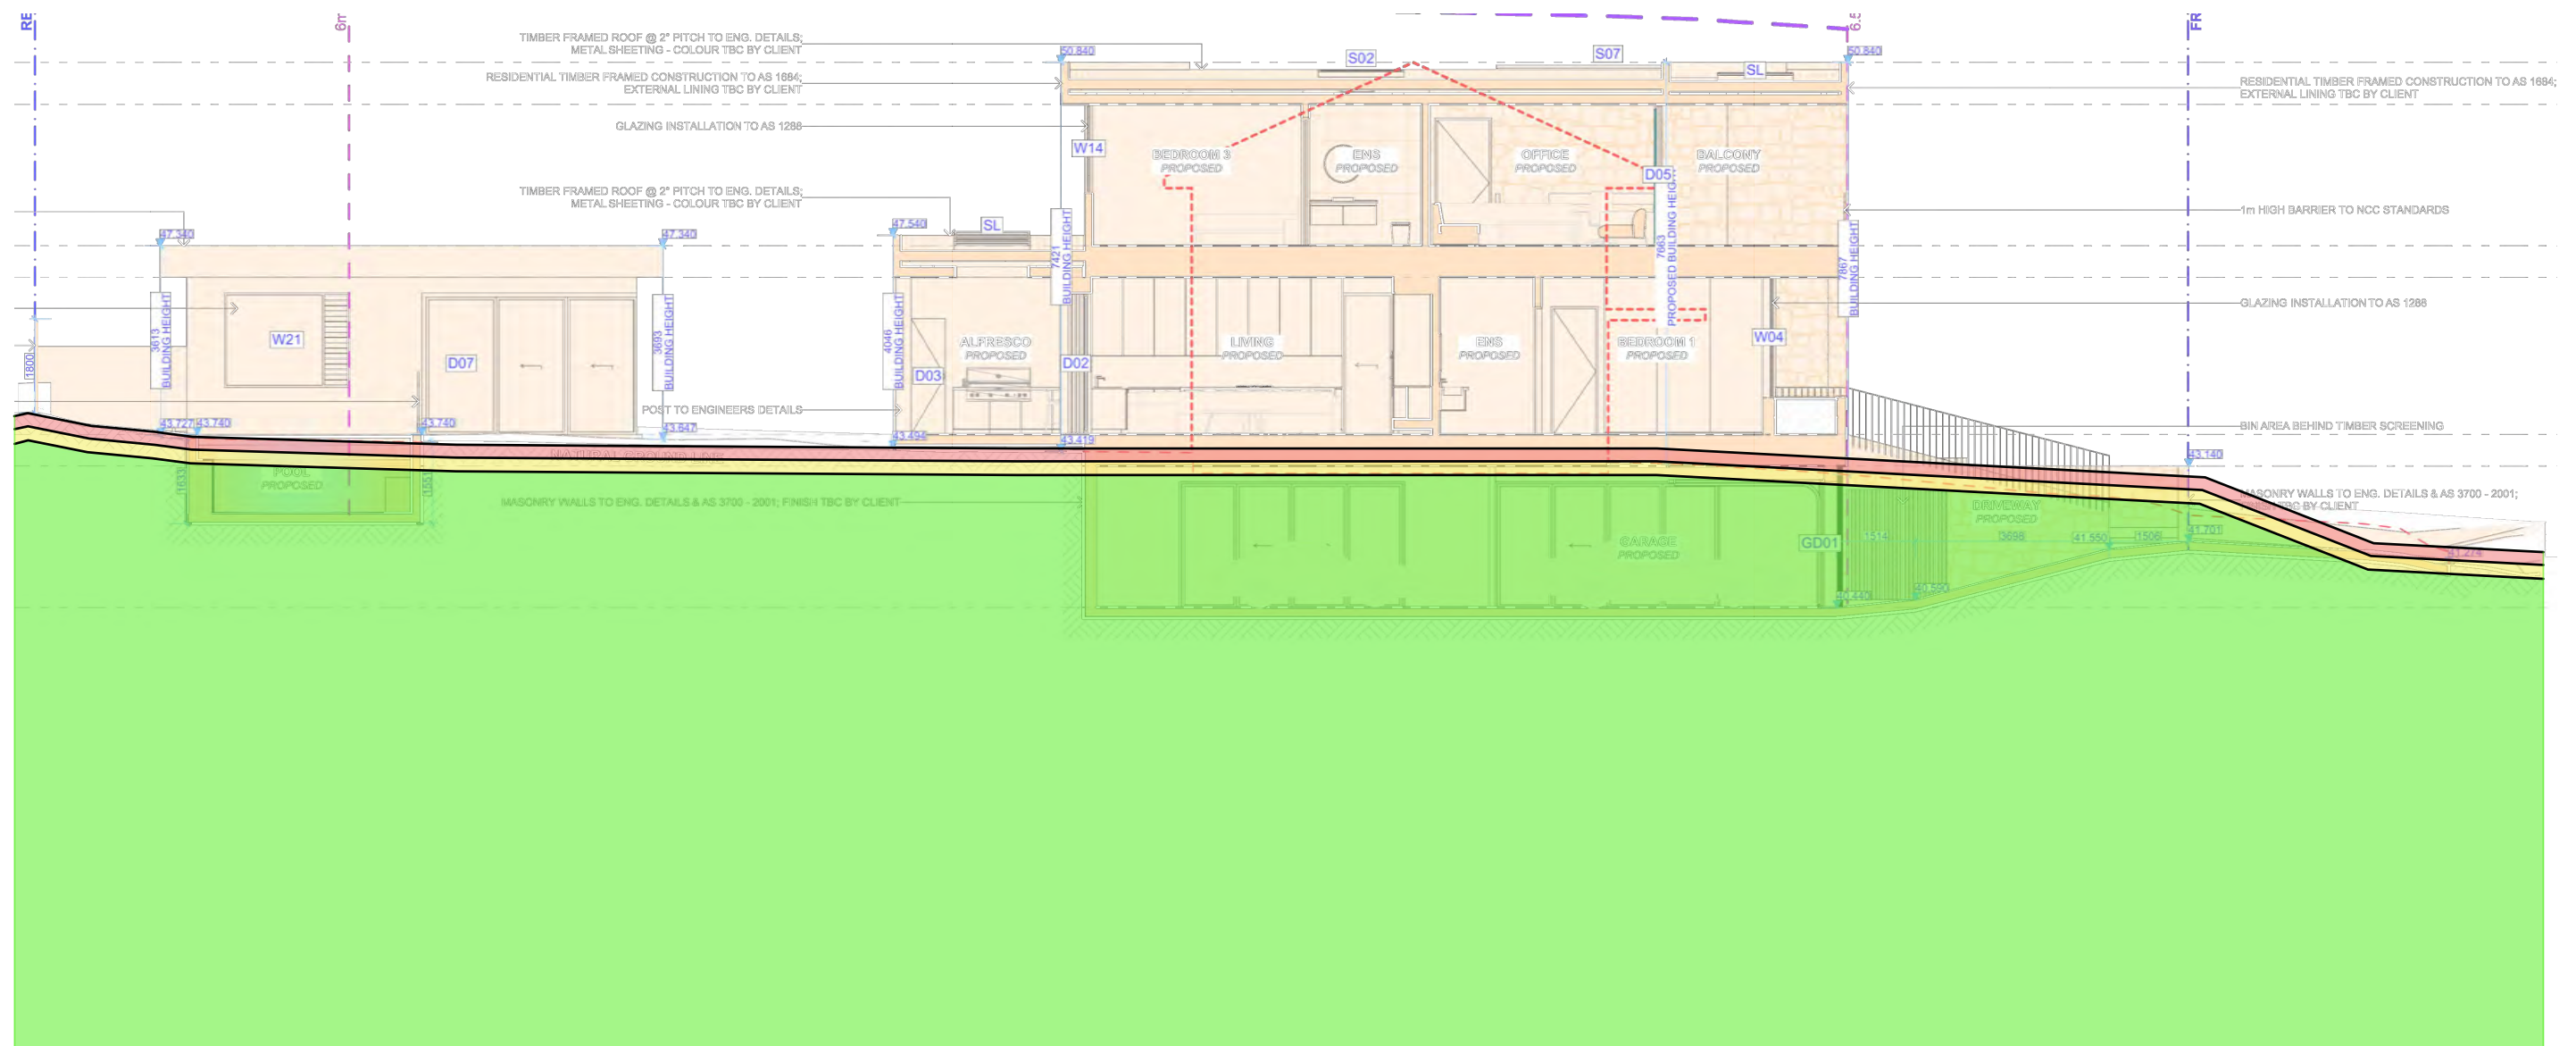
INFERRED GEOLOGICAL SECTION

Unit	Material	Comments
1	Topsoil / Fill	Sandy disturbed topsoil and uncontrolled, poorly compacted fill material.
2	Silty Sand	Fine to medium grained, Silty Sand. Loose to medium dense in consistency, increasing density with depth.
3	Sandstone	Medium strength or greater sandstone bedrock (Class III+*) expected to be found below the weathered crust (Class V*).

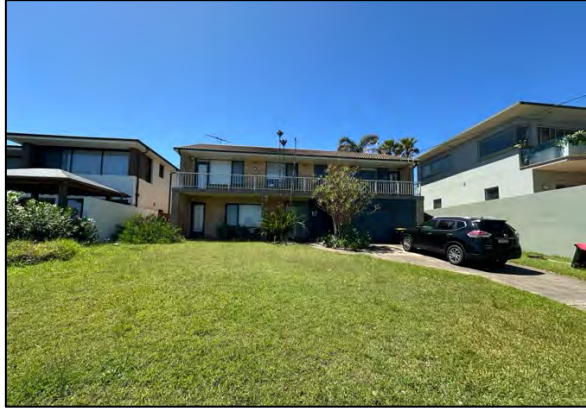
Photo 1: Site frontage, looking north.

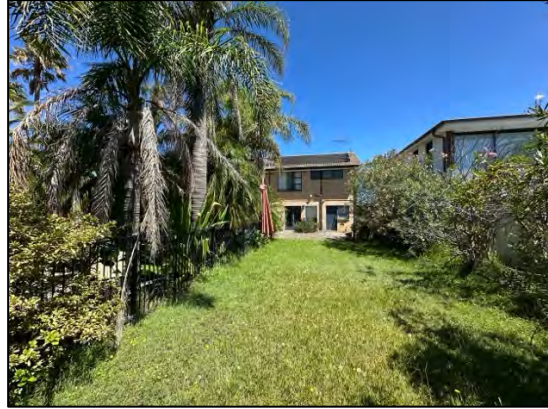
Photo 2: Photo taken from northern boundary, looking south.

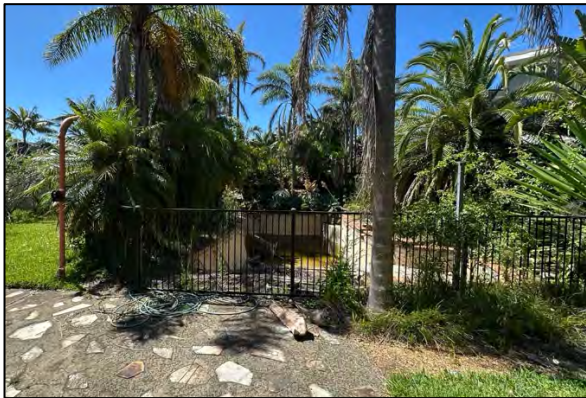
Photo 3: Rear of site, existing dilapidated pool to be demolished, looking north.

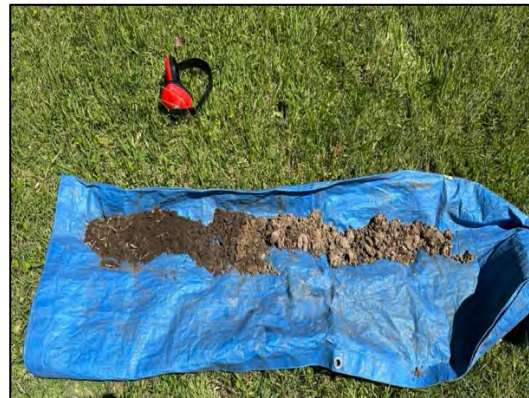
Photo 4: Subsurface soil profile of BH02.
